INTERSTATE COMMERCE COMMISSION

REPORT OF THE DIRECTOR

COLORADO AND SOUTHERN RAILWAY

KENOSHA, COLO

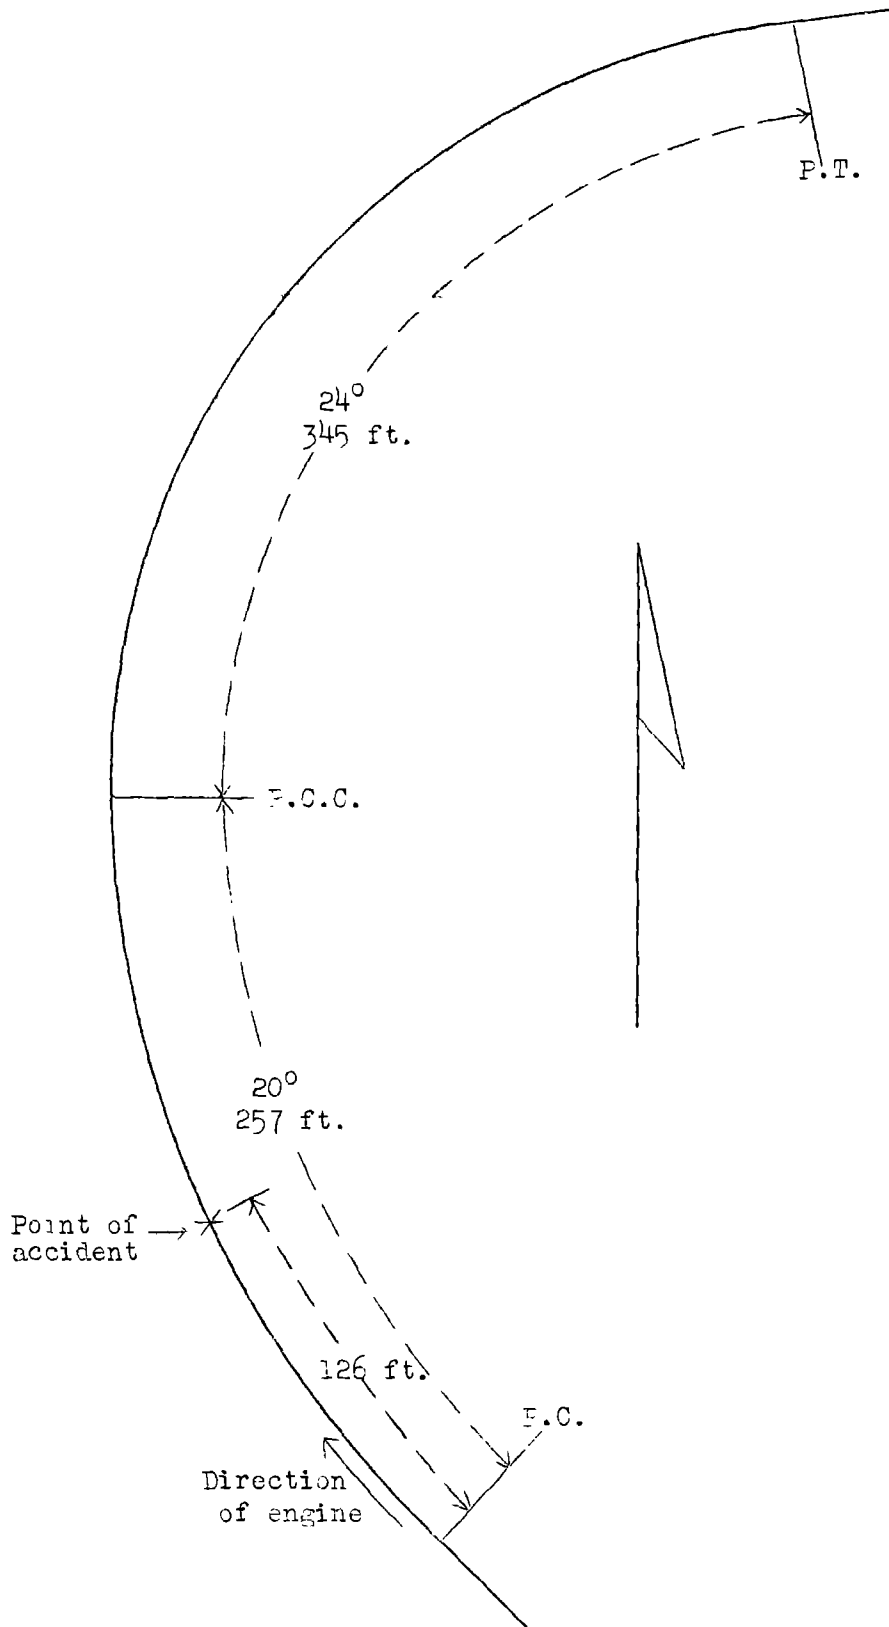
Inv. No. 2087  
Colorado and Southern Ry.  
Kenosha, Colo.  
July 25, 1936.

o	Denver, Colo.
	7.6 mi.
o	Sheridan Jct.
	68.4 mi.
■	Point of accident
o	Kenosha
	12.12 mi.
o	Como, Colo.
