RAILROAD ACCIDENT INVESTIGATION

Report No 3819

THE COLORADO AND SOUTHERN RAILWAY COMPANY

CHUGWATER, WYO

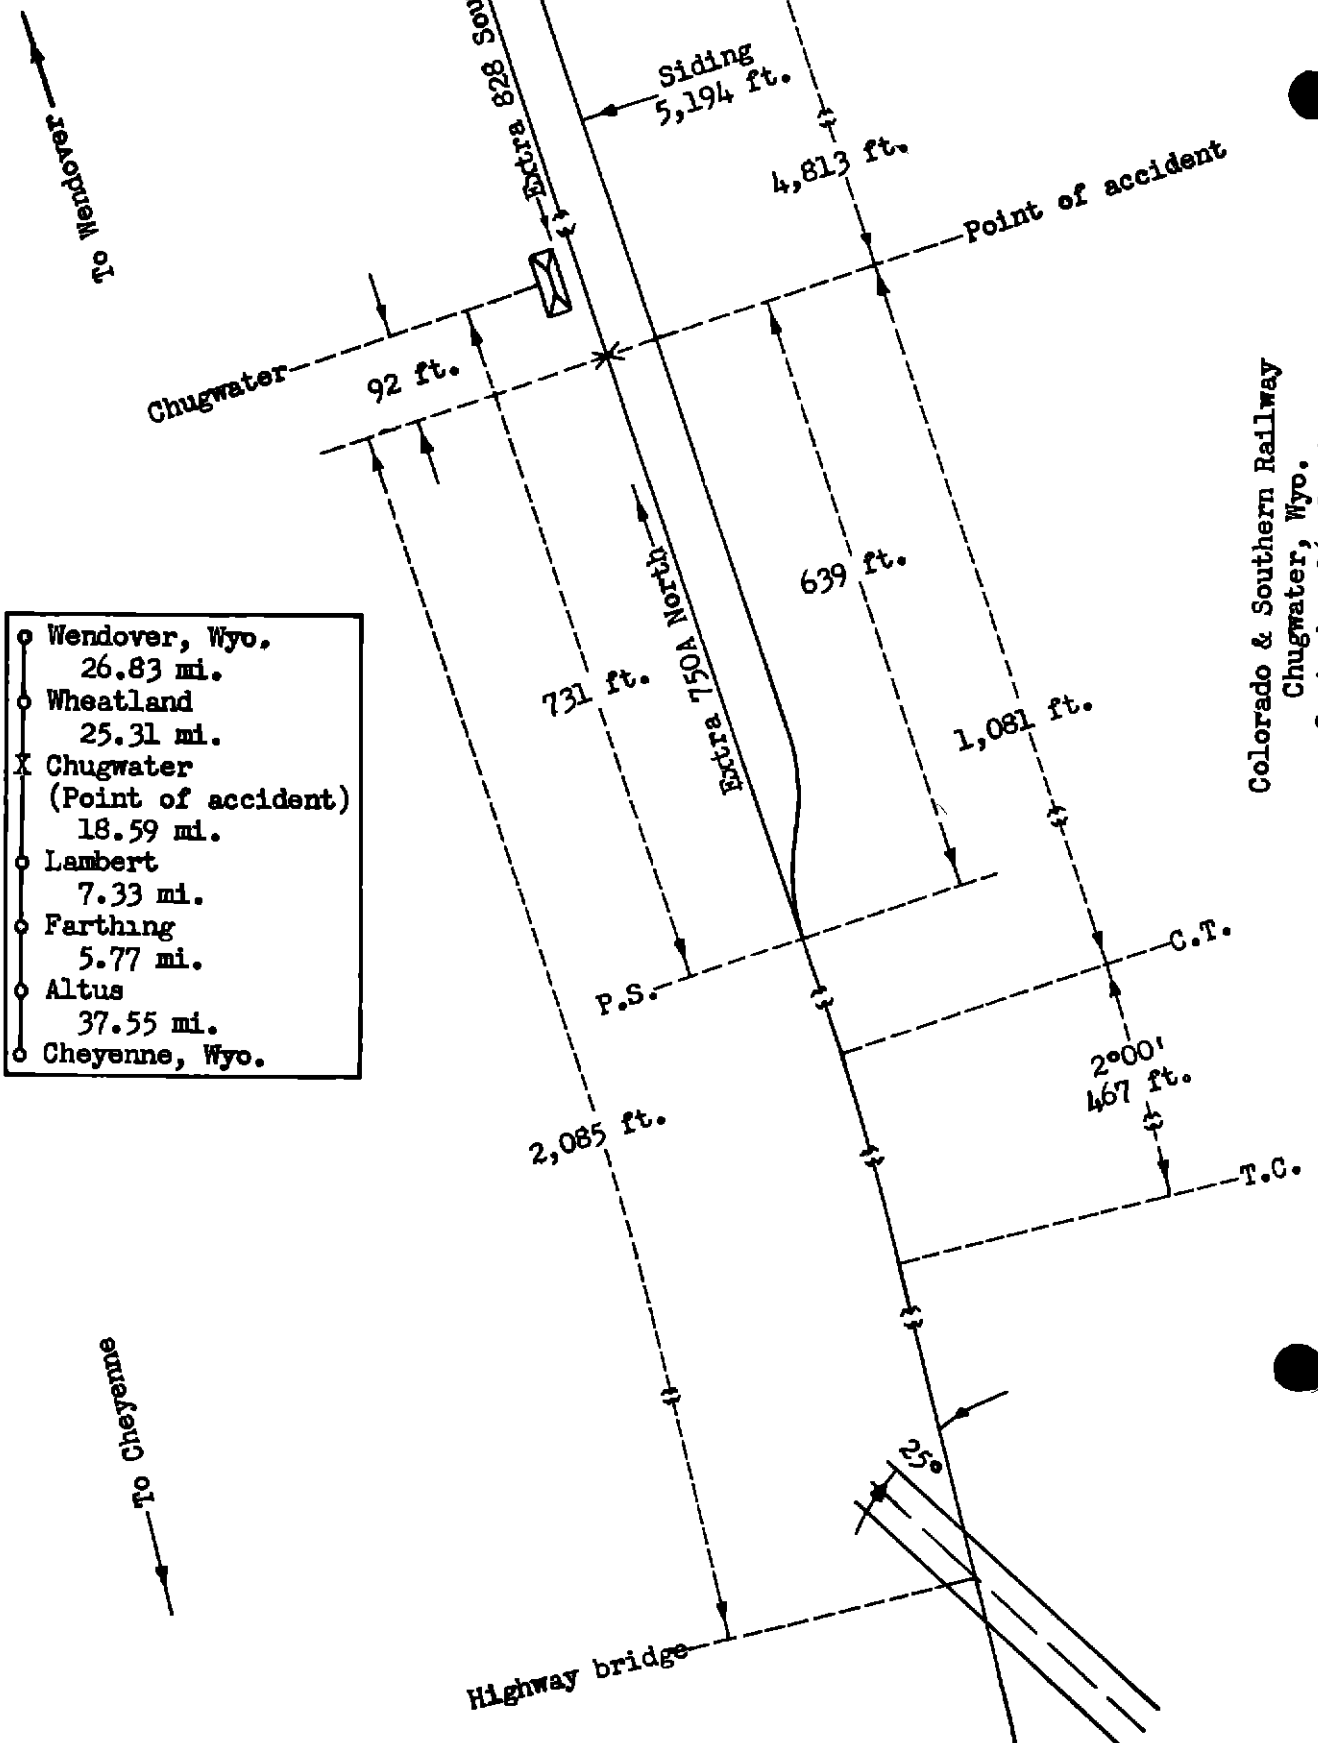
Colorado & Southern Railway
 Chugwater, Wyo.
 September 16, 1958

○	Wendover, Wyo.	26.83 mi.
○	Wheatland	25.31 mi.
X	Chugwater (Point of accident)	18.59 mi.
○	Lambert	7.33 mi.
○	Farthing	5.77 mi.
○	Altus	37.55 mi.
○	Cheyenne, Wyo.

This accident occurred on that part of the Northern Division extending between Cheyenne and Wendover, Wyo., 121.4 miles, a single-track line over which trains are operated by timetable and train orders. There is no block system in use. At Chugwater, 69.3 miles north of Cheyenne, a siding 5,194 feet in length parallels the main track on the east. The south switch of this siding is 731 feet south of the station at Chugwater. The accident occurred on the main track at a point 639 feet north of the south switch of the siding and 92 feet south of the station. From the south there are, in succession, a 2° curve to the left 457 feet in length, a tangent 1,081 feet to the point of accident and 4,813 feet northward. The grade in the vicinity of the point of accident is 0.15 percent descending northward.
