INTERSTATE COMMERCE COMMISSION

INVESTIGATION NO. 3020

THE DELAWARE AND HUDSON RAILROAD CORPORATION

Accident near The Glen, N. Y., on August 26, 1946, caused
by failure to obey a meet order.

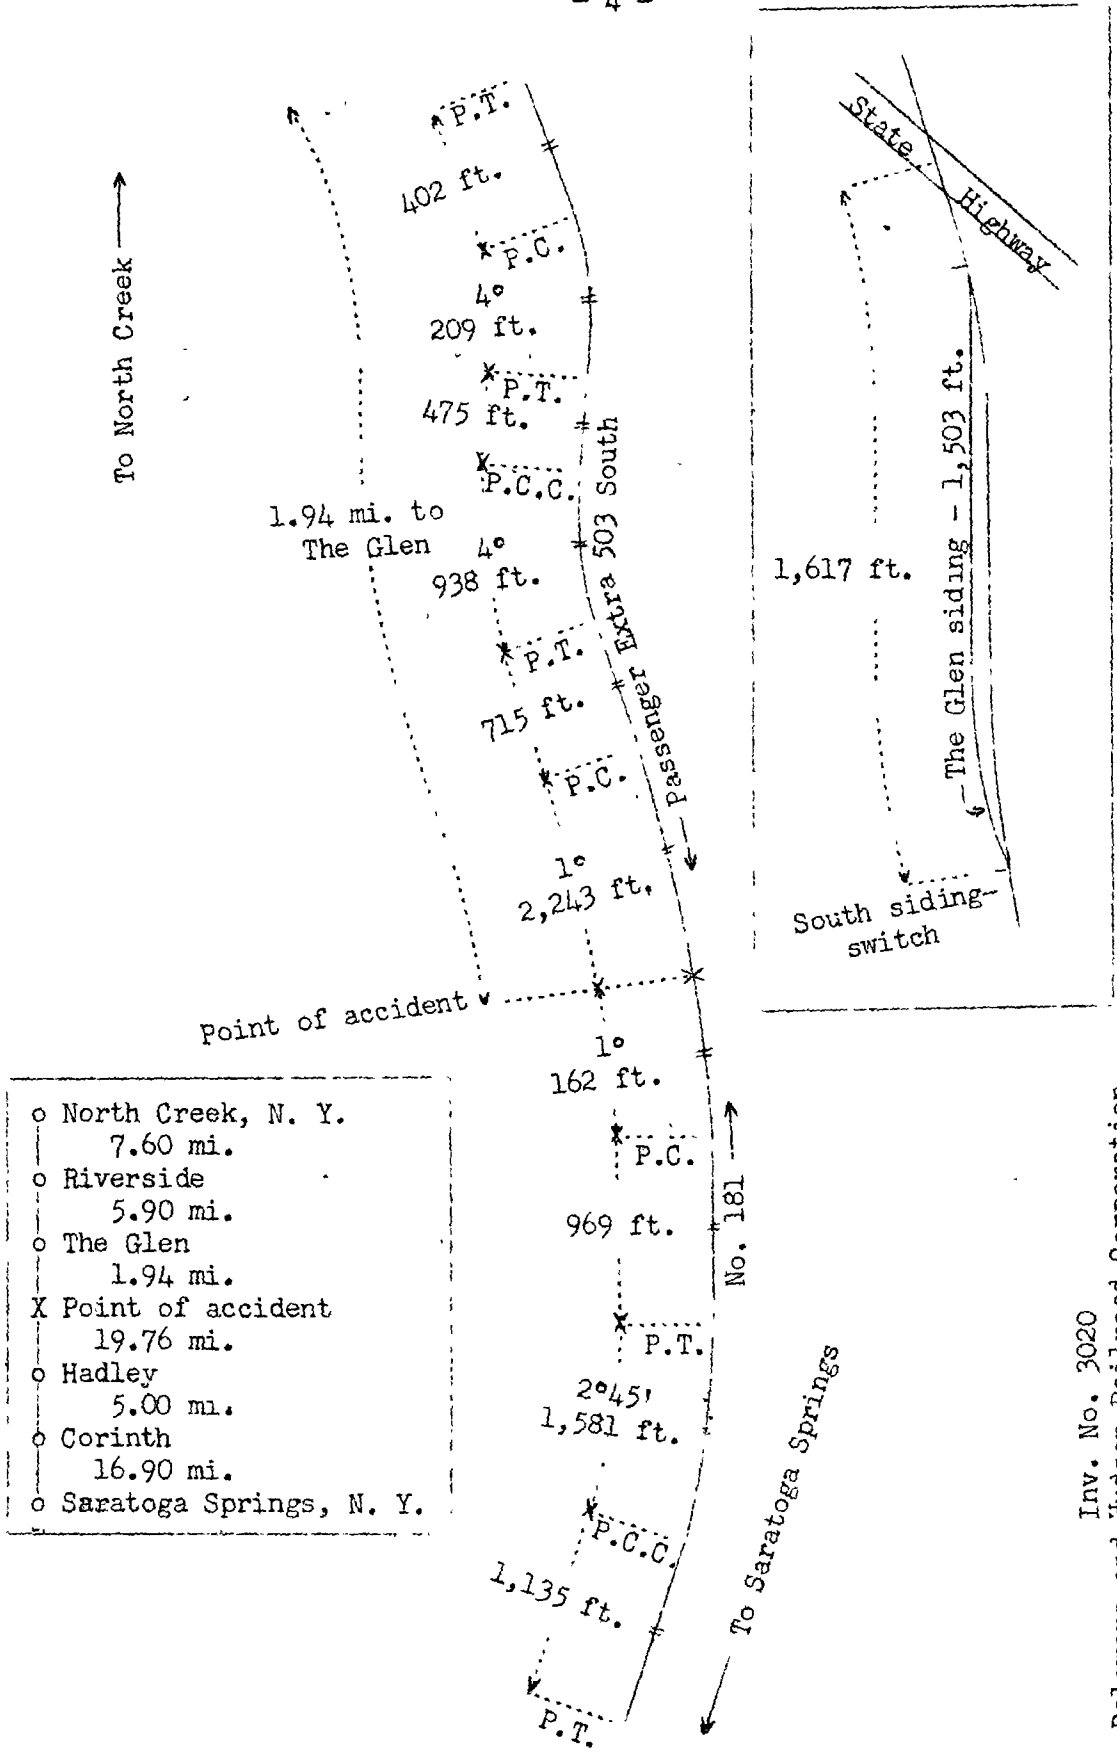
Inv. No. 3020
 Delaware and Hudson Railroad Corporation
 The Glen, N. Y.
 August 26, 1946

o North Creek, N. Y.	7.60 mi.
o Riverside	5.90 mi.
o The Glen	1.94 mi.
X Point of accident	19.76 mi.
o Hadley	5.00 mi.
o Corinth	16.90 mi.
o Saratoga Springs, N. Y.

Location of Accident and Method of Operation

This accident occurred on that part of the Saratoga-Champlain Division extending between Saratoga Springs and North Creek, N. Y., 57.1 miles, a single-track line, over which trains are operated by timetable and train orders. There is no block system in use. At The Glen, 43.6 miles north of Saratoga Springs, a siding 1,503 feet in length parallels the main track on the west. There is no station building at The Glen. The south switch of this siding is 1,617 feet south of a highway grade crossing, where traffic is received and discharged. The accident occurred on the main track 1.94 miles south of the south siding-switch. From the south there are, in succession, a tangent 1,135 feet in length, a compound curve to the left, the maximum curvature of which is $2^{\circ}45'$, 1,581 feet, a tangent 969 feet and a 1° curve to the left 162 feet to the point of accident and 2,243 feet northward. From the north there are, in succession, a tangent 402 feet in length, a 4° curve to the right 209 feet, a tangent 475 feet, a compound curve to the left, the maximum curvature of which is 4° , 938 feet, a tangent 715 feet and the curve on which the accident occurred. At the point of accident the grade is level.
