BUREAU OF SAFETY

REPORT NO. 1963

Railroad: Delaware, Lackawanna & Western
Date: January 29, 1935
Location: Harrison, N. J.
Kind of Accident: Rear-end collision
Trains involved: Deadhead passenger equipment extra
and passenger; both all-steel multiple
unit electric trains
Casualties: 93 injured
Summary of facts: While rounding curve engineman thought
train ahead was standing upon another
track, and did not reduce speed so
as to be able to stop at next signal.
Cause of accident: Failure of engineman properly to ob-
serve and obey signal indications.

REPORT OF THE DIRECTOR OF THE BUREAU OF SAFETY CONCERNING AN
ACCIDENT ON THE DELAWARE, LACKAWANNA & WESTERN RAILROAD
AT HARRISON, N. J., ON JANUARY 29, 1935.

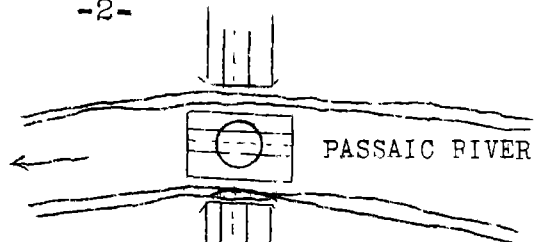
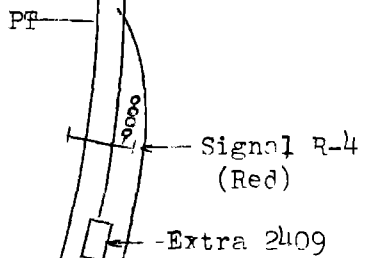
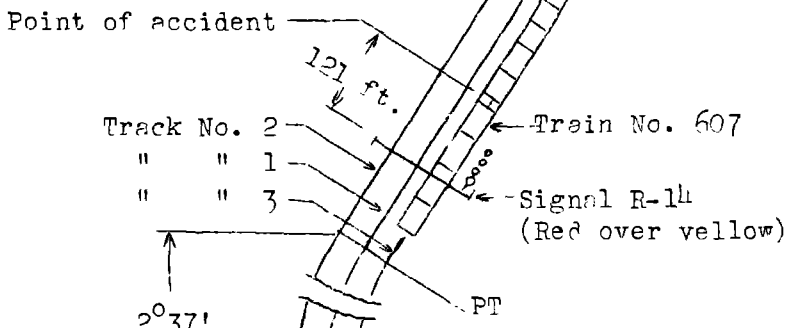
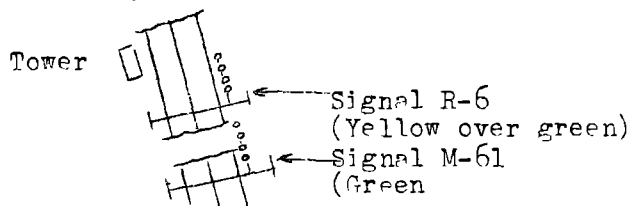
Inv. No. 1963
 D. L. & W. RR
 Harrison, N.J.
 Jan. 29, 1935

○ Danville, N.J.
 29.17 miles
 × Harrison
 Point of accident
 7.13 miles
 ○ Hoboken, N.J.

Distance between signals	
Signal R-4	1,733 ft.
Signal R-14	1,752 ft.
Signal R-12	1,012 ft.
Signal R-6	2,171 ft.
Signal M-61

Harrison station is located south of the tracks and about 1,725 feet east of Newark drawbridge, over the Passaic River, while Harrison interlocking tower is also located on the south side of the tracks and about 3,000 feet east of the station; opposite the station there is a cross-over 367 feet in length which connects track 3 with track 1, this being a facing-point cross-over for west-bound trains moving on track 3. The switches and signals in the territory involved are controlled from a 23-lever electro-pneumatic interlocking machine, located in
