INVESTIGATION NO. 2725
THE DELAWARE, LACKAWANNA & WESTERN
RAILROAD COMPANY
REPORT IN RE ACCIDENT
AT WAYLAND, N. Y., ON
AUGUST 30, 1943

Accident at Wayland, N. Y., on August 30, 1943, caused by failure of operating officers of the Delaware, Lackawanna & Western Railroad Company to adhere to and enforce operating rules which are essential to safety.

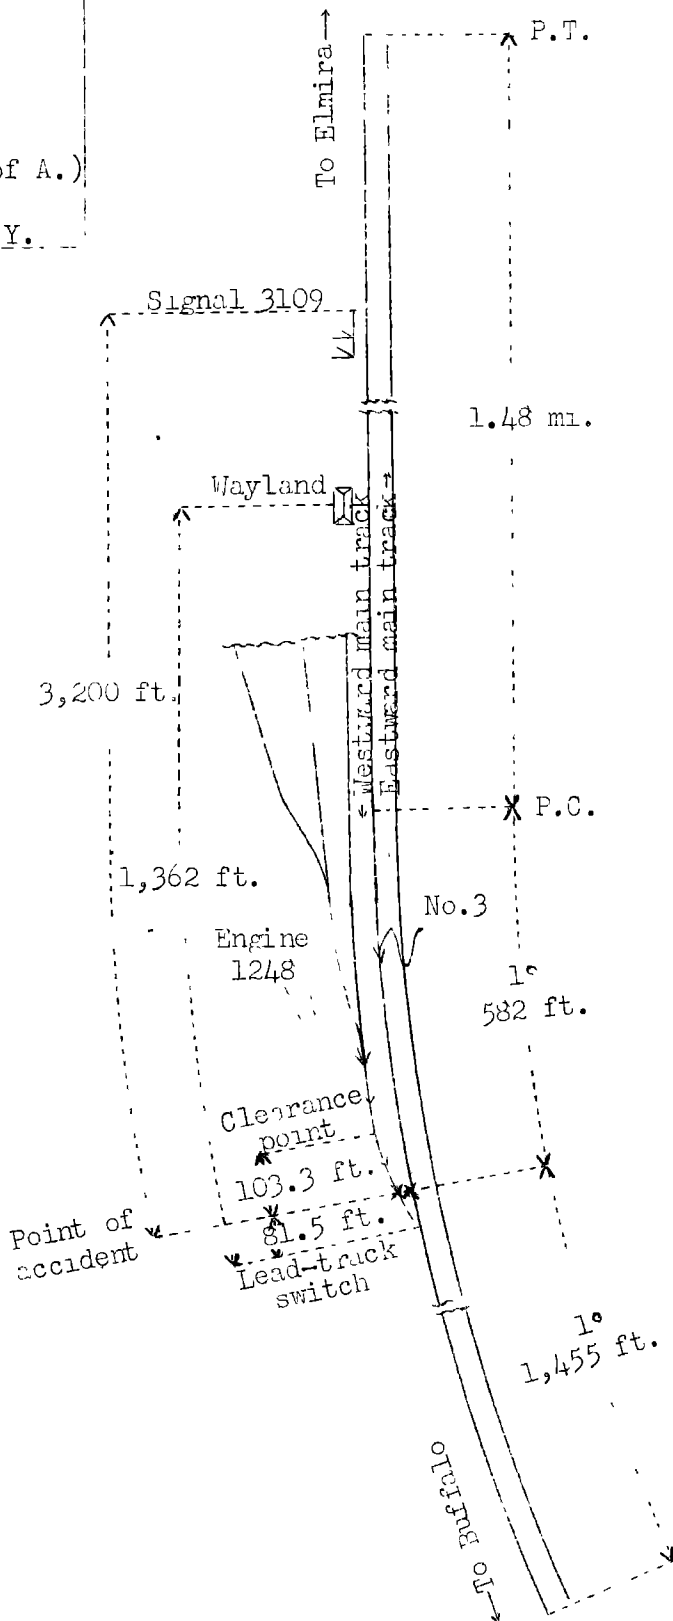
Inv. No. 2725
Delaware, Lackawanna & Western Railroad
Wayland, N. Y.
August 26 1943

- Elmira, N. Y. 36.92 mi.
- Bath 15.36 mi.
- Cohocton 10.37 mi.
- X Wayland (P. of A.) 83.78 mi.
- Buffalo, N. Y.

Location of Accident and Method of Operation
