INVESTIGATION NO. 2749
THE DELAWARE, LACKAWANNA & WESTERN
RAILROAD COMPANY
REPORT IN RE ACCIDENT
AT OSWEGO, N. Y., ON
DECEMBER 7, 1943

Railroad: Delaware, Lackawanna & Western
Date: December 7, 1943
Location: Oswego, N. Y.
Kind of accident: Head-end collision
Trains involved: Track motor-car : Yard engine
Engine numbers: 234 : 172
Speed: 5 m. p. h. : 5 m. p. h.
Operation: Yard rules
Track: Single; 11°40' curve; 0.74 percent
descending grade northward
Weather: Clear
Time: About 12:05 p. m.
Casualties: 1 killed; 8 injured
Cause: Yard engine being permitted to
enter tunnel after track motor-
car had been authorized to move
in opposite direction

Accident at Oswego, N. Y., on December 7, 1943, caused by yard engine being permitted to enter tunnel after track motor-car had been authorized to move in opposite direction.

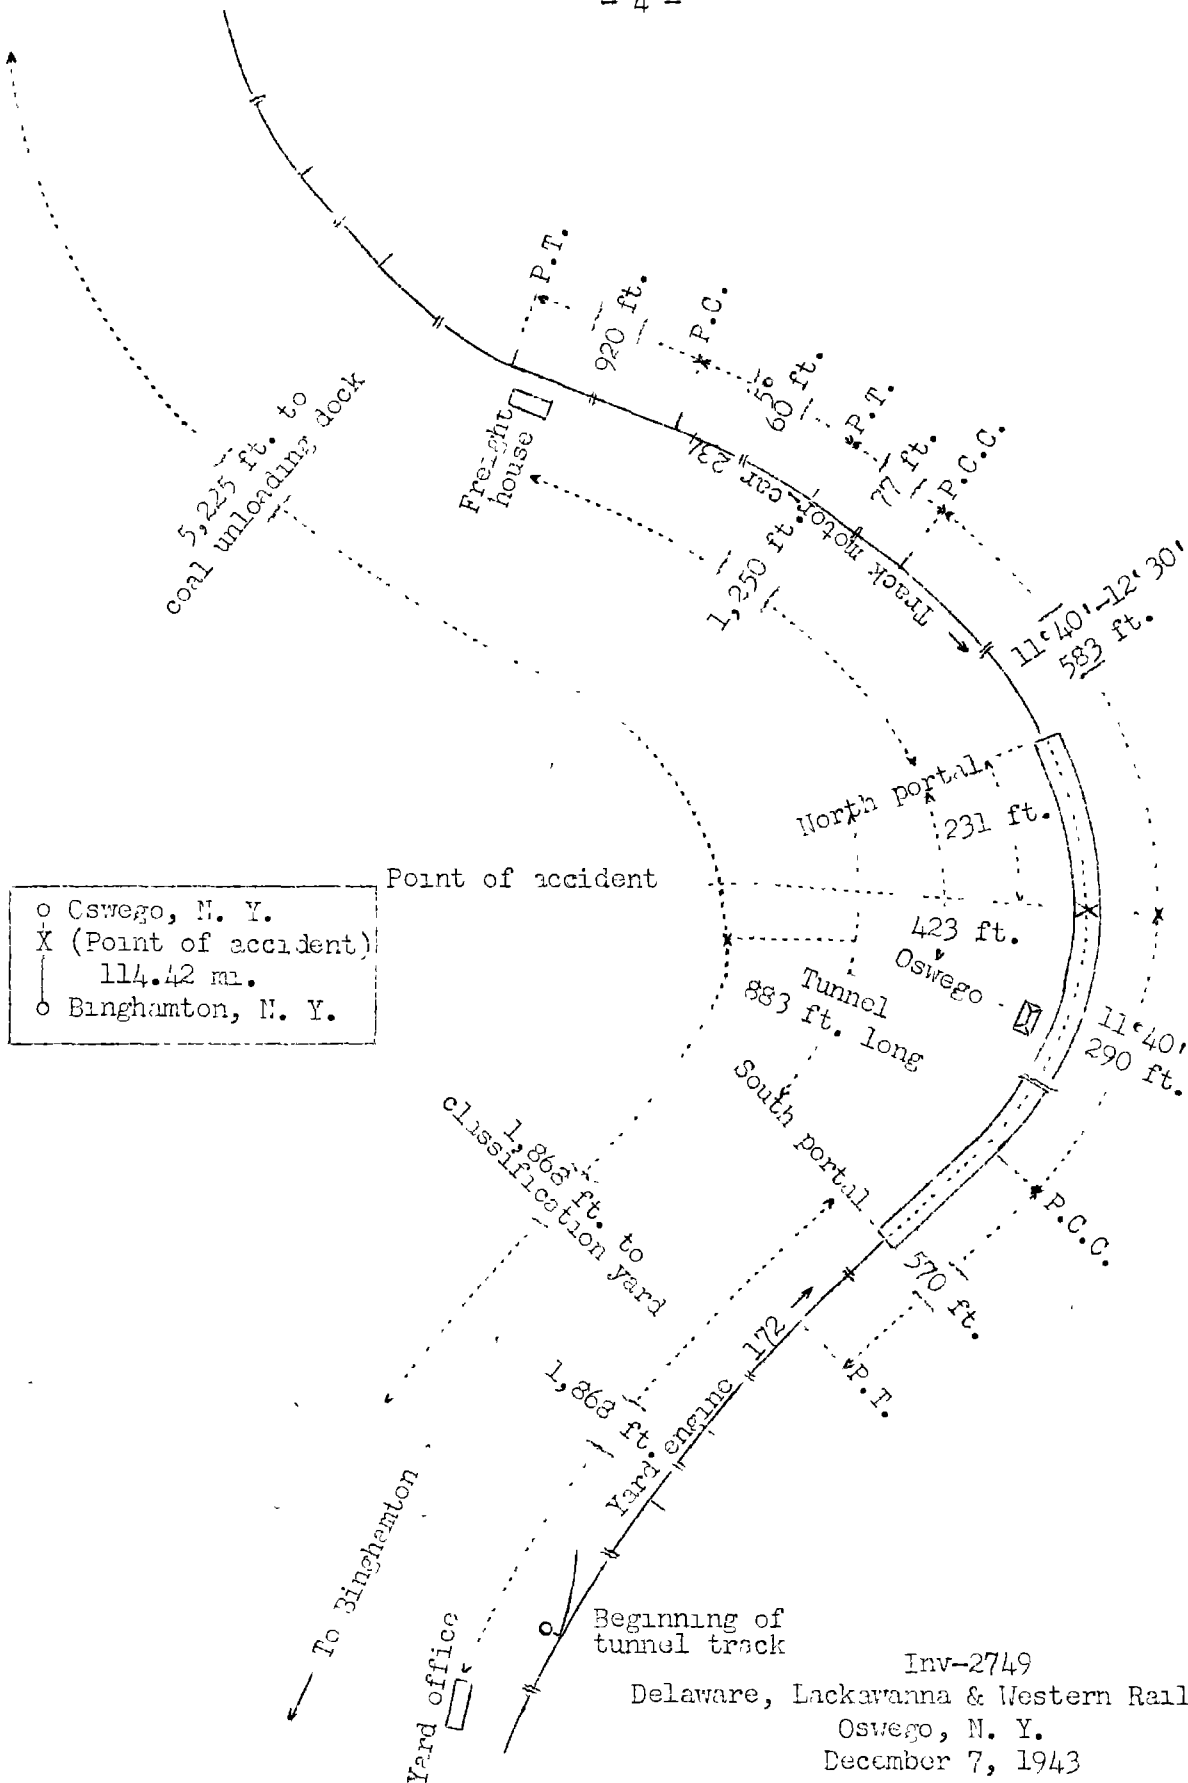
Inv-2749

○ Oswego, N. Y.
 X (Point of accident)
 | 114.42 mi.
 ○ Binghamton, N. Y.

Delaware, Lackawanna & Western Railroad

Oswego, N. Y.

December 7, 1943

This accident occurred on that part of the Scranton Division extending between Oswego and Binghamton, N. Y., 114.42 miles. At Oswego the north end of a classification yard and a coal-unloading dock were, respectively, 1,868 feet south and 5,225 feet north of the station. A track, designated as the tunnel track, over which trains, engines and track motor-cars were operated under yard rules, connected the classification yard and the coal dock. This track extended through a tunnel 883 feet in length. The north portal was 423 feet north of the station. The accident occurred in the tunnel 231 feet south of the north portal. From the south there was a tangent 570 feet in length, which was followed by a compound curve to the left, having a maximum curvature of $12^{\circ}30'$, 290 feet to the point of accident and 583 feet beyond. From the north there were, in succession, a tangent 920 feet in length, a 5° curve to the right 60 feet, a tangent 77 feet, and the curve on which the accident occurred. Northward from the south portal the grade was 1.65 percent descending 292 feet, then it was 0.74 percent descending 360 feet to the point of accident and 231 feet beyond.

A bridge force was engaged temporarily in repair work at the coal-unloading dock, 1.34 miles north of the classification yard, and was required to pass through the tunnel four times daily. About 11:45 a. m. the operator of the motor-car used by this force communicated by telephone with the conductor of yard engine 172, who was in the yard office at that time. The conductor informed the motor-car operator to the effect that no north-bound movement would be permitted until after the motor-car had arrived at the classification yard; however, the conductor did not inform any other member of his crew as to the movement of the motor-car, and he did not accompany the engine until some time after the accident occurred. The motor-car proceeded southward, and about 20 minutes later it collided with the yard engine a short distance south of the north portal of the tunnel, where the curvature was 11°40'.
