REPORT NO. 3544

THE DENVER AND RIO GRANDE WESTERN
RAILROAD COMPANY

IN RE ACCIDENT

AT DOS, COLO., ON

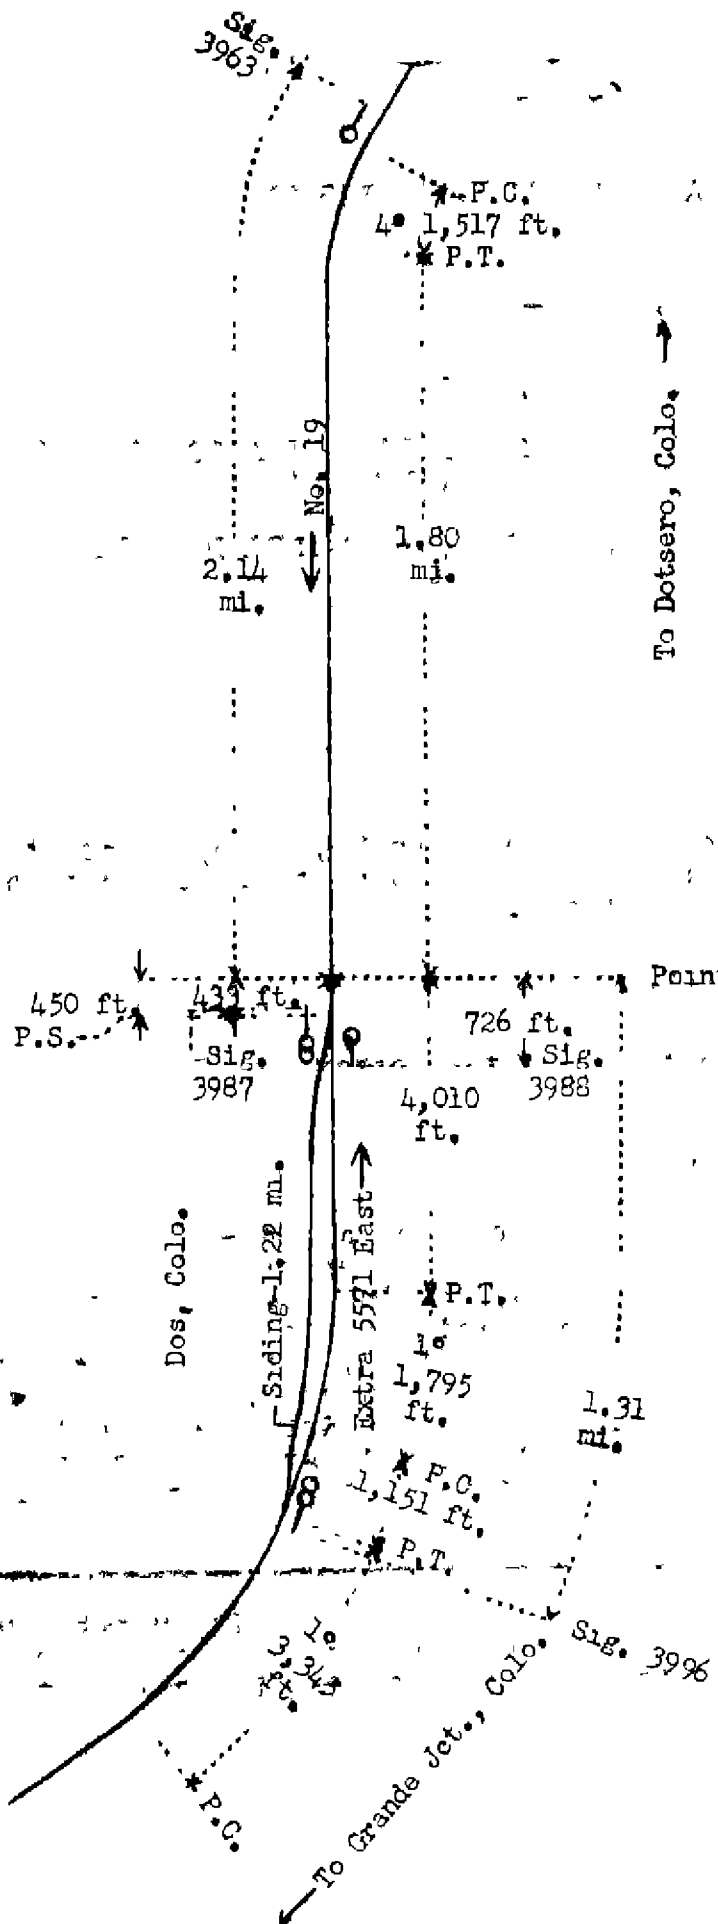
Report No. 3544
 Denver and Rio Grande Western Railroad
 Dos, Colo.
 Nov. 20, 1953

•	Dotsero, Colo.
○	19.4 mi.
○	Fünstön
○	25.3 mi.
○	Rifle
○	12.5 mi.
X	Dos
	(Point of accident)
	4.9 mi.
•	Grande Valley
	4.7 mi.
○	Una
	23.9 mi.
○	Cameo
	17.0 mi.
•	Grande Jct., Colo.
