ACCIDENT ON THE
DENVER & RIO GRANDE WESTERN RAILROAD

GRAND VALLEY, COLO.

SEPTEMBER 8, 1937

INVESTIGATION NO. 2199

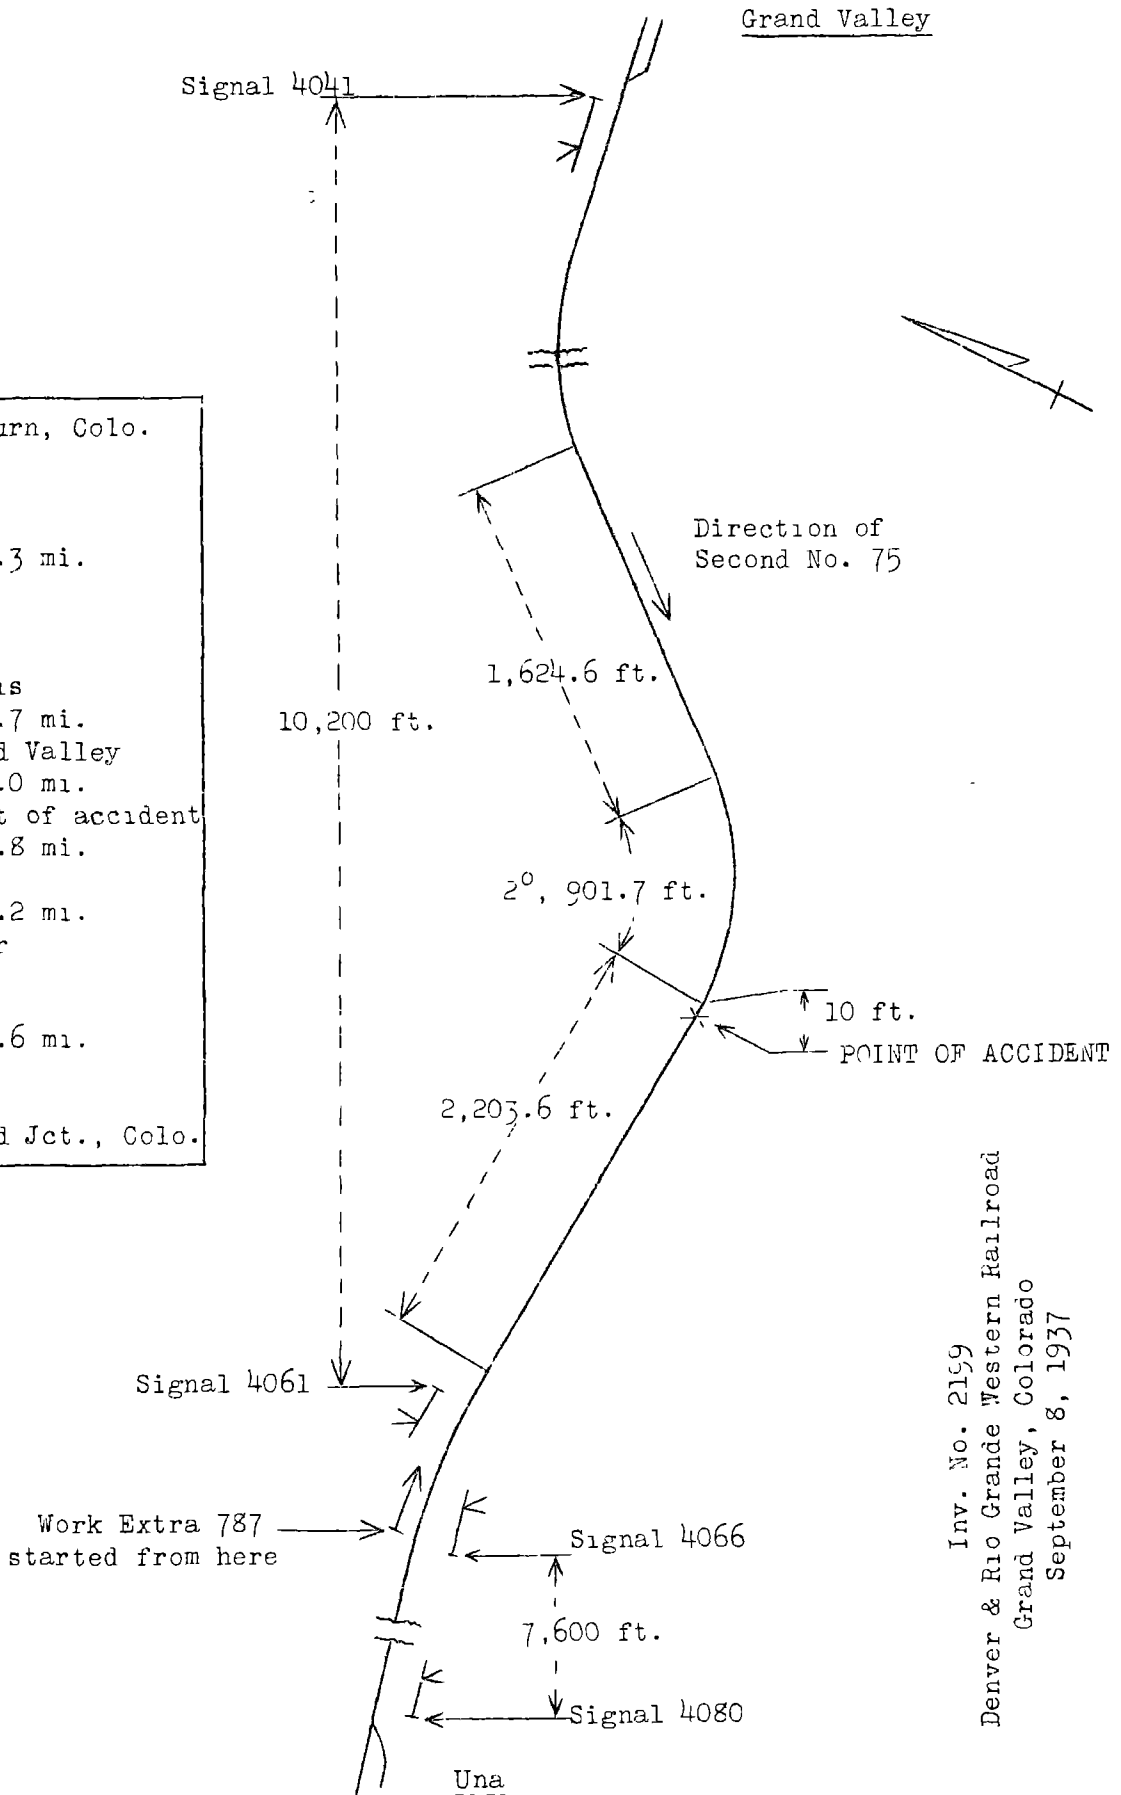
Inv. No. 2159
 Denver & Rio Grande Western Railroad
 Grand Valley, Colorado
 September 8, 1937

This accident occurred on Sub-division 4, of the Grand Junction Division, which extends between Minturn and Grand Junction, Colo., a distance of 147.6 miles. This is a single-track line over which trains are operated by timetable, train orders, and an automatic block-signal system of the absolute-permissive type. The accident occurred at a point approximately 1.6 miles west of the west switch of the siding at Grand Valley. Approaching this point from the west the track is tangent for a distance of 2,203.6 feet and the accident occurred on this tangent at a point about 10 feet from its eastern end; approaching from the east there is a tangent 1,624.6 feet in length, followed by a 2° curve to the right 901.7 feet in length, and then the tangent on which the accident occurred. The grade is 0.902 percent ascending for east-bound trains. The curve just east of the point of accident is in a cut bordered by trees and shrubbery, and the view of an engineman of a west-bound train is restricted to about 1,200 feet until about half way around the curve.
