INVESTIGATION NO. 2929
THE DENVER AND RIO GRANDE WESTERN
RAILROAD COMPANY
REPORT IN RE ACCIDENT
AT GRIZZLY, COLO., ON
SEPTEMBER 7, 1945

Railroad: Denver and Rio Grande Western
Date: September 7, 1945
Location: Grizzly, Colo.
Kind of accident: Rear-end collision
Trains involved: U. P. passenger : U. P. passenger
Train numbers: Extra 5017 West : Extra 2492 West
Engine numbers: 5017 : 2492
Consist: 20 cars : 19 cars
Estimated speed: Standing : 8 m. p. h.
Operation: Signal indications
Track: Single; 5°51' curve; 0.85 percent
descending grade westward
Weather: Clear
Time: 5:30 p. m.
Casualties: 49 injured
Cause: Failure properly to control speed
of following train moving on siding

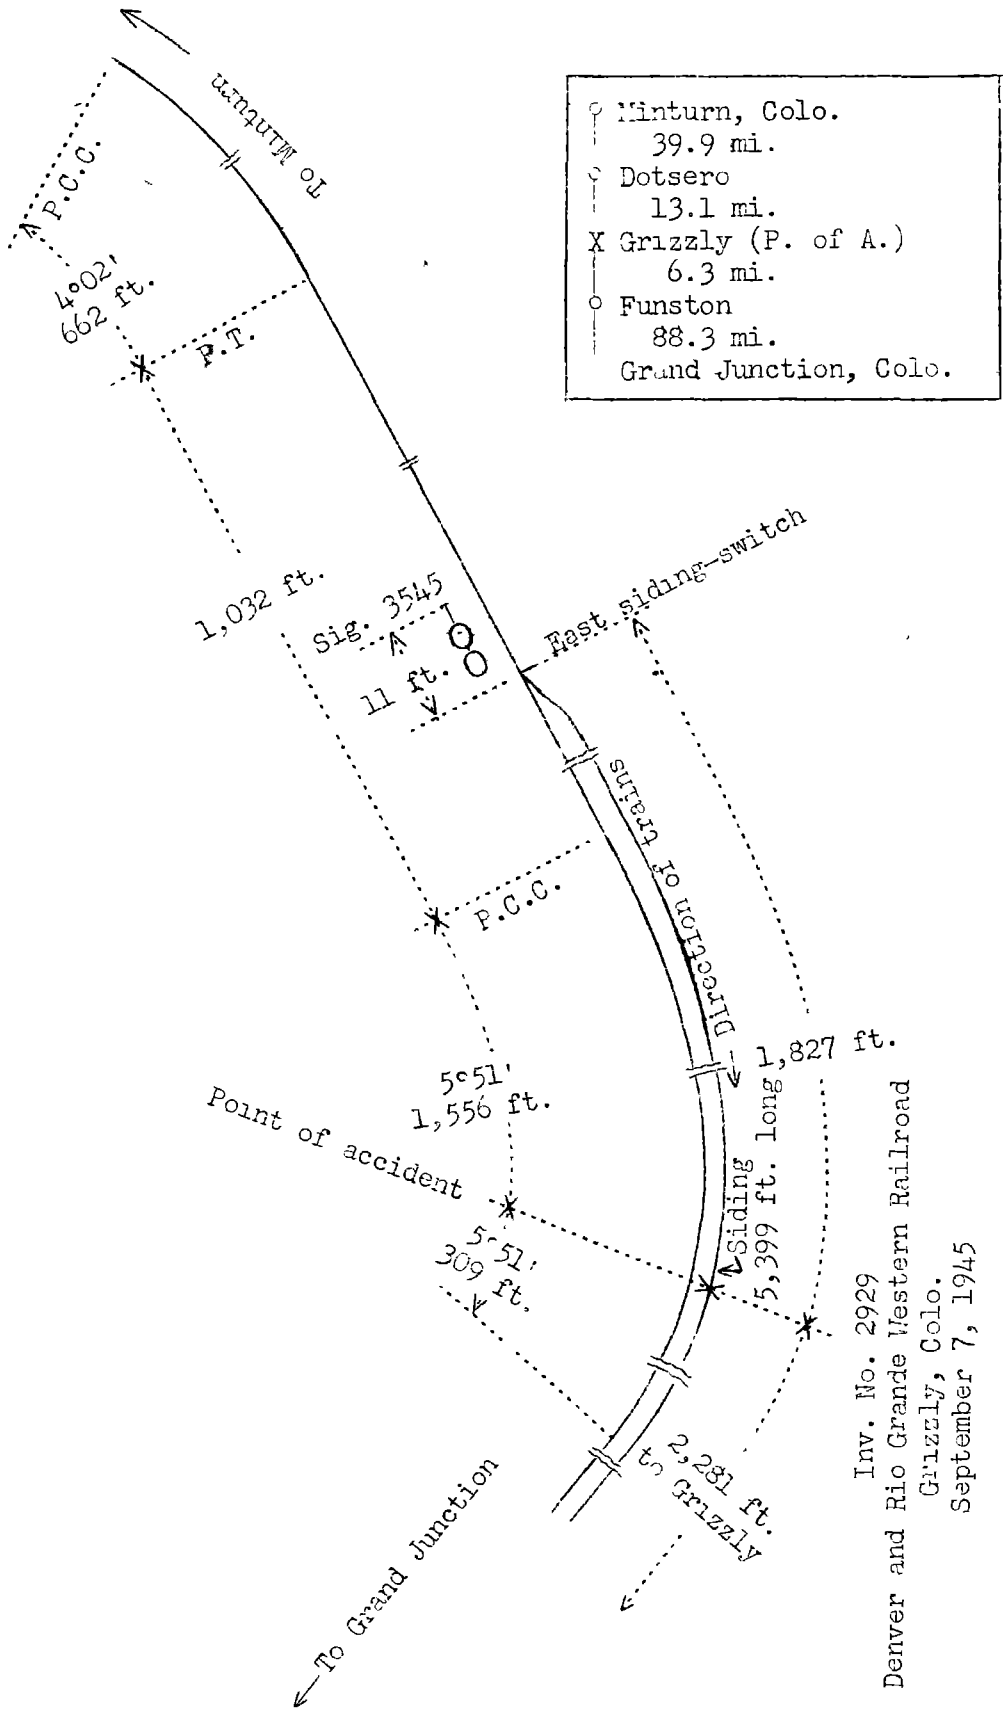
Inv. No. 2929
Denver and Rio Grande Western Railroad
Grizzly, Colo.
September 7, 1945

- Minturn, Colo. 39.9 mi.
- Dotsero 13.1 mi.
- X Grizzly (P. of A.) 6.3 mi.
- Funston 88.3 mi.
- Grand Junction, Colo.

This accident occurred on that part of the Grand Junction Division which extends between Minturn and Grand Junction, Colo., 147.6 miles, a single-track line in the vicinity of the point of accident, over which trains are operated by signal indications. Because of a burned bridge on a line of the Union Pacific Railroad, trains of this railroad were being operated over the line on which the accident occurred. At Grizzly, 53 miles west of Minturn, a siding 5,399 feet in length parallels the main track on the south. The east switch of this siding is 4,108 feet east of the station. Entry to the siding at the east switch is made through a No. 15 turnout. The accident occurred on the siding at a point 1,827 feet west of the east switch. From the east on the main track there are, in succession, a compound curve to the right 662 feet in length, the maximum curvature of which is 4°02', a tangent 1,032 feet and a compound curve to the right, the maximum curvature of which is 5°51', extending 1,556 feet to the point of accident and 309 feet westward. From the east siding-switch to the point of accident, the gradient on the siding varies from 0.77 to 1.25 percent descending for west-bound trains, and it is 0.85 percent at the point of accident.
