REPORT OF THE DIRECTOR OF THE BUREAU OF SAFETY CONCERNING AN
ACCIDENT ON THE DENVER AND RIO GRANDE WESTERN RAILROAD
AT MEARS JUNCTION, COLO., ON AUGUST 6, 1935.

October 11, 1935.

On August 6, 1935, there was a derailment of a freight train on the Denver and Rio Grande Western Railroad near Mears Junction, Colo., resulting in the death of 1 employee and 3 trespassers and the injury of 8 trespassers.

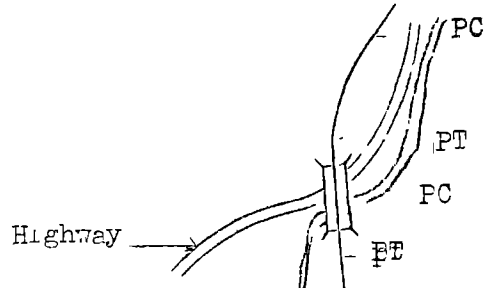
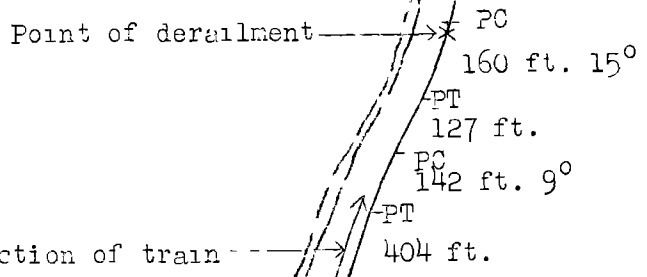
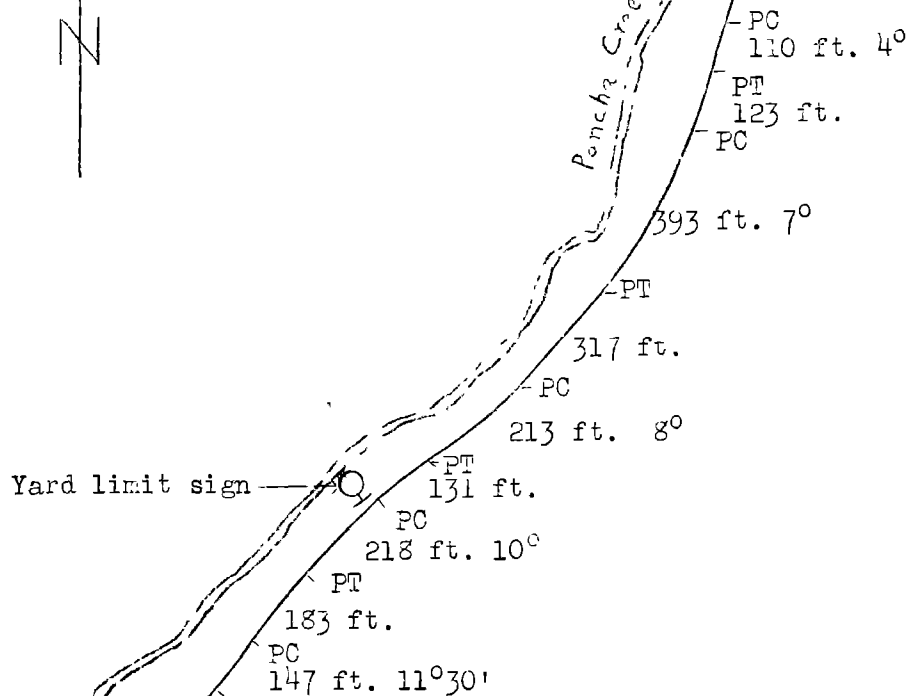
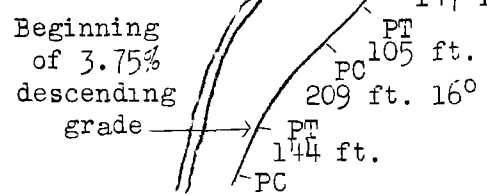
Inv. No. 2001
Denver & Rio Grande Western RR,
Mears Junction, Colorado
August 6, 1935.

• Salida, Colo.
10.9 mi.
✕ Point of accident
• Mears Jct;
14.7
• Marshall Pass
47.9 mi.
• Gunnison, Colo.

Poncha Creek

Yard limit sign → ○

Between the east switch at Mears Junction and the point of accident the track is laid on the side of the mountain, with an ascending grade of 0.15 percent for approximately 1,100 feet, then a descending grade of 3.75 percent approximately 3,000 feet to the point of accident. At the point of accident a wall of granite slopes upward on the right; on the left Poncha Creek flows about 55 feet below. The maximum speed for freight trains in this vicinity is restricted to 12 miles per hour, while that for passenger trains is limited to 18 miles per hour. The track is laid with 70-pound rails, 30 feet in length, with an average of 17 pine ties to the rail length, fully tieplated and double-spiked on all curves of 8° or more, and further secured with rail anchors. The ballast is natural soil of decomposed granite and the track is in fair condition. There is an elevation of 1 inch on the outer rail of the 15° curve on which the derailment occurred.
