REPORT OF THE DIRECTOR
BUREAU OF SAFETY

ACCIDENT ON THE
DENVER AND RIO GRANDE WESTERN RAILROAD

RIVERTON, UTAH

INVESTIGATION NO. 2315

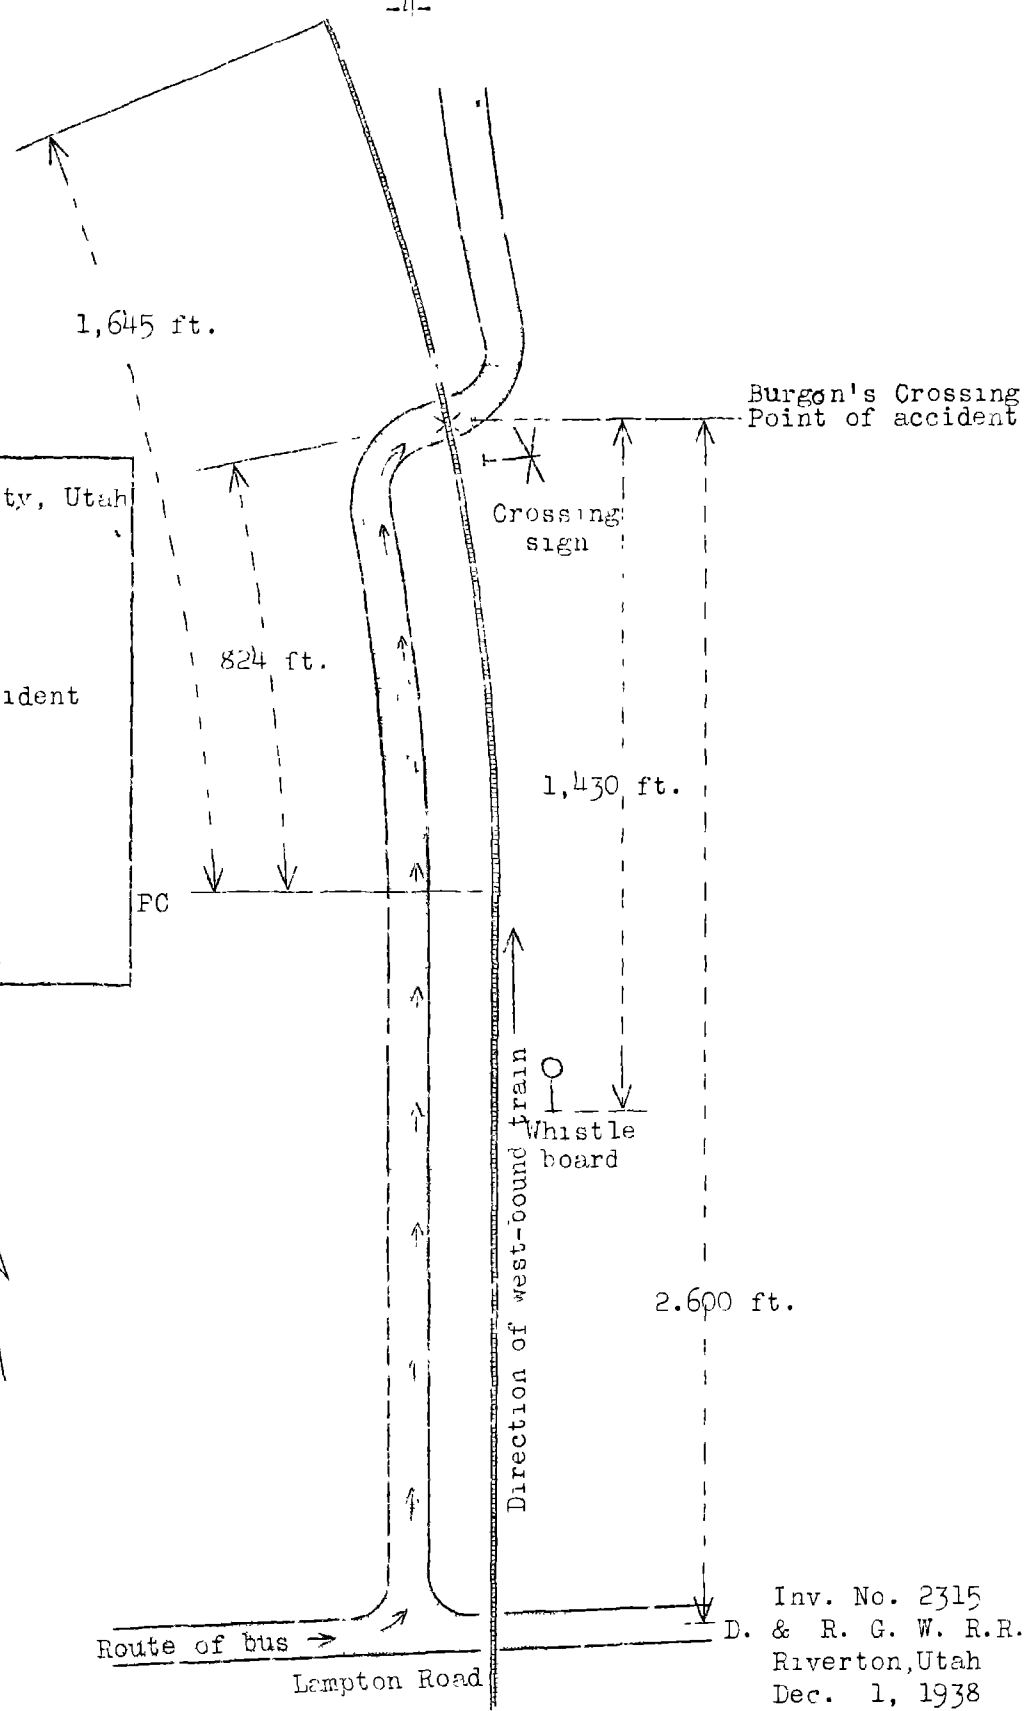
Inv. No. 2315
 & R. G. W. R.R.
 Riverton, Utah
 Dec. 1, 1938

o Salt Lake City, Utah	2.6 mi.
o Roper	11.2 mi.
X Point of accident	2.7 mi.
o Riverton	103.1 mi.
o Helper, Utah
