REPORT NO. 3686

THE DENVER AND RIO GRANDE WESTERN RAILROAD
COMPANY

IN RE ACCIDENT

AT TROUBLESOME, COLO., ON

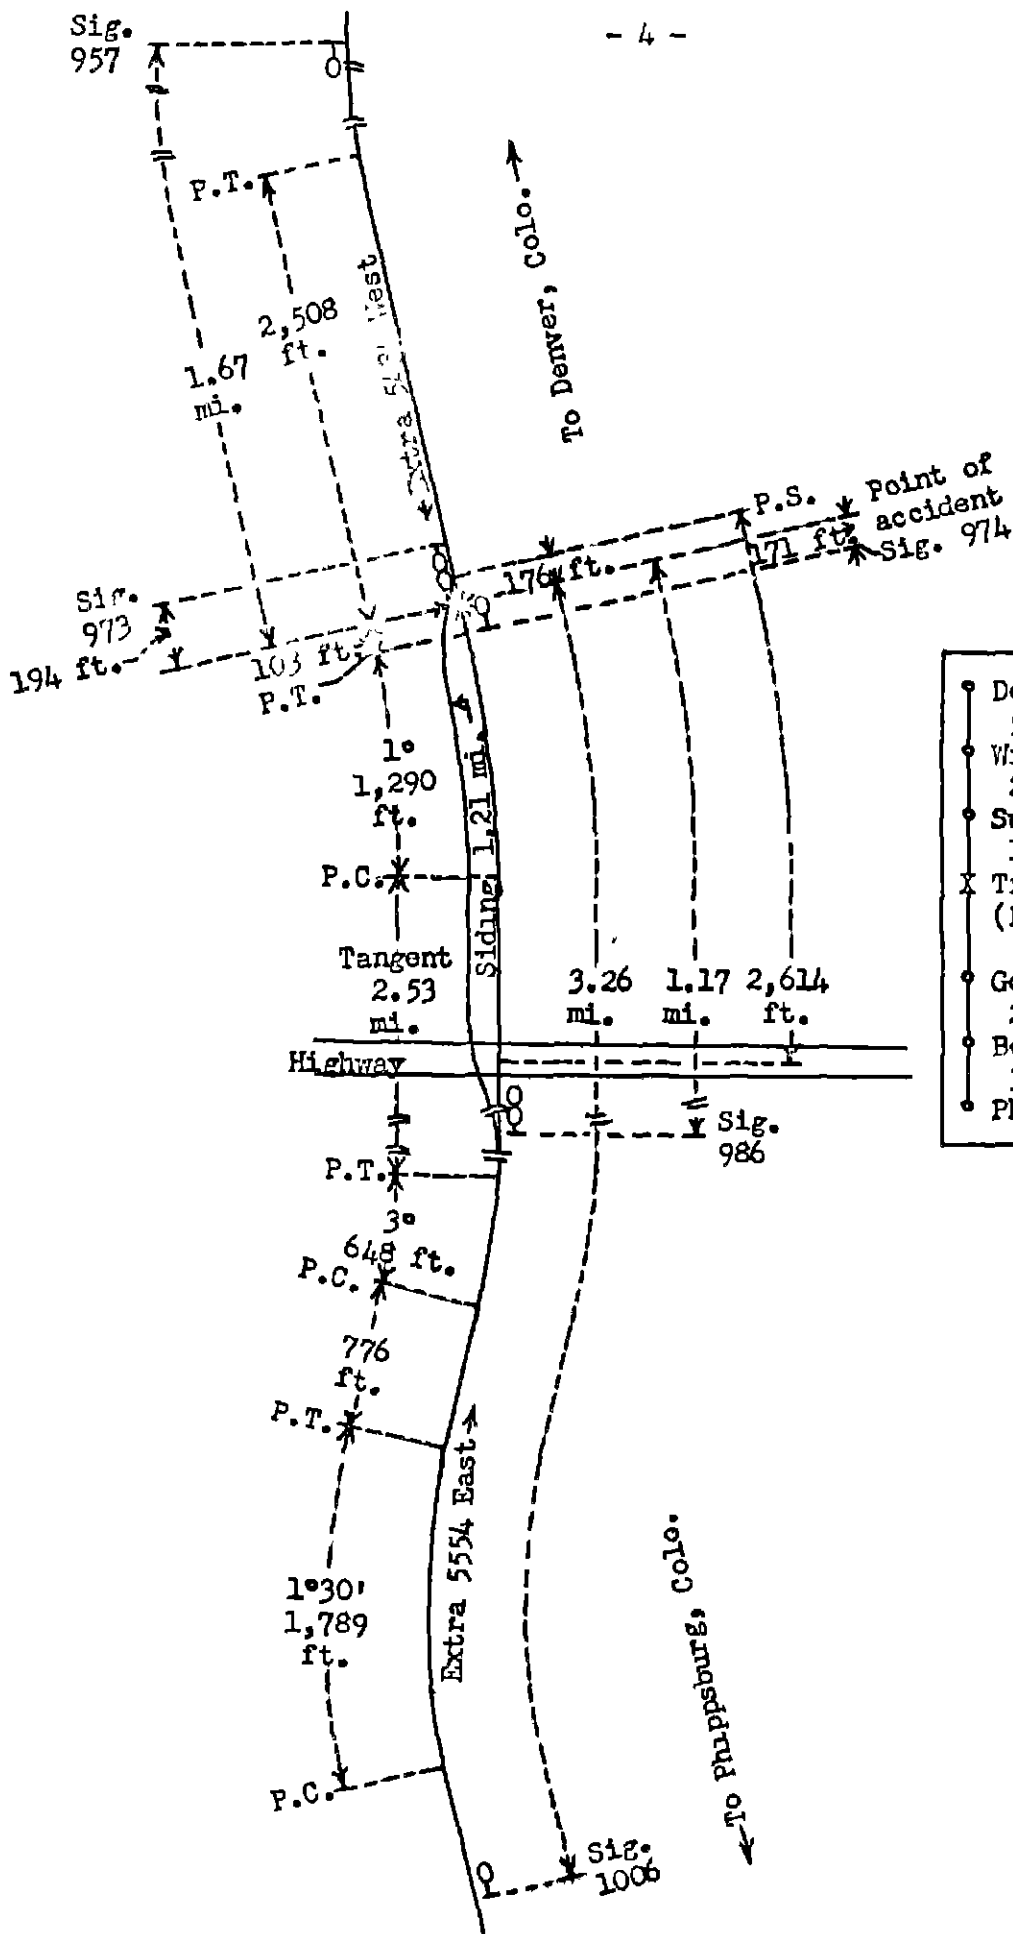
Report No. 3686
 Denver and Rio Grande Western Railroad
 Troublesome, Colo.
 May 15, 1956

○	Denver, Colo.	56.9 mi.
○	Winter Park	29.3 mi.
○	Sulphur	11.8 mi.
×	Troublesome (Point of accident)	8.0 mi.
○	Gore	23.3 mi.
○	Bond	38.7 mi.
○	Phippsburg, Colo.
