REPORT NO. 1982

Railroad: Denver & Salt Lake
Date: May 2, 1935
Location: Tolland, Colo.
Kind of accident: Rear-end collision.
Trains involved: Freight : Passenger
Train numbers: Extra 209 : Train No. 2
Engine numbers: 209 : 302
Consist: 35 cars & : Engine &
caboose : 4 cars
Speed: Standing : 15-25 m.p.h.
Track: 1°30' curve, then 358 feet of tangent;
2 percent descending grade
Weather: Cloudy, with light snow falling
Time: 3:51 p.m.
Casualties: 17 injured
Cause: Failure of flagman of Extra 209 to
provide proper flag protection when
standing on main track on time of
following superior train

REPORT OF THE DIRECTOR OF THE BUREAU OF SAFETY CONCERNING AN
ACCIDENT ON THE DENVER & SALT LAKE RAILWAY AT TOLLAND,
COLO., ON MAY 2, 1935.

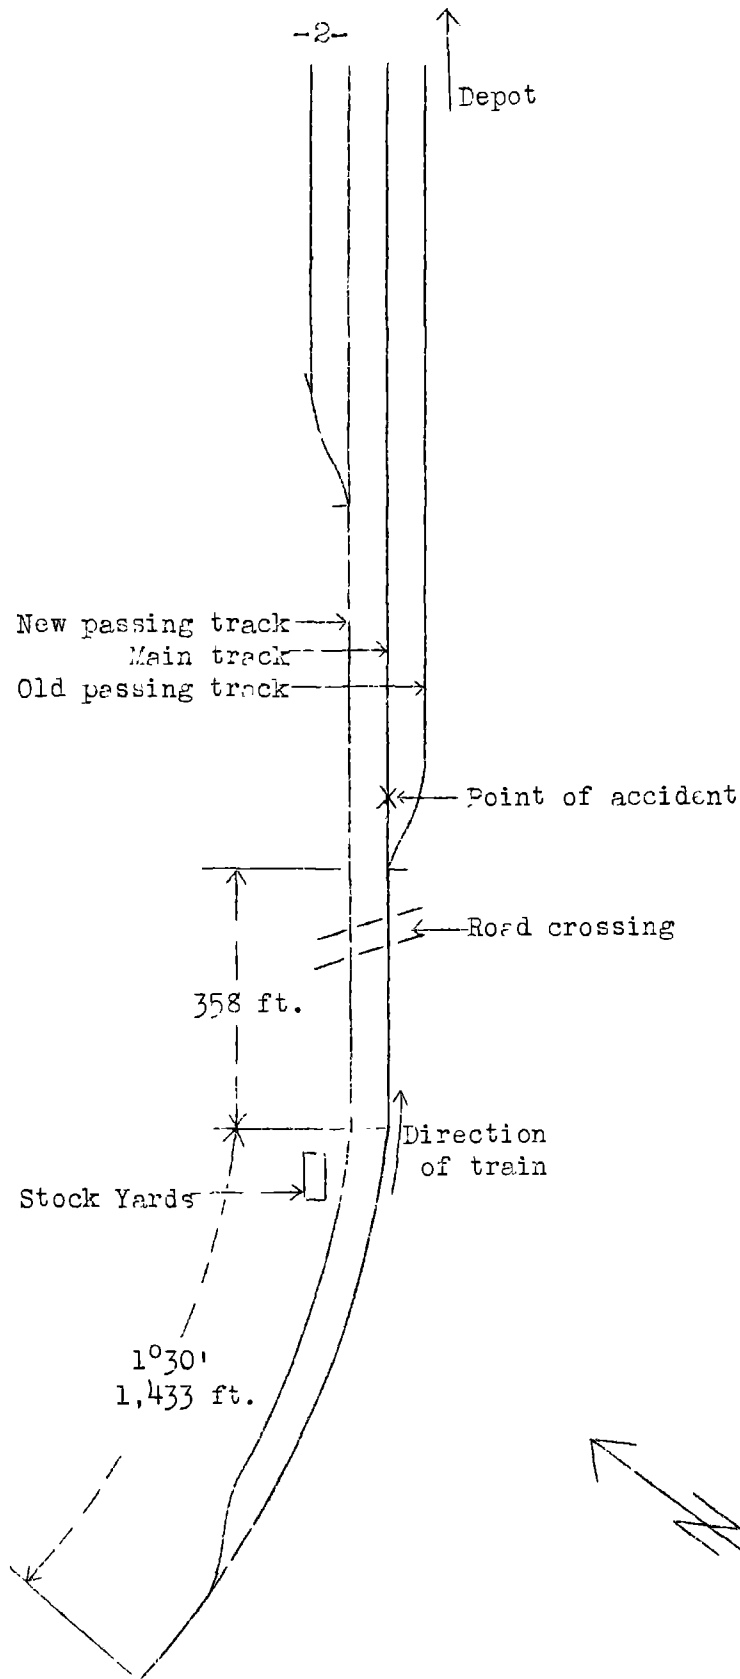
Inv. No. 1982
 Denver & Salt Lake R.R.
 Tolland, Colo.
 May 2, 1935.

• Denver, Colo.	
	37.04 mi.
• Pine Cliff	
	9.85 mi.
• Tolland (P of A)	
	2.94 mi.
• East Portal	
	6.8 mi.
• West Portal	
	9.35 mi.
• Tabernash, Colo.

This accident occurred on that part of Subdivision 1 extending between Tabernash and Denver, Colo., a distance of 65.98 miles; in the vicinity of the point of accident this is a single-track line over which trains are operated by time table and train orders, no block-signal system being in use. The accident occurred on the main track just east of the west switch of the old passing track at Tolland; approaching this point from the west, there is a 1°30' curve to the left 1,433 feet in length, followed by 358 feet of tangent to the switch, this tangent extending for a considerable distance beyond that point. The grade for east-bound trains is descending, the maximum being 2 percent, and the accident occurred on that portion of track where the gradient changes from 2 percent to 1.2 percent. A track known as the new passing track parallels the main track on the north, and the old passing track parallels it on the south; the west switch of the new passing track is located 1,271 feet west of the west switch of the old passing track.
