INVESTIGATION NO. 2683
THE DENVER TRAMWAY CORPORATION
REPORT IN RE ACCIDENT
NEAR SWADLEY, COLO., ON
MARCH 1, 1943

Railroad: Denver Tramway
Date: March 1, 1943
Location: Swadley, Colo.
Kind of accident: Head-end collision
Trains involved: Passenger : Freight
Train numbers: 125 : Extra 1110-1111
East
Engine numbers: Electric motor : Electric engines
car 07 1111-1110
Consist: Motor car : 14 cars, caboose
Estimated speed: 20 m. p. h. : 10-15 m. p. h.
Operation: Timetable and train orders
Track: Single; 3° curve; 1.5 percent
descending grade eastward
Weather: Snowing
Time: About 1:08 p. m.
Casualties: 2 killed, 1 injured
Cause: Accident caused by failure to obey
a rect order

Accident near Swadley, Colo., on March 1, 1943, caused
by failure to obey a meet order.

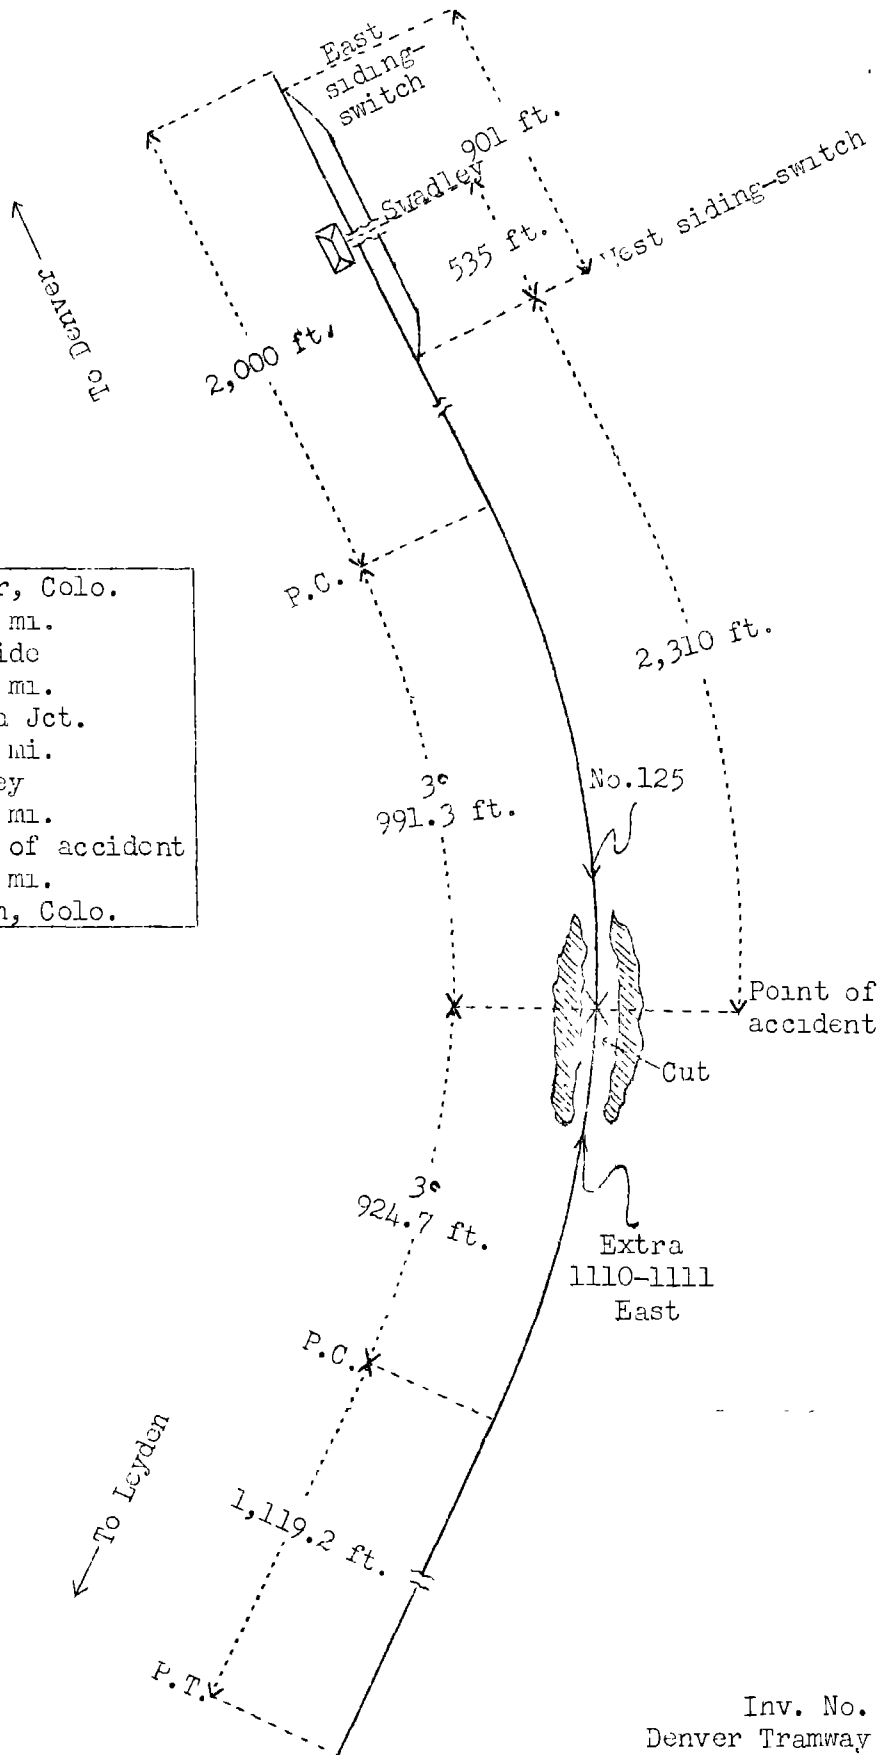
Inv. No. 2683
 Denver Tramway Corporation
 Swadley, Colo.
 March 1, 1943

- Denver, Colo. 4.76 mi.
- Lakeside 2.29 mi.
- Arvada Jct. 1.23 mi.
- Swadley 0.44 mi.
- ✕ Point of accident 5.78 mi.
- Leyden, Colo.

This accident occurred on that part of the Denver-Leyden Division which extends between Denver and Leyden, Colo., 14.5 miles. The line is equipped with an overhead catenary system for the electric propulsion of trains. Freight trains of the Denver and Intermountain Railroad and passenger trains of the Denver Tramway Corporation operate over this line on a trackage agreement. In the vicinity of the point of accident this is a single-track line arranged to handle both standard and narrow gage cars, over which trains are operated by timetable and train orders. There is no block system in use. At Swadley a siding 901 feet in length parallels the main track on the south. The west switch of this siding is 535 feet west of the station. The accident occurred on the main track at a point 2,310 feet west of the west siding-switch. Approaching from the east there is a tangent more than 2,000 feet in length, which is followed by a 3° curve to the right 991.3 feet to the point of accident and 924.7 feet beyond. Approaching from the west there is a tangent 1,119.2 feet in length, which is followed by the curve on which the accident occurred. Throughout a considerable distance immediately east and west of the point of accident, the grade for east-bound trains is 1.5 percent descending. The accident occurred in a cut, the walls of which rise to a maximum height of about 20 feet.
