INTERSTATE COMMERCE COMMISSION

REPORT NO. 3395

DETROIT, TOLEDO AND IRCNTON RAILROAD COMPANY
AND
THE PENNSYLVANIA RAILROAD COMPANY

AT PENFORD, MICH., ON

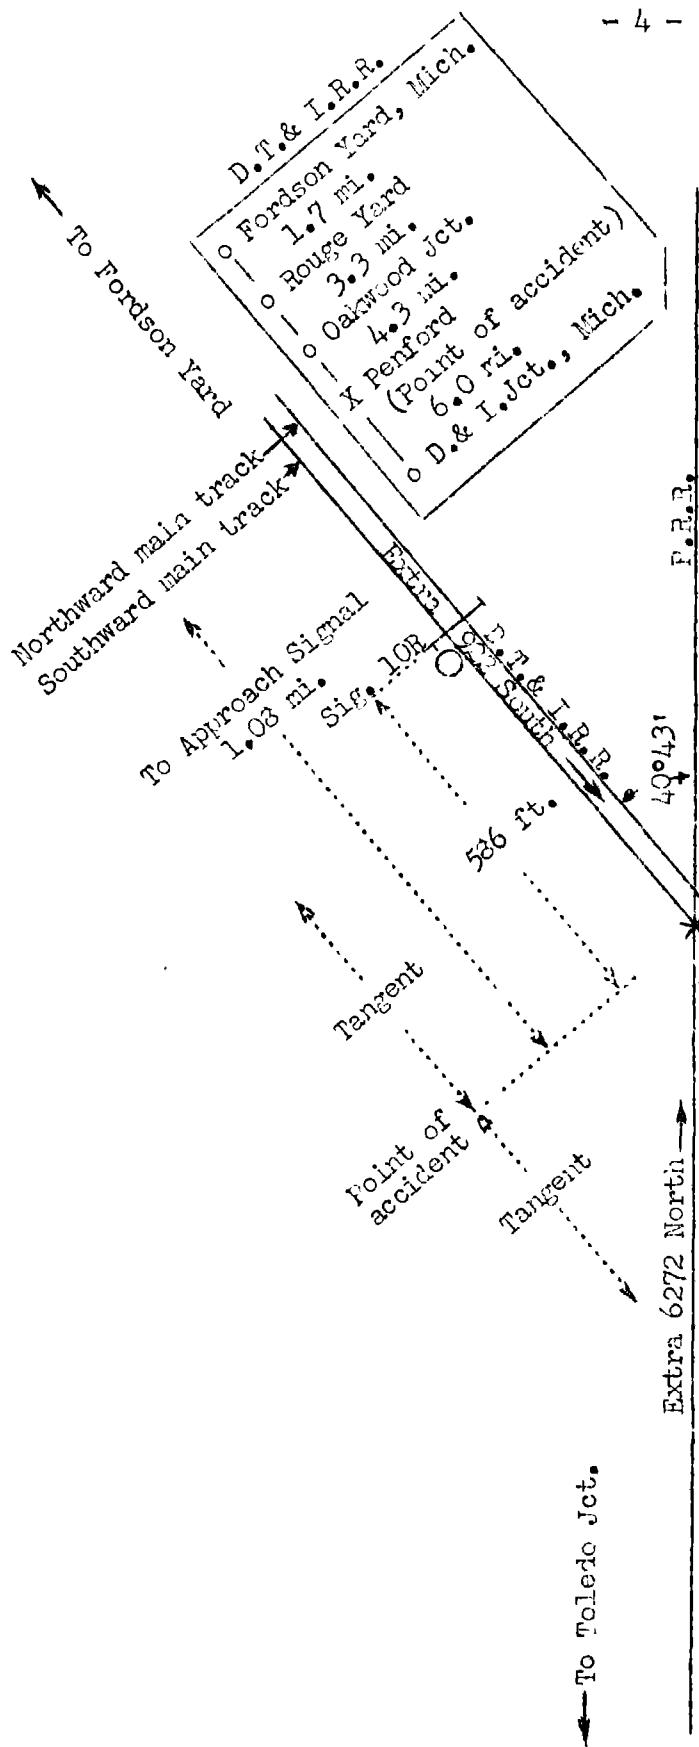
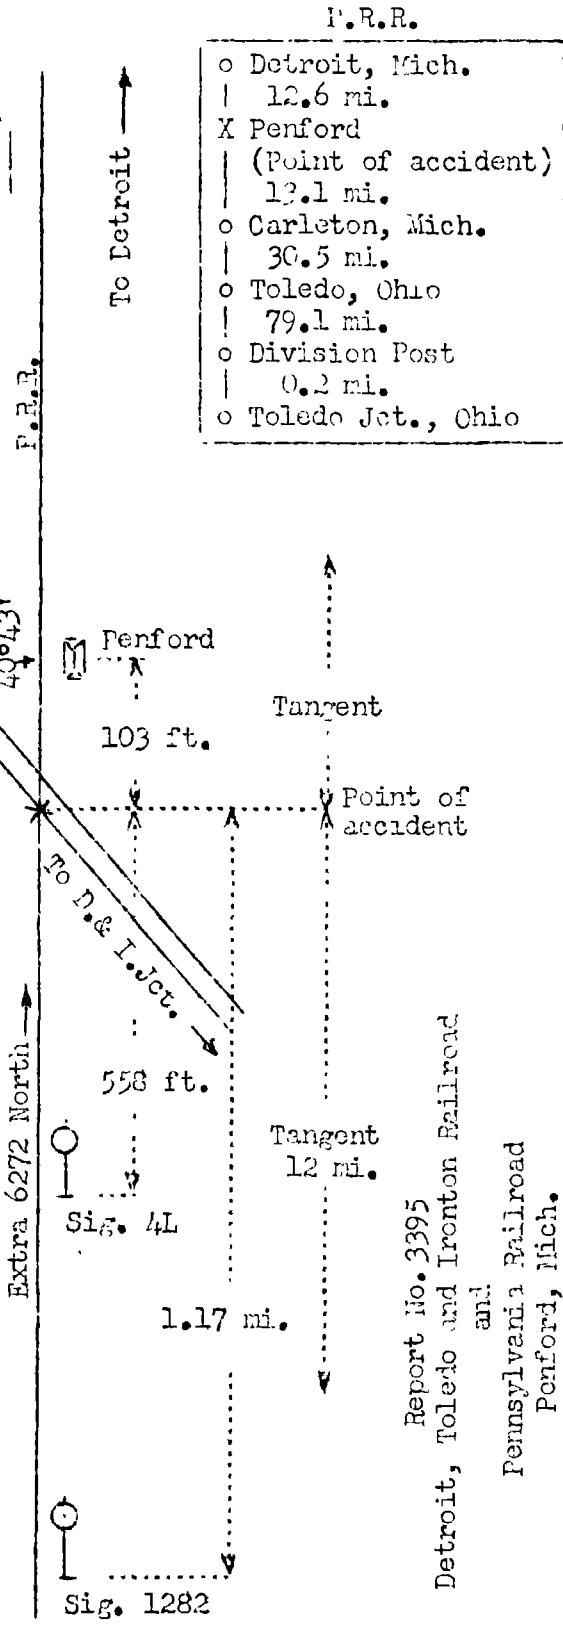
Report No. 3395
 Detroit, Toledo and Ironton Railroad
 and
 Pennsylvania Railroad
 Penford, Mich.
 March 14, 1951

Location of Accident and Method of Operation

None of the members of the train crew of Extra 6272 North saw the aspects displayed by signals 1282 and 4L. After the accident occurred, the signal system in the vicinity of the point of accident was tested and was found to be functioning properly.
