INVESTIGATION NO. 2599  
THE DETROIT, TOLEDO AND IRONTON RAILROAD COMPANY  
REPORT IN RE ACCIDENT  
NEAR DENVER, OHIO, ON  
JULY 9, 1942

Kind of accident: Rear-end collision

Accident near Denver, Ohio, on July 9, 1942, caused by  
failure to provide adequate flag protection for  
preceding train.

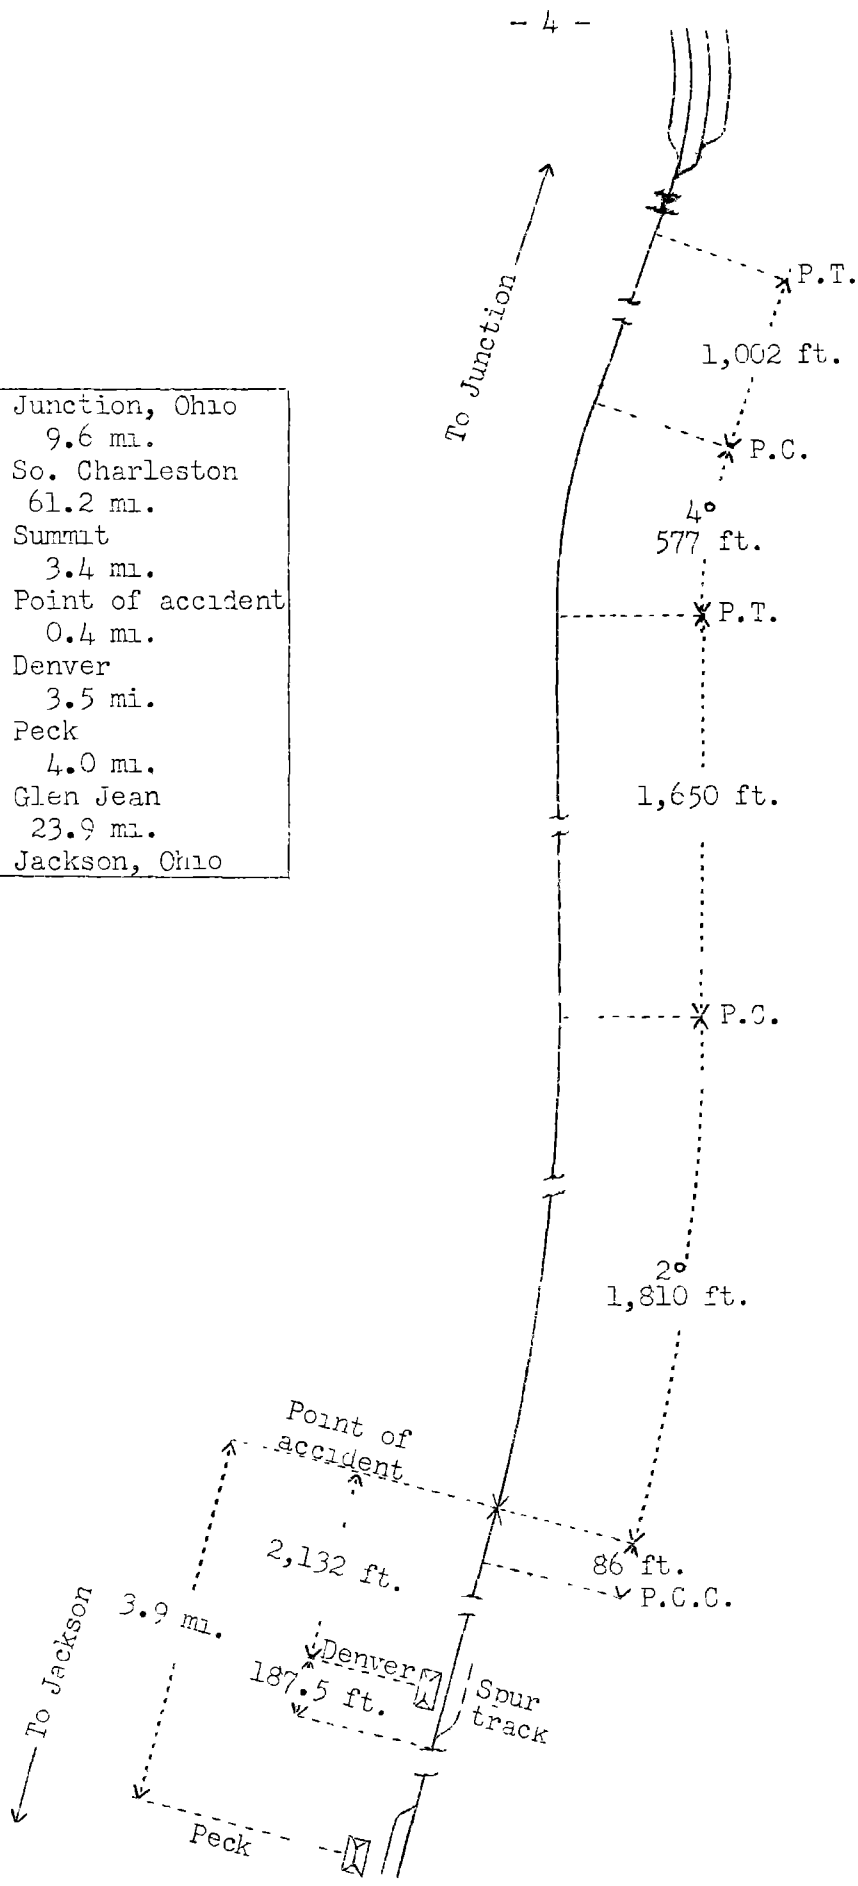
Inv. No. 2599  
 Detroit, Toledo and Ironton Railroad  
 Denver, Ohio  
 July 9, 1942

○	Junction, Ohio	
		9.6 mi.
○	So. Charleston	
		61.2 mi.
○	Summit	
		3.4 mi.
X	Point of accident	
		0.4 mi.
○	Denver	
		3.5 mi.
○	Peck	
		4.0 mi.
○	Glen Jean	
		23.9 mi.
○	Jackson, Ohio

Location of Accident and Method of Operation
