ACCIDENT ON THE
DULUTH, SOUTH SHORE AND ATLANTIC RAILWAY

MICHIGAMME, MICH.

MARCH 30, 1939

INVESTIGATION NO. 2341

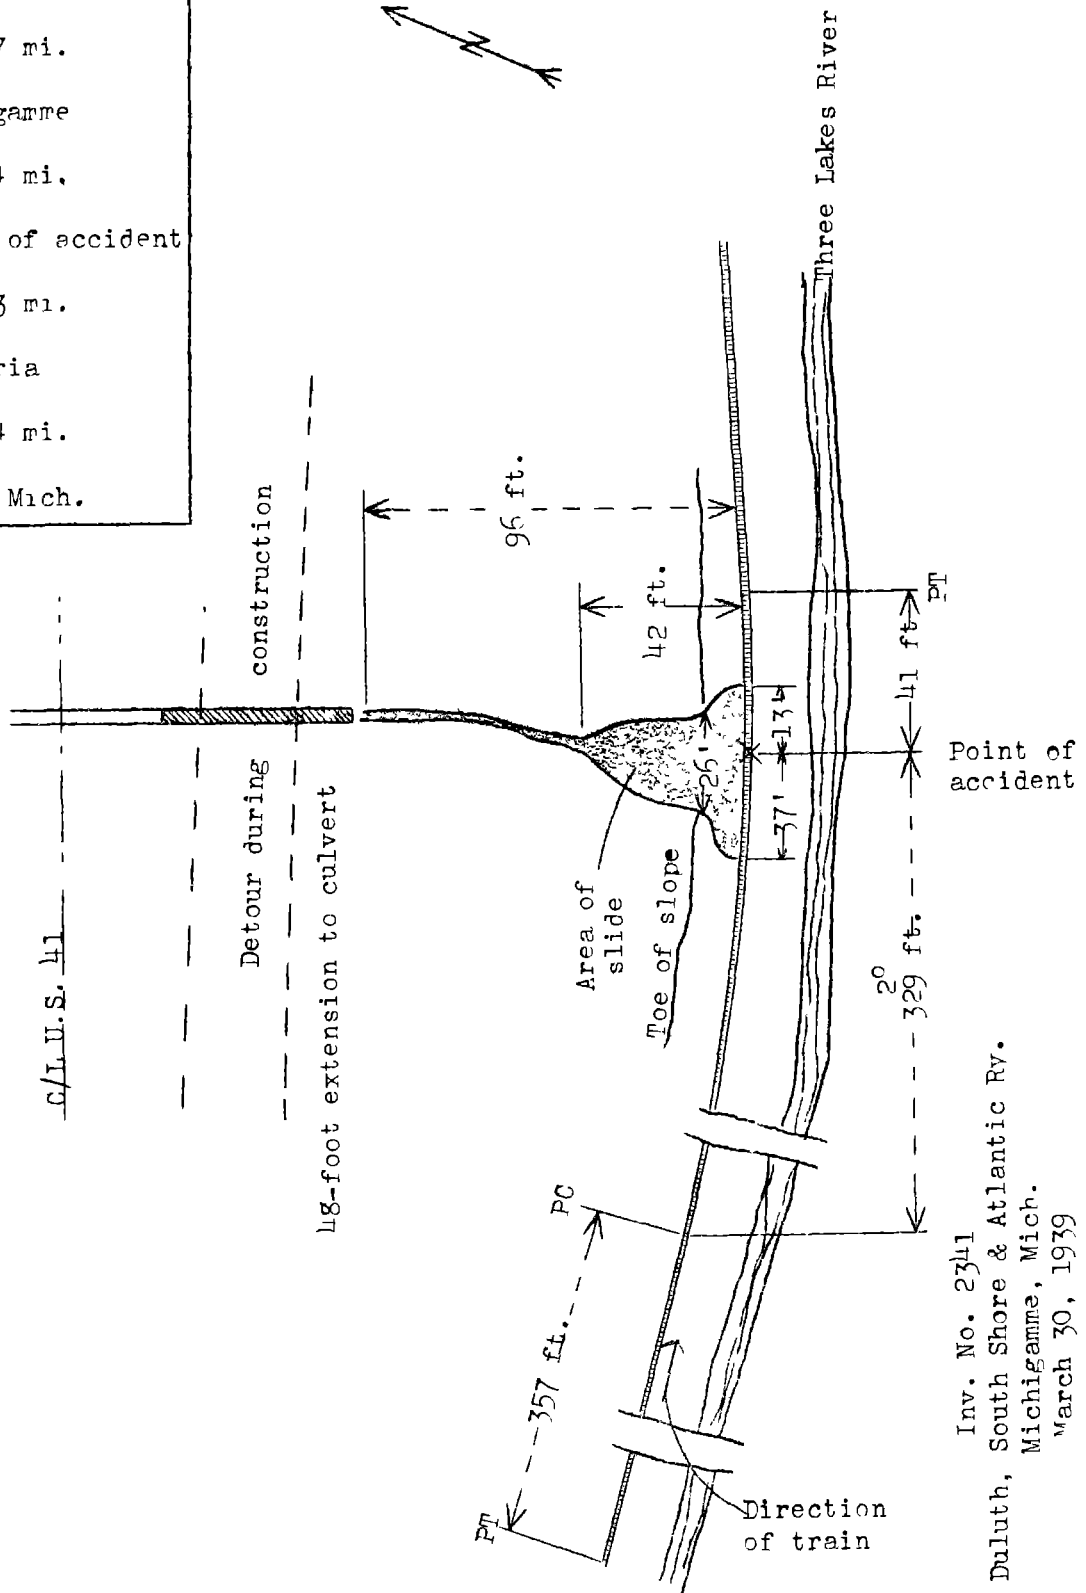
Inv. No. 2341
 Duluth, South Shore & Atlantic Ry.
 Michigamme, Mich.
 March 30, 1939

o	East Yard, Mich.
	38.7 mi.
o	Michigamme
	3.4 mi.
X	Point of accident
	4.3 mi.
o	Nestoria
	54.4 mi.
o	Ewen, Mich.

In the immediate vicinity of the point of derailment the track is laid through a hill-side cut about 150 feet in length. To the north side of the track a slope, the toe of which is 5 feet from the center-line, rises to a height of 44 feet at a point 110 feet from the track, or at a ratio of 2 to 5. The formation is composed of a mixture of rock, clay, sand, and gravel, the surface of which is covered with grass and brush. U. S. Highway No. 41 is located at the top of the slope and parallels the track, its center-line being 175 feet north of the center-line of the track. A detour road had been built by a construction company between the rim of the slope and U. S. Highway No. 41 for use during the reconstruction of the latter road. Before the detour road was built an 18-inch culvert under the highway provided drainage from a hill and a marshy basin on the north to a ditch paralleling the highway on the south side. A 48-foot extension to this culvert was installed under the detour road, resulting in its outlet being located about 96 feet from the center-line of the track and causing the drainage to be diverted to the slope toward the track and Three Lakes River which is located to the south of the track. The north bank of the river is from 10 to 50 feet from the roadbed.

The engine, badly damaged, stopped almost entirely submerged in the river, with its front end 123 feet east of the point of derailment, parallel to and about 42 feet from the track. The tender, also badly damaged, stopped behind and at right angles to the locomotive, with the rear end of its cistern on the roadbed. The first car was badly damaged and was derailed to the south with its forward portion leaning against the rear of the tender. The second car, slightly damaged and remaining coupled to the first car, was derailed but remained in upright position and in line with the track. The leading truck of the third car was derailed. All the derailed equipment stopped within a distance of 236 feet, and the track was damaged a distance of 198 feet. The employees killed were the engineman and the fireman.
