REPORT NO. 3487  
DULUTH, SOUTH SHORE & ATLANTIC  
RAILROAD COMPANY  
IN RE ACCIDENT  
NEAR ONOTA, MICH., ON  
OCTOBER 3, 1952

Kind of accident: Head-end collision

Cause: Failure to provide adequate protection  
for movement of track motor-car

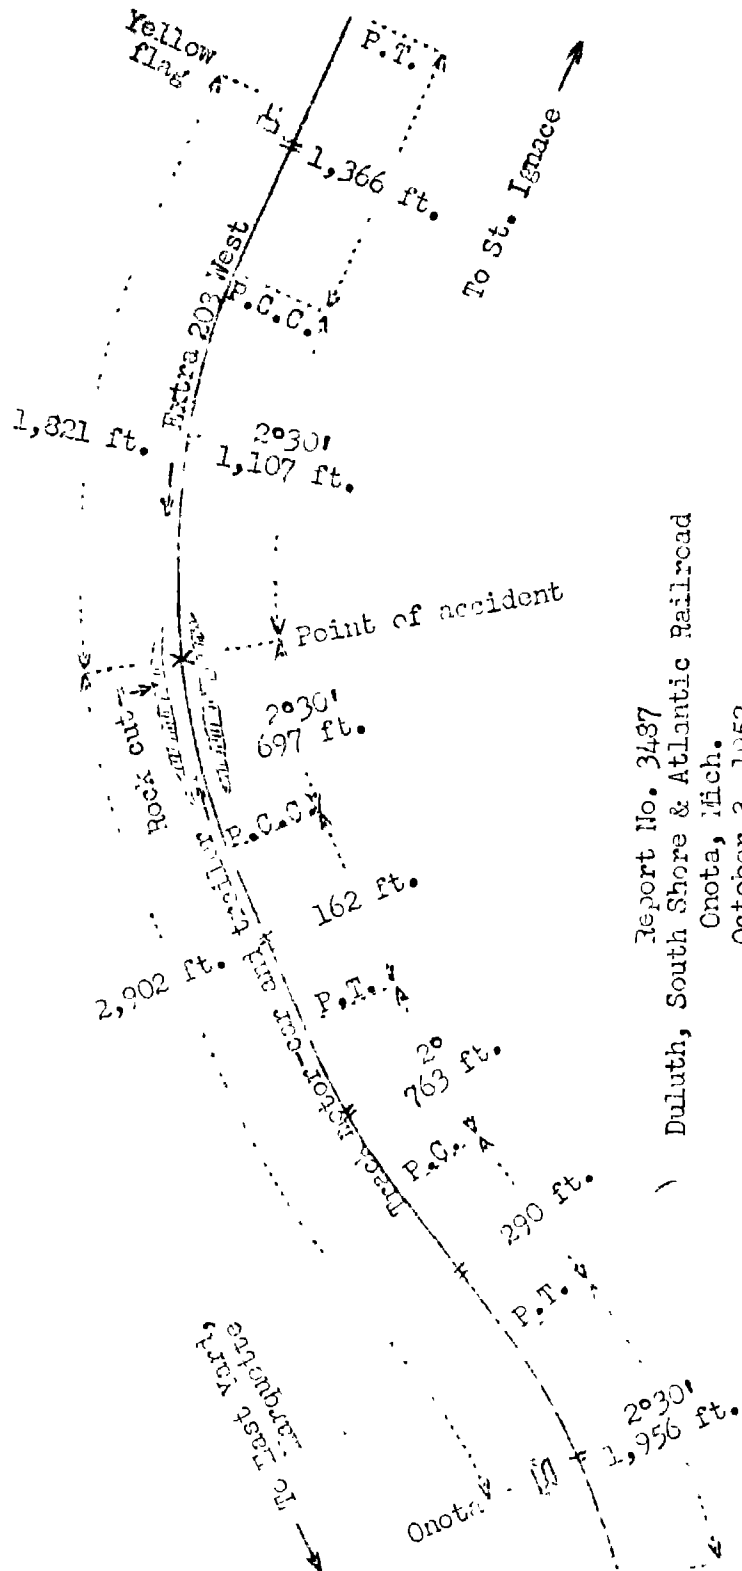
Report No. 3487  
Duluth, South Shore & Atlantic Railroad  
Onota, Mich.  
October 3, 1952

Location of Accident and Method of Operation
