REPORT NO. 3327
ELGIN, JOLIET & EASTERN RAILWAY COMPANY
IN RE ACCIDENT
AT CAVANAUGH, IND., ON
MAY 9, 1950

Report No. 3327
 Elgin, Joliet & Eastern Railway
 Cavanaugh, Ind.
 May 9, 1950

Location of Accident and Method of Operation

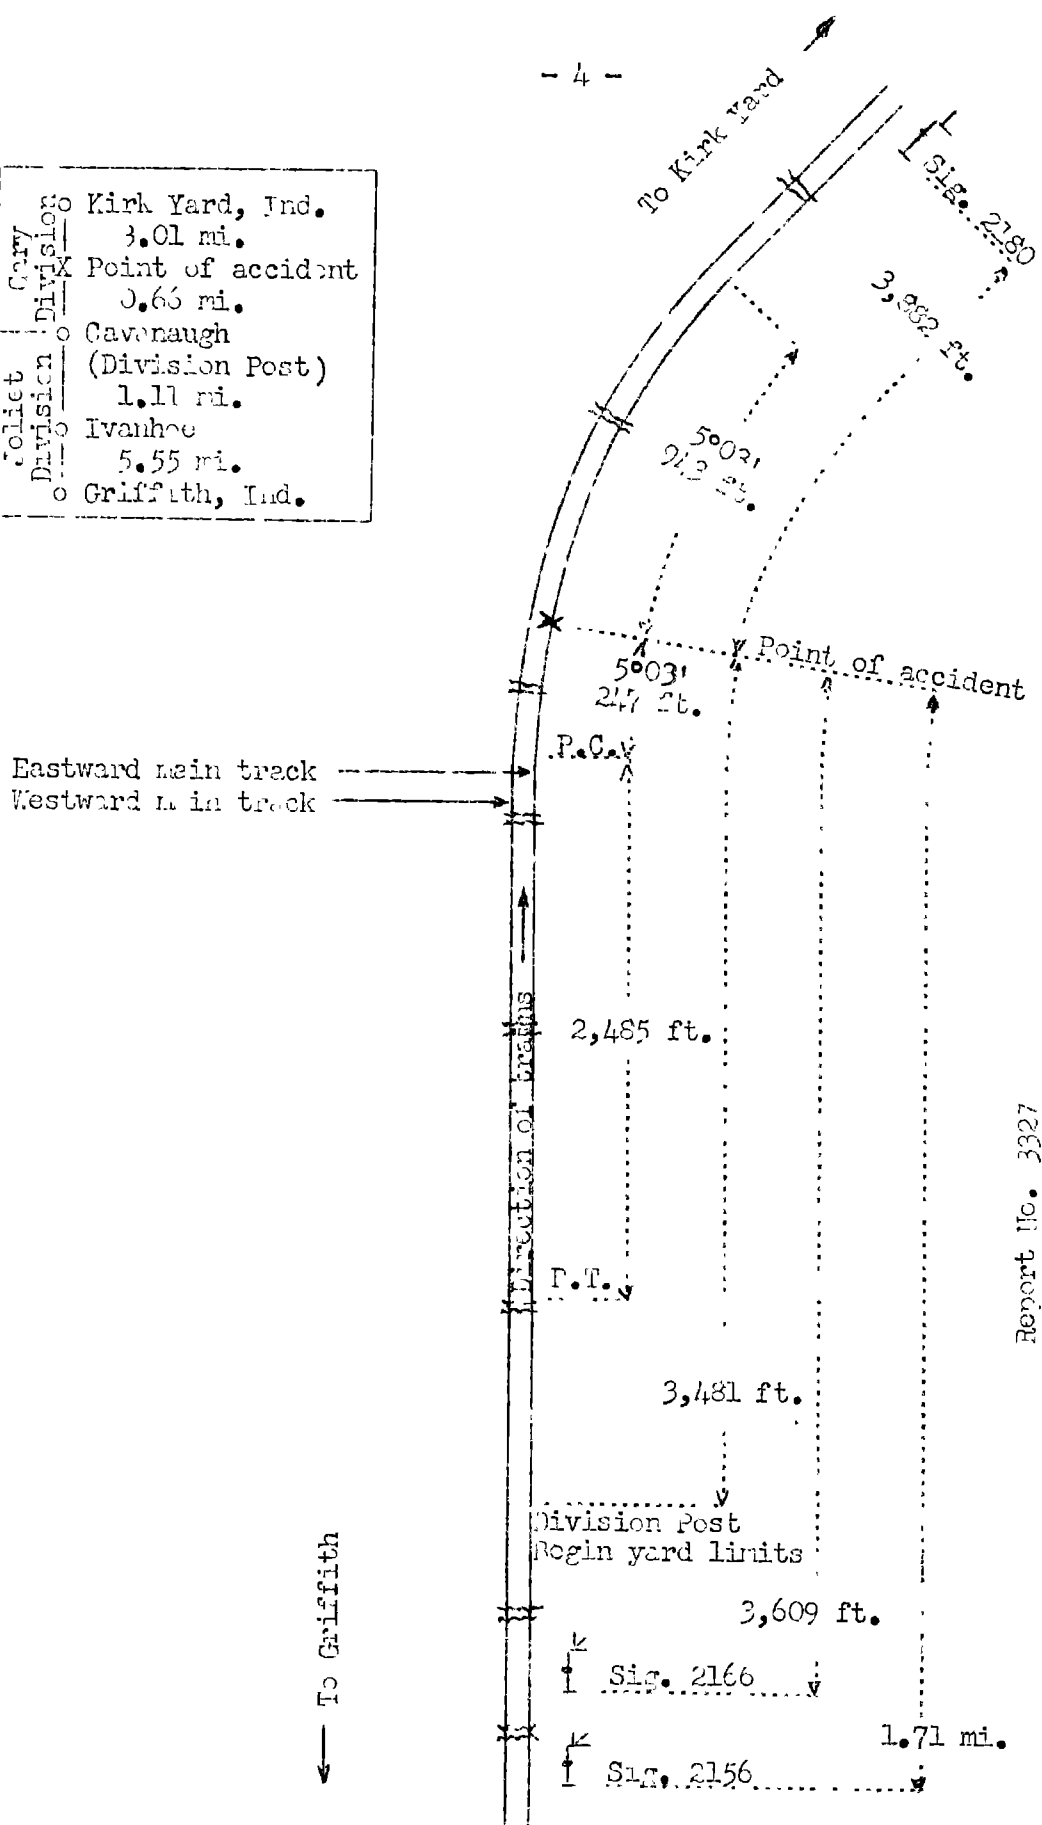
Joliet	Cary	o	Kirk Yard, Ind.
			3.01 mi.
Division	X		Point of accident
			0.66 mi.
Division	o		Cavanaugh
			(Division Post)
Division	o		Ivanhoe
			5.55 mi.
Division	o		Griffith, Ind.
