INVESTIGATION NO. 2694
THE ELGIN, JOLIET AND EASTERN RAILWAY COMPANY
REPORT IN RE ACCIDENT
NEAR EAST JOLIET, ILL., ON
APRIL 19, 1943

Railroad: Elgin, Joliet and Eastern
Date: April 19, 1943
Location: East Joliet, Ill.
Kind of accident: Rear-end collision
Trains involved: Freight : Freight
Train numbers: Extra 706 West : Extra 718 West
Engine numbers: 706 : 718
Consist: 36 cars, caboose : 31 cars, caboose
Speed: Standing : 6-18 m. p. h.
Operation: Timetable, train orders and
automatic block-signal system
Track: Double; 1°29'50" curve to right;
0.57 percent descending grade
westward
Weather: Cloudy
Time: About 8:45 a. m.
Casualties: 1 killed; 2 injured
Cause: Accident caused by failure to
provide adequate flag protec-
tion for preceding train, and
by failure to operate following
train in accordance with signal
indications

Accident near East Joliet, Ill., on April 19, 1943, caused
by failure to provide adequate flag protection for
preceding train, and by failure to operate following
train in accordance with signal indications.

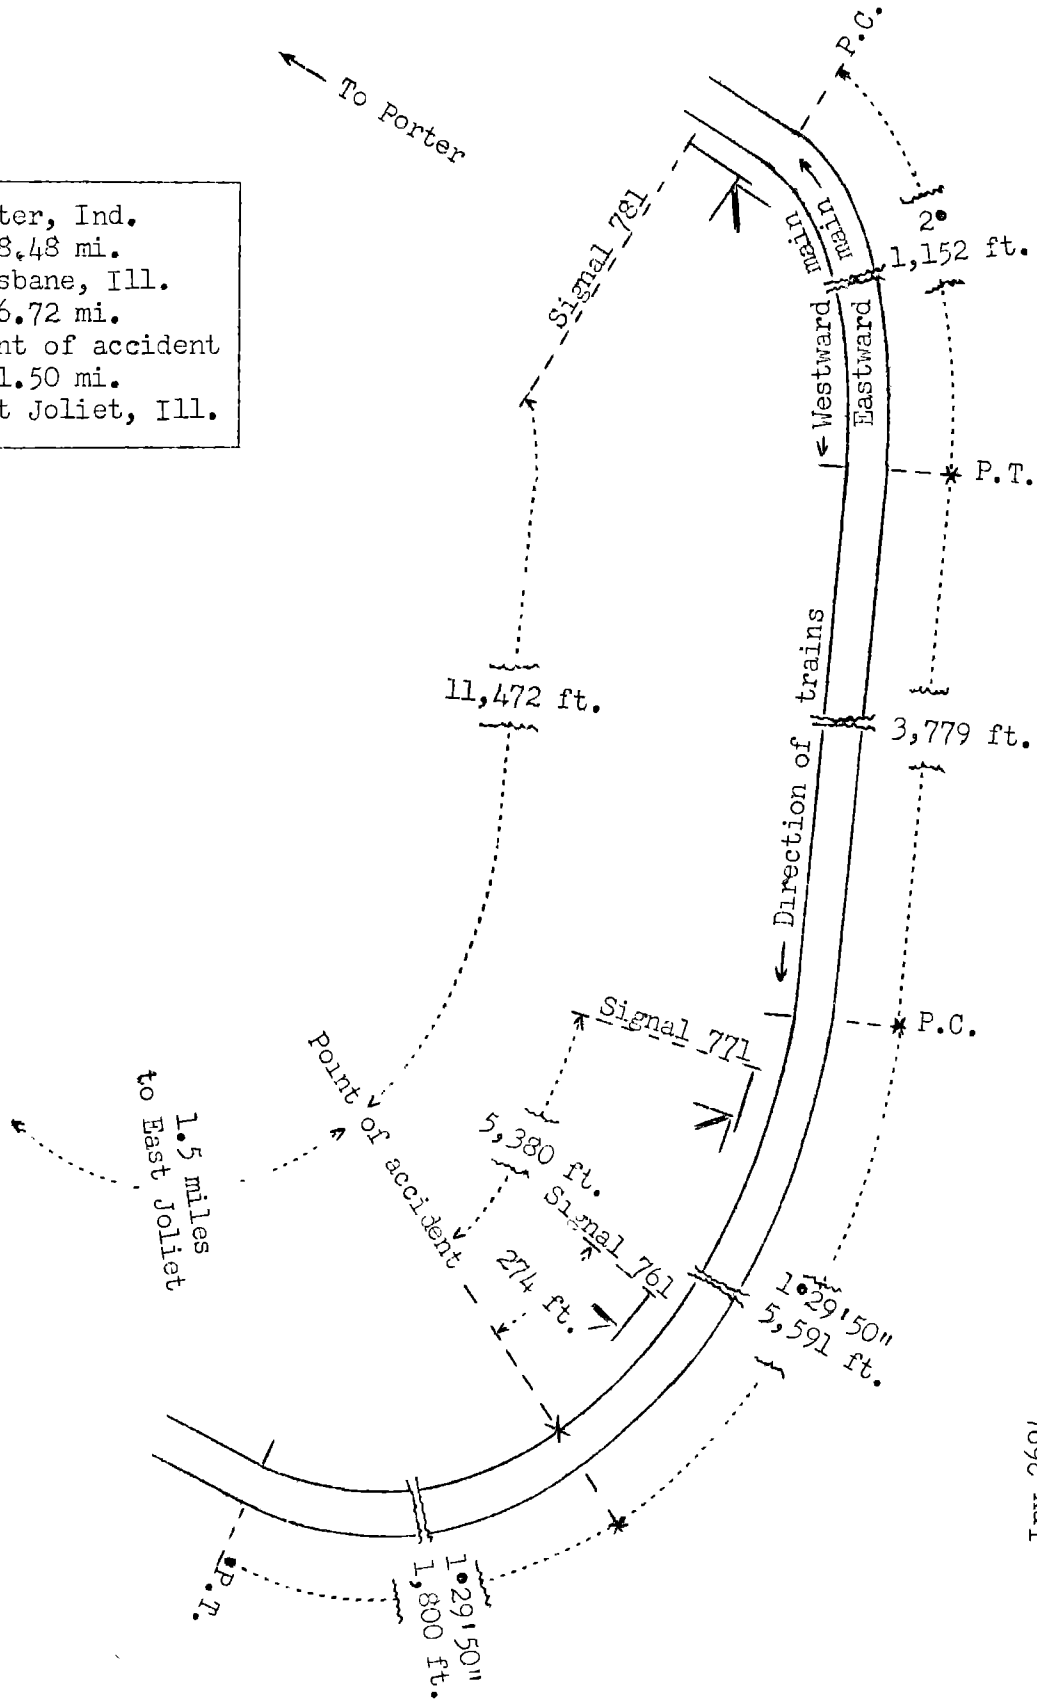
Inv-2694
 Elgin, Joliet and Eastern Railway
 East Joliet, Ill.
 April 19, 1943

- | | | |

| o | Porter, Ind. | 48.48 mi. |
| o | Brisbane, Ill. | 6.72 mi. |
| X | Point of accident | 1.50 mi. |
| o | East Joliet, Ill. | |

Location of Accident and Method of Operation

Signals 781 and 771

As Extra 718 was approaching signal 781, located 11,472 feet east of the point where the collision occurred, the speed was about 45 miles per hour. The enginemen were on their respective sides of the engine and the front brakeman was standing beside the engineer. These employees were maintaining a lookout ahead. There was no condition of the engine which obscured the view ahead or distracted their attention. The brakes functioned properly at all points where used en route. Signal 781 displayed approach and the engineer made a service brake-pipe reduction, which reduced the speed to about 25 miles per hour. This speed was maintained as the train passed signal 771, which displayed approach. When the engine reached a point about 1,800 feet east of signal 761 the front brakeman observed that this signal was displaying stop-and-proceed. Because he thought the engineer saw the indication displayed by this signal, he did not call the indication, and the engineer did not call it. Because of track curvature, the fireman could not see signal 761 until the engine reached a point about 500 feet east of it. Then he observed simultaneously two members of the crew of Extra 706 giving stop signals and the stop-and-proceed indication displayed by this signal. He called a warning to the engineer, who immediately moved the brake valve to emergency position, but the collision occurred before Extra 718 could be stopped. Why Extra 718 was not stopped in accordance with the stop-and-proceed indication displayed by signal 761 could not be determined, as the engineer was fatally injured in the accident. The rules required the employees who were on the engine
