INTERSTATE COMMERCE COMMISSION

REPORT OF THE DIRECTOR OF THE BUREAU OF SAFETY CONCERNING AN
ACCIDENT ON THE ELGIN, JOLIET AND EASTERN RAILWAY AT INDIANA
HARBOR, IND., ON JUNE 26, 1934.

August 2, 1934.

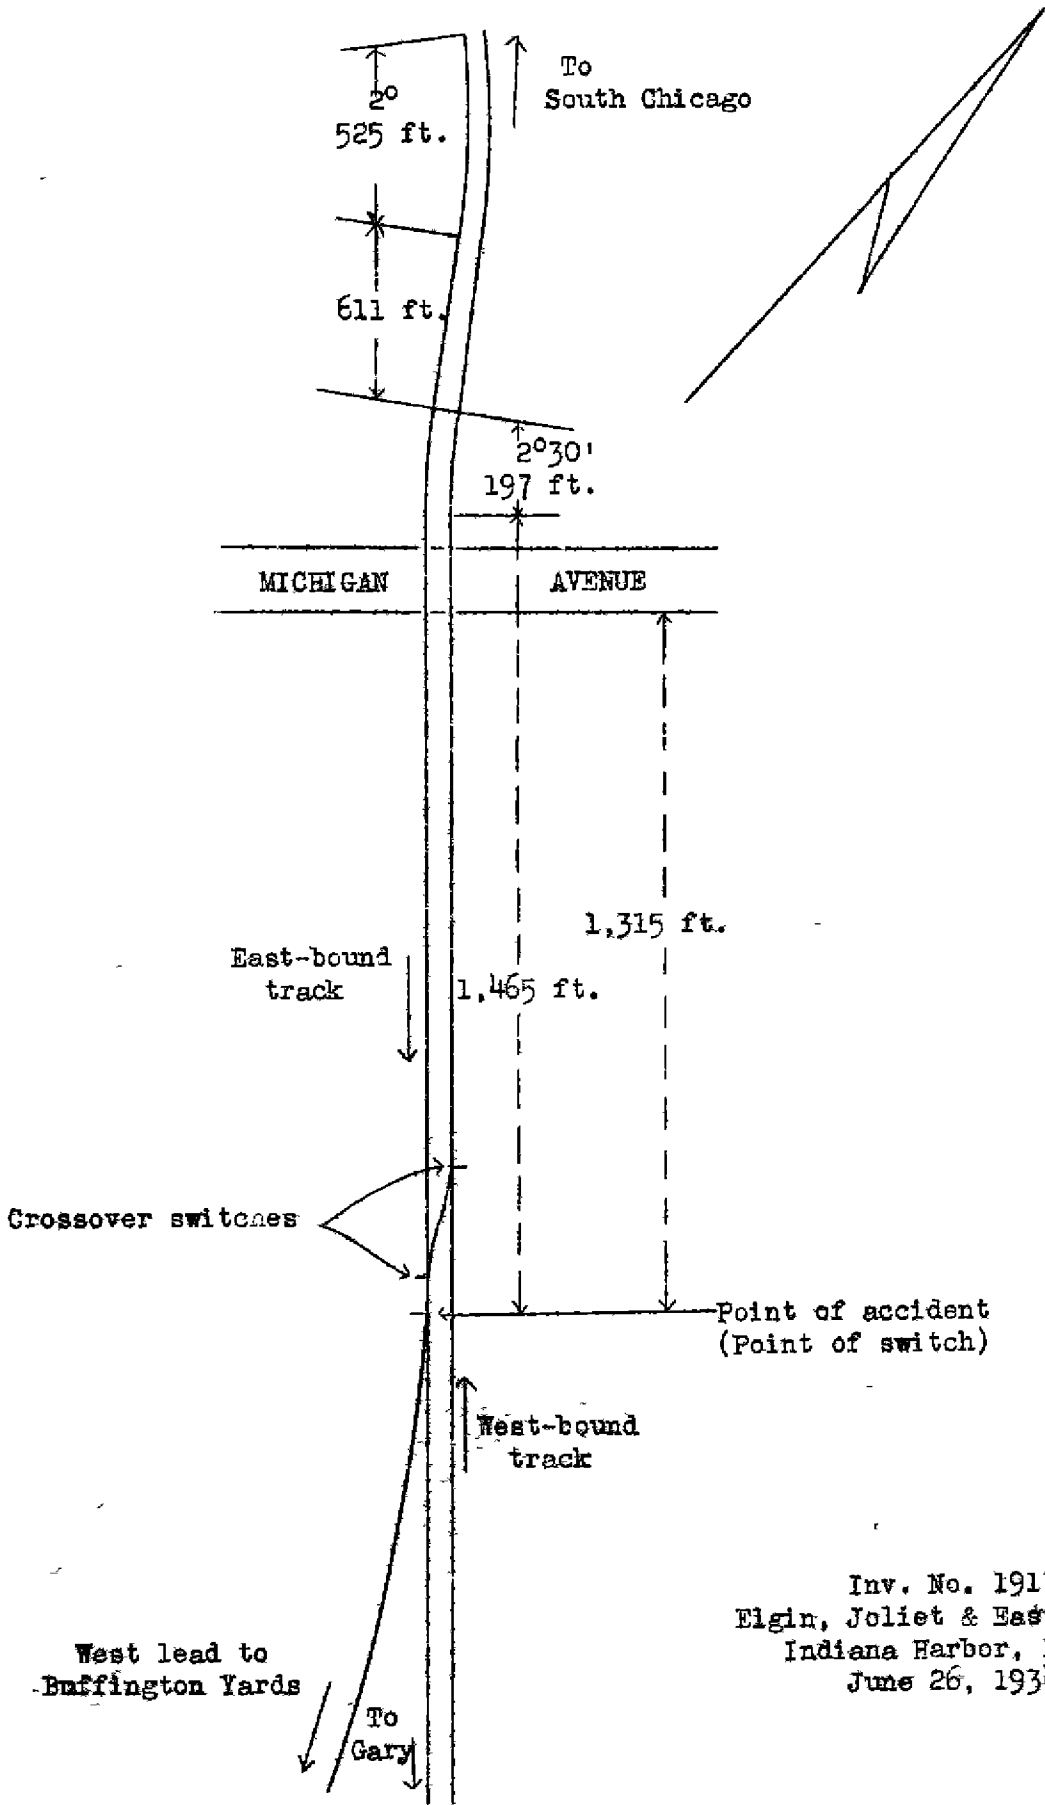
Inv. No. 1917
Elgin, Joliet & Eastern Ry.
Indiana Harbor, Ind.
June 26, 1934

The switch involved is a facing-point switch for east-bound trains, with a no. 10 turnout. The switch stand, located on the south side of the east-bound track, is a Star stand, manufactured by the Pettibone Lulliken Company, and is of the high revolving type with switch light roundels 6 feet 9 inches above the head block ties, displaying a green indication when the switch is lined for the main track and a red indication for the diverging route. The stand is equipped with a red fish-tail banner 12 by 30 inches which is 3 feet 4 inches above the head blocks; this banner is displayed only when the switch is lined for the diverging route. The view of the switch is unobstructed for over 1,400 feet.
