INVESTIGATION NO. 2564
THE ERIE RAILROAD COMPANY
REPORT IN RE ACCIDENT
NEAR BIPPUS, IND., ON
JANUARY 27, 1942

Kind of accident: Rear-end collision

Accident near Bippus, Ind., on January 27, 1942, caused by failure to operate following train in accordance with automatic block-signal indications and by failure to obey flagman's signals.

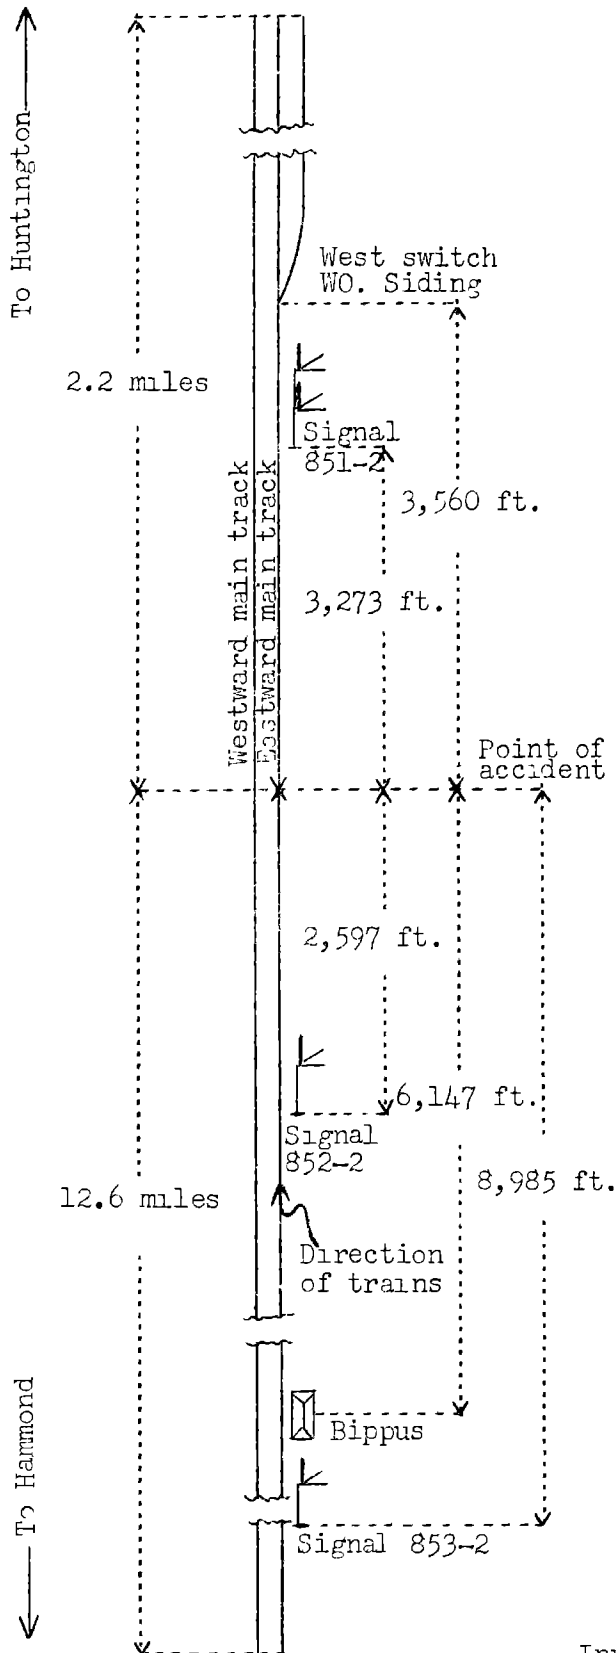
Inv. No. 2564
 Erie Railroad
 Bippus, Ind.
 January 27, 1942

Location of Accident and Method of Operation
