REPORT NO. 3293  
ERIE RAILROAD COMPANY  
IN RE ACCIDENT  
NEAR KINGSLAND, IND., ON  
OCTOBER 29, 1949

Kind of accident: Collision

Accident near Kingsland, Ind., on October 29, 1949, caused  
by failure to operate a motor-truck approaching a  
rail-highway grade-crossing in accordance with require-  
ments of law.

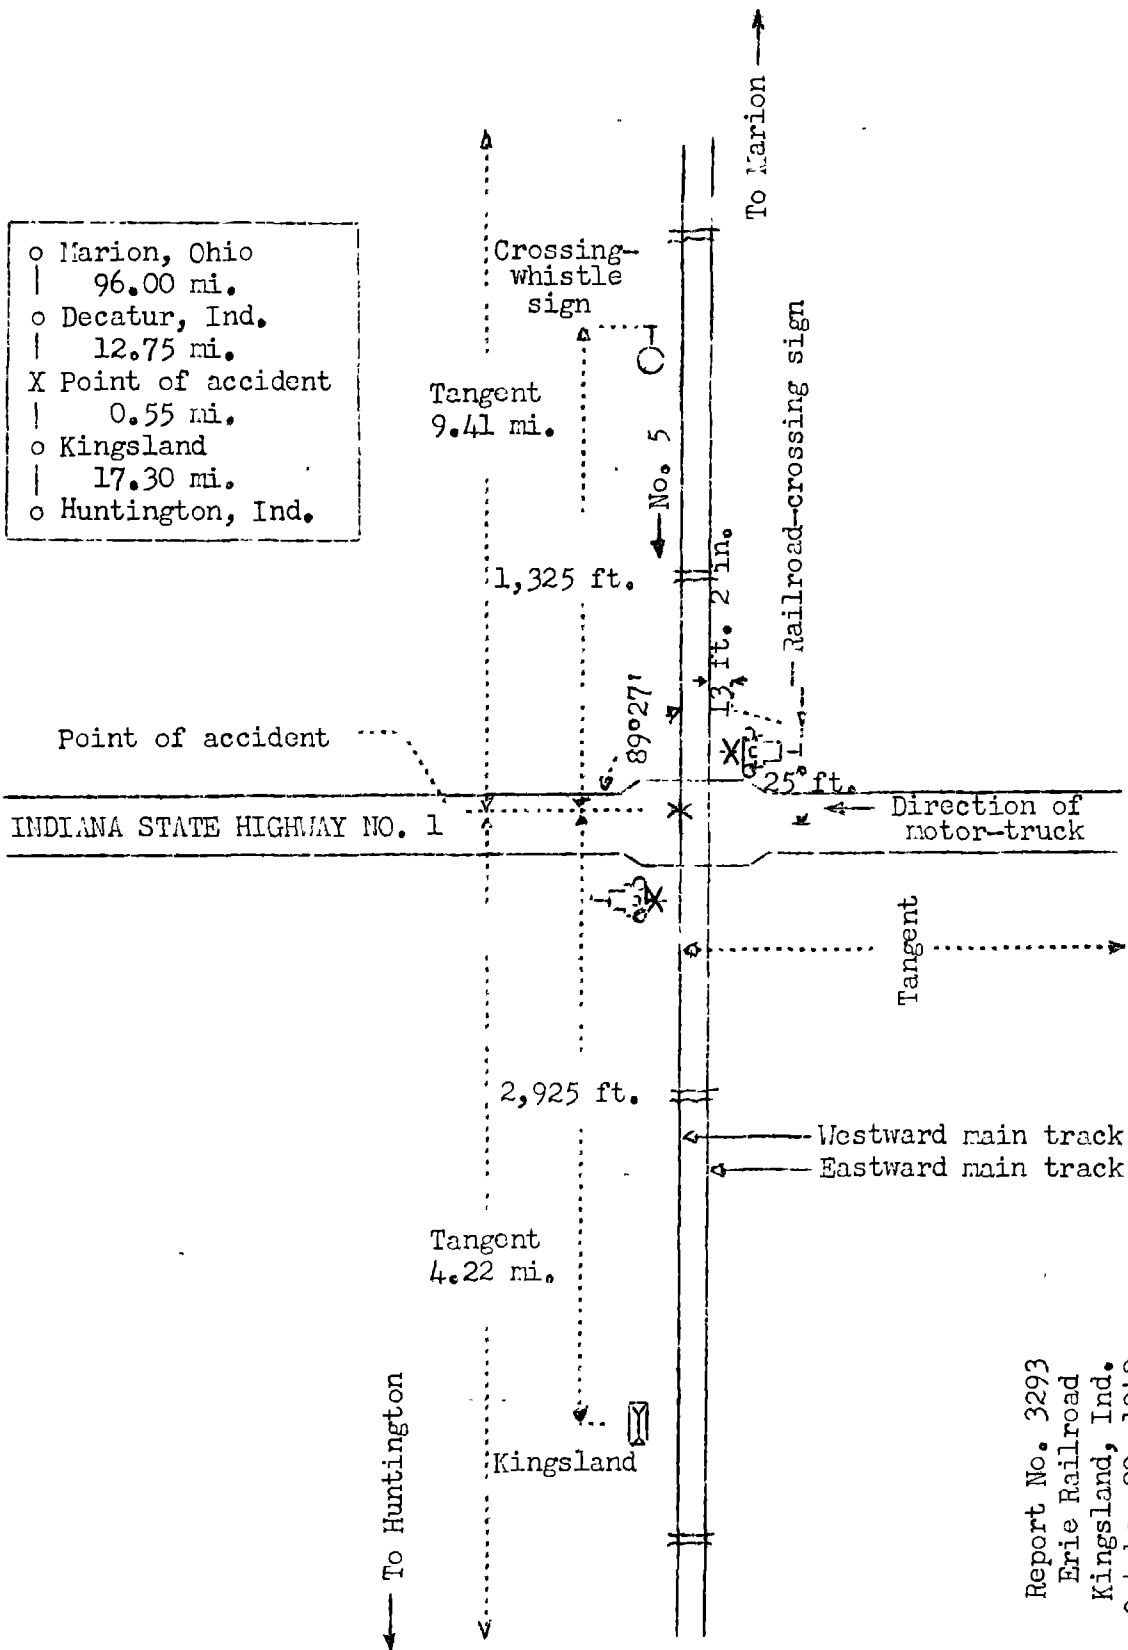
Report No. 3293  
 Erie Railroad  
 Kingsland, Ind.  
 October 29, 1949

- o Marion, Ohio
- | 96.00 mi.
- o Decatur, Ind.
- | 12.75 mi.
- X Point of accident
- | 0.55 mi.
- o Kingsland
- | 17.30 mi.
- o Huntington, Ind.
