INVESTIGATION NO. 2986
ERIE RAILROAD COMPANY
REPORT IN RE ACCIDENT
AT MADISON, OHIO, ON
APRIL 22, 1946

Accident at Marion, Ohio, on April 22, 1946, caused by
failure of the railroad to provide adequate safe-
guards for the movements involved.

Inv. No. 2986
 Erie Railroad
 Marion, Ohio
 April 22, 1946

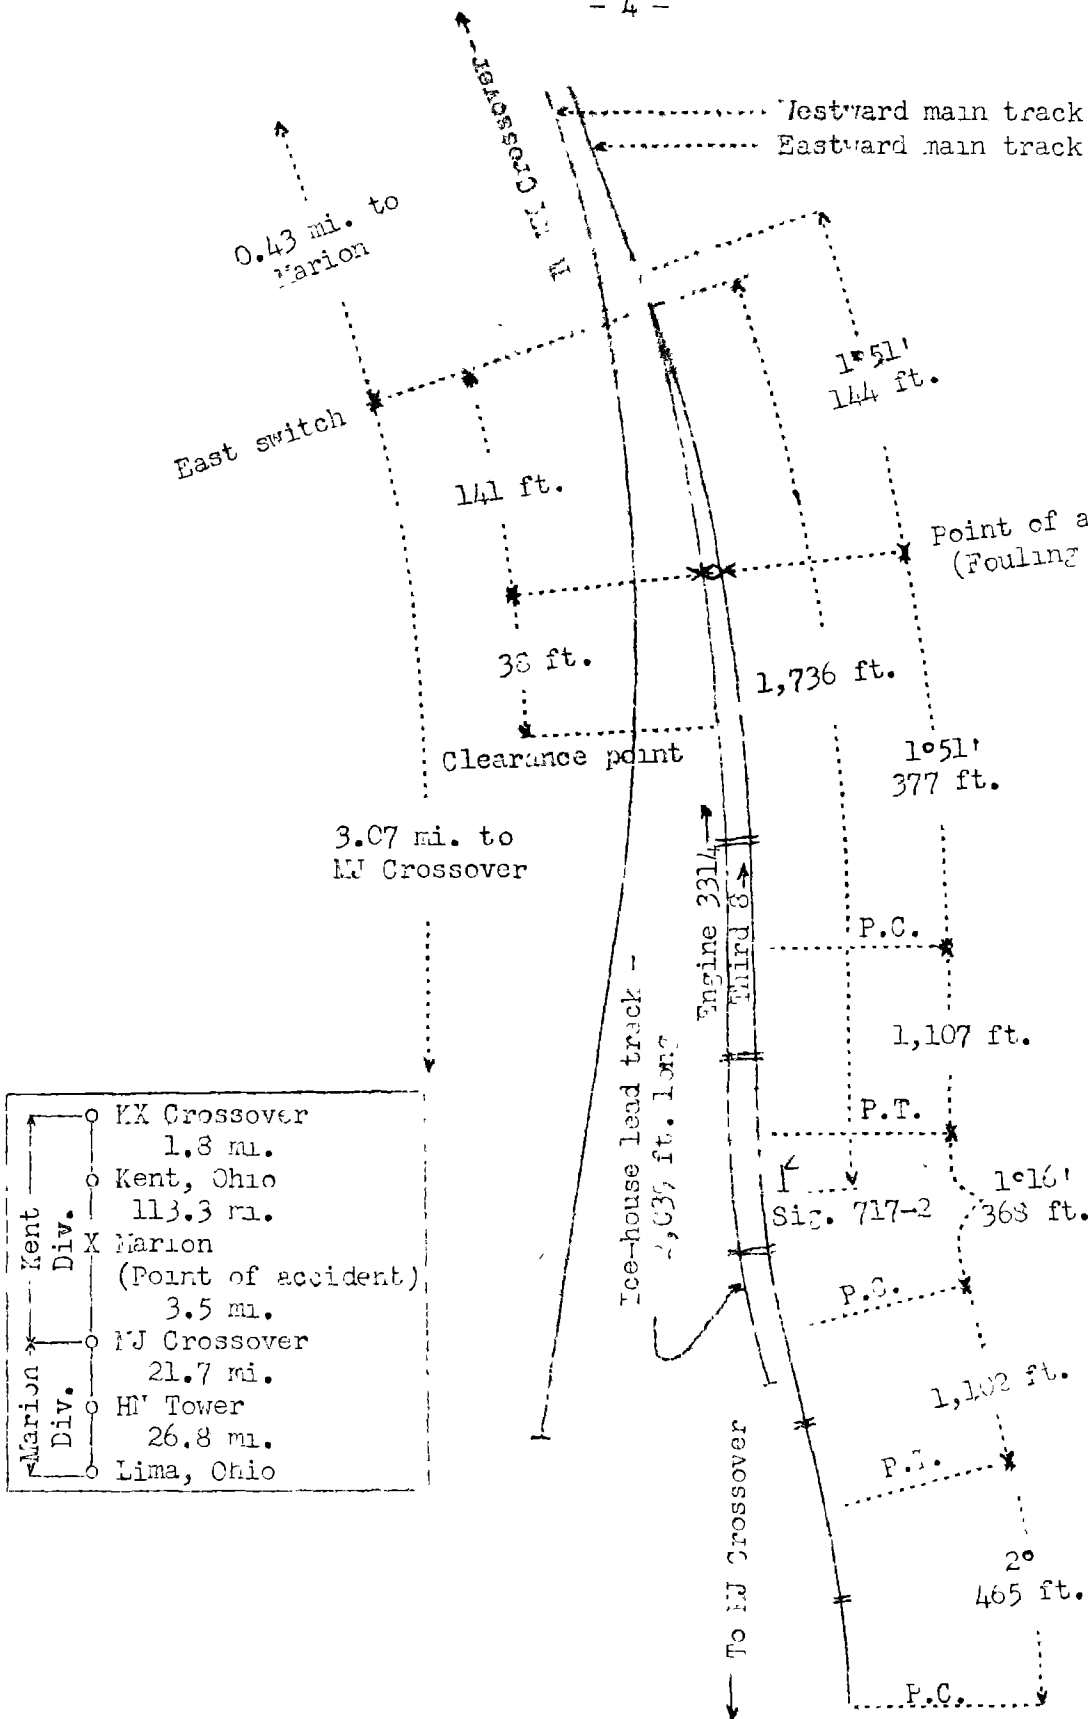
Kent Div.	○	KX Crossover	1.8 mi.
	○	Kent, Ohio	113.3 mi.
Marion Div.	×	Marion (Point of accident)	3.5 mi.
	○	NJ Crossover	21.7 mi.
	○	H ¹ Tower	26.8 mi.
	○	Lima, Ohio

This accident occurred on that part of the Kent Division extending between MJ Crossover, Marion, and KX Crossover, Kent, Ohio, 118.6 miles, a double-track line in the vicinity of the point of accident, over which trains moving with the current of traffic are operated by an automatic block-signal system, the indications of which supersede the superiority of trains. Within yard limits at Marion, an ice-house yard is located between the eastward and the westward main tracks. The eastern ice-house lead track, which connects the ice-house yard and the eastward main track, is 2,039 feet in length and parallels the eastward main track on the north. The east switch of the ice-house lead track is 3.07 miles east of MJ Crossover and 0.43 mile west of the station. The accident occurred at the fouling point of the turnout of this switch and the eastward main track, at a point 141 feet west of the switch and 58 feet east of the clearance point. From the west on the eastward main track there are, in succession, a 2° curve to the left 465 feet in length, a tangent 1,102 feet, a 1°13' curve to the right 568 feet, a tangent 1,107 feet, and a 1°51' curve to the left 377 feet to the point of accident and 144 feet eastward. The grade for east-bound trains is 0.55 percent ascending.
