INVESTIGATION NO. 2980
ERIE RAILROAD COMPANY
REPORT IN RE ACCIDENT
NEAR ROCHESTER, IND., ON
MARCH 20, 1946

Railroad: Erie
Date: March 20, 1946
Location: Rochester, Ind
Kind of accident: Rear-end collision
Equipment involved: Track motor-car : Passenger train
Train number: : 16
Engine number: : 2932
Consist: Motor-car 1327 : 5 cars
Estimated speed: Unknown : 25 m. p. h.
Operation: Signal indications
Track: Double; tangent; level
Weather: Clear
Time: 10:37 a. m.
Casualties: 2 killed
Cause: Failure to provide adequate protection for movement of track motor-car
Recommendation: That the Erie Railroad Company provide adequate train-order or block-signal protection for the movement of track motor-cars on its line

Accident near Rochester, Ind., on March 20, 1946, caused
by failure to provide adequate protection for the
movement of a track motor-car.

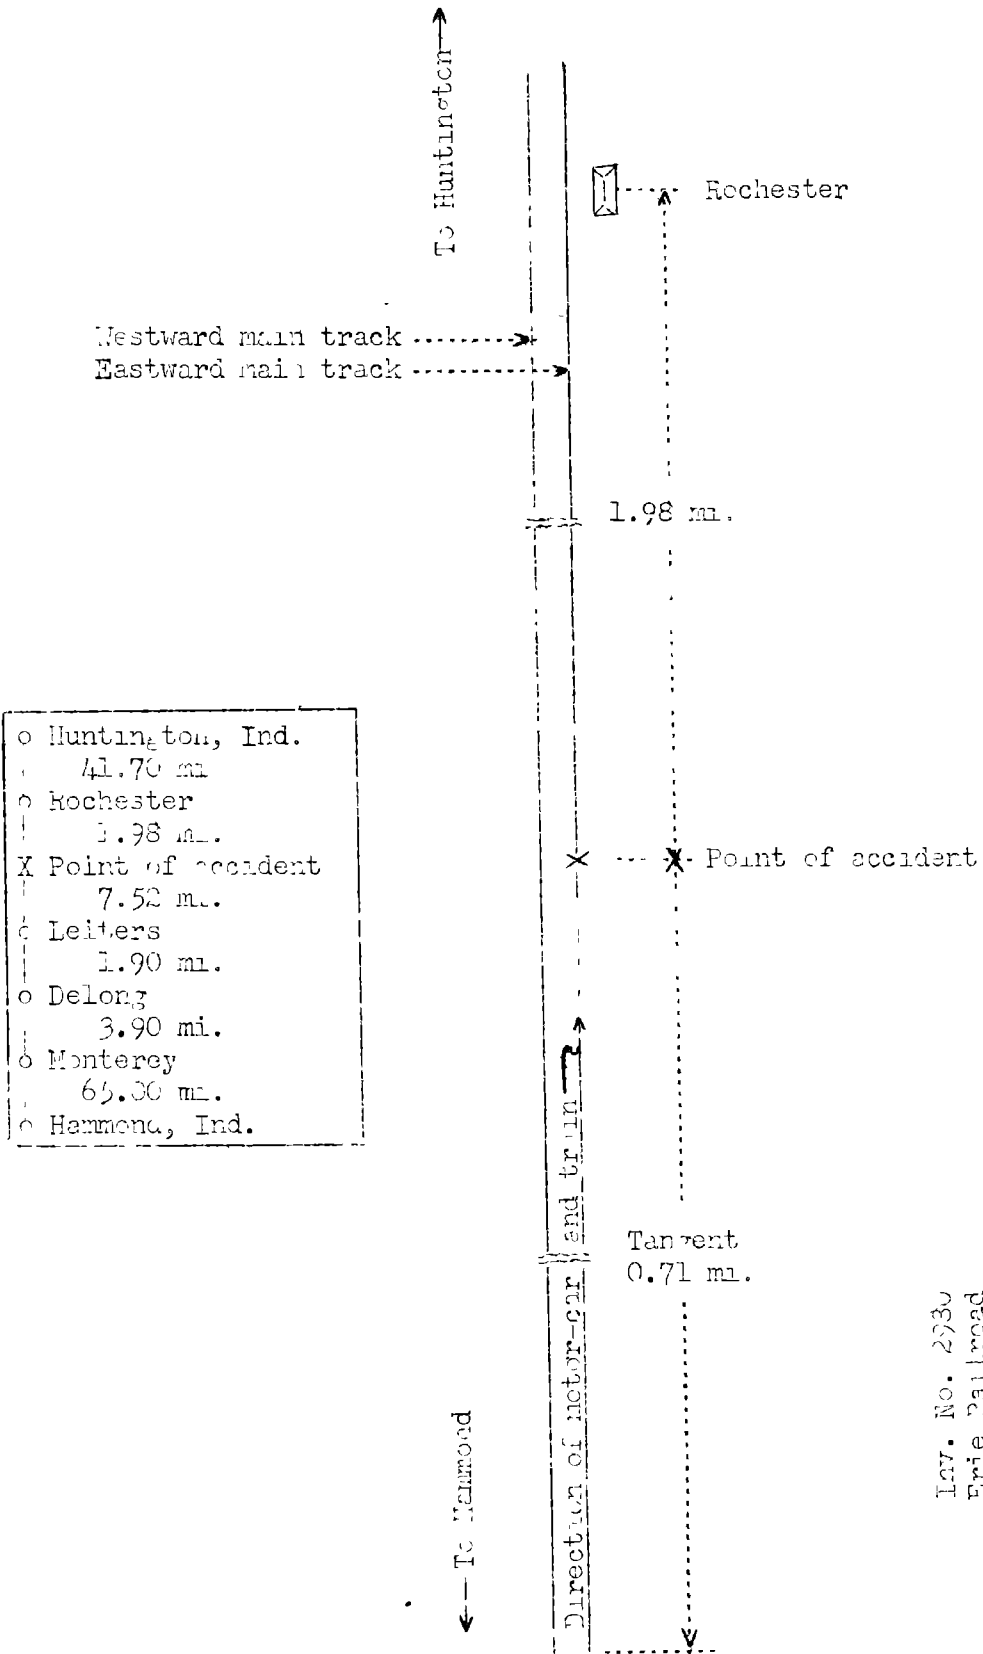
Inv. No. 2930
 Erie Railroad
 Rochester, Ind.
 March 20, 1916

- o Huntington, Ind. 41.70 mi.
- o Rochester 1.98 mi.
- X Point of accident 7.52 mi.
- o Leiters 1.90 mi.
- o DeLong 3.90 mi.
- o Monterey 65.30 mi.
- o Hammond, Ind.
