INVESTIGATION NO. 2857
THE ERIE RAILROAD COMPANY
REPORT IN RE ACCIDENT
AT STERLING, OHIO, ON
JANUARY 2, 1945

Railroad: Erie
Date: January 2, 1945
Location: Sterling, Ohio
Kind of accident: Derailment
Train involved: Passenger
Train number: 2
Engine number: 2944
Consist: 8 cars
Estimated speed: 30 m. p. h.
Operation: Interlocking
Track: Double; tangent; 0.2 percent
descending grade eastward
Weather: Clear
Time: 3:43 a. m.
Casualties: 1 killed; 1 injured
Cause: Making indication displayed by
home signal and position of
derail not in accordance with
position of movable-point
crossing

Accident at Sterling, Ohio, on January 2, 1945, caused by making the indication displayed by the home signal and the position of the derail not in accordance with the position of the movable-point crossing.

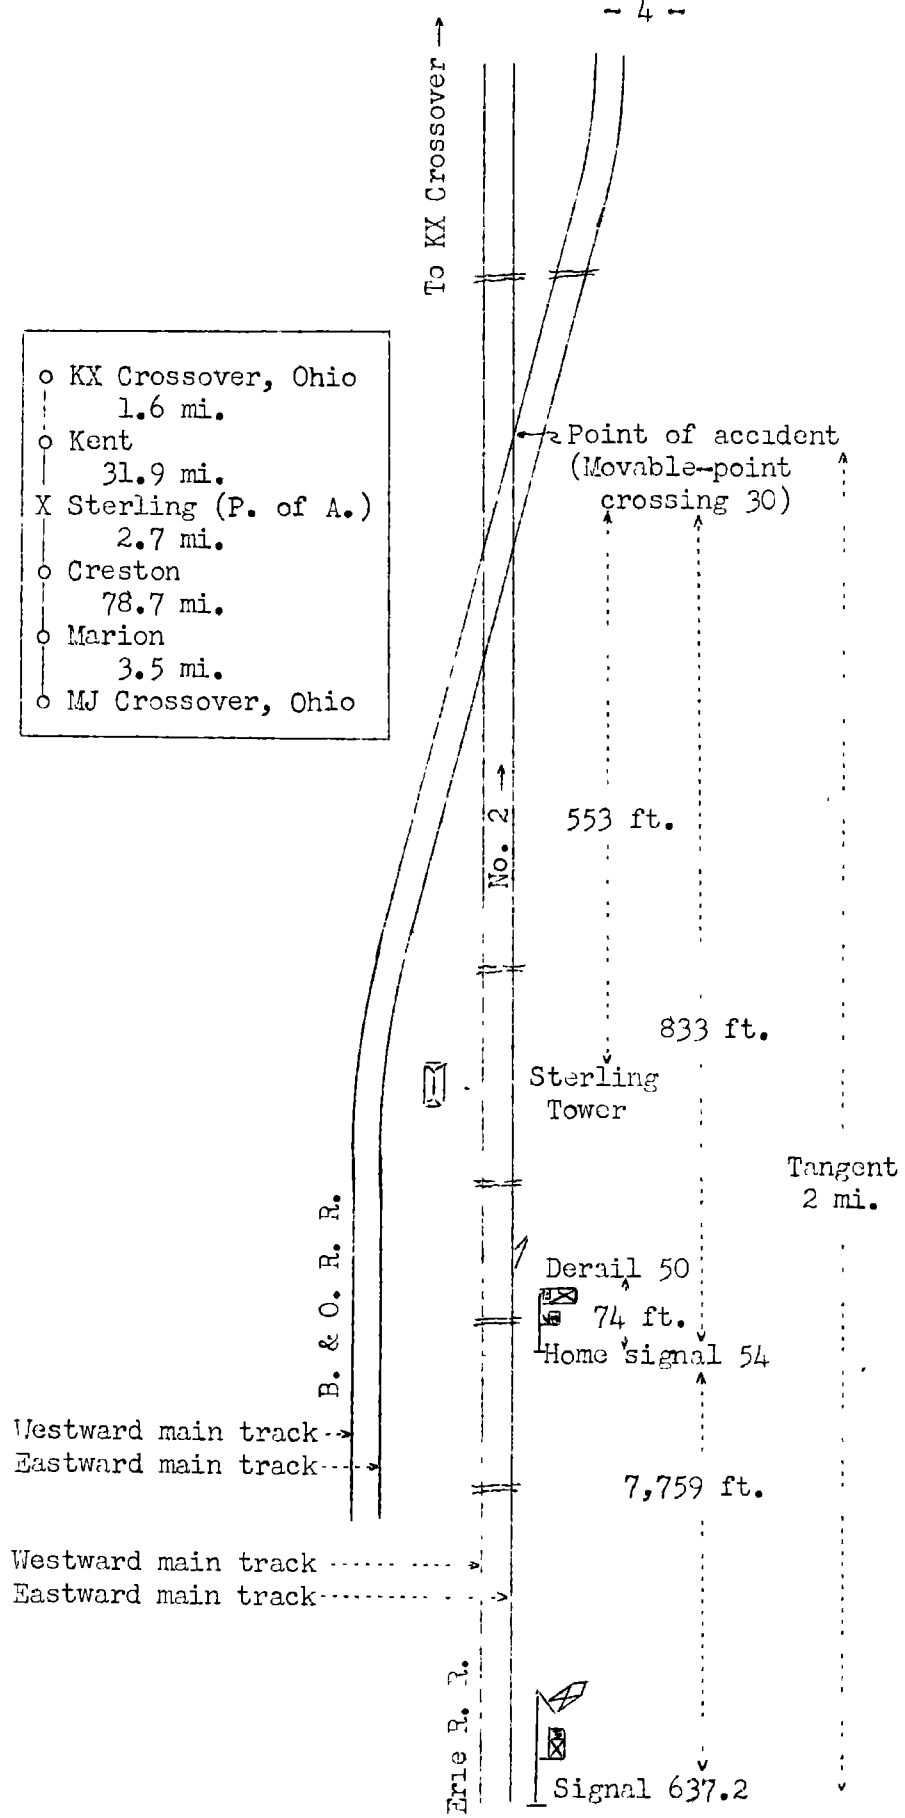
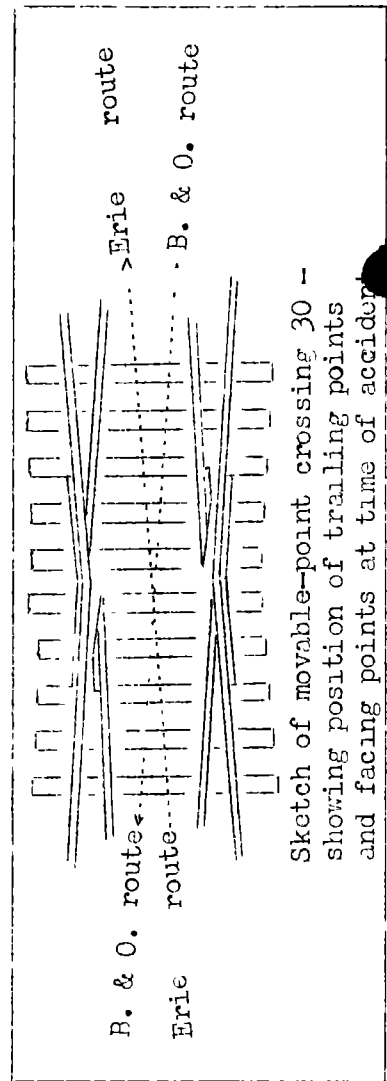
Inv. No. 2857
Erie Railroad
Sterling, Ohio
January 2, 1945

- o KX Crossover, Ohio
1.6 mi.
- o Kent
31.9 mi.
- X Sterling (P. of A.)
2.7 mi.
- o Creston
78.7 mi.
- o Marion
3.5 mi.
- o MJ Crossover, Ohio

Location of Accident and Method of Operation

The investigation disclosed that when the accident occurred crossing 30 was lined for movement on the B. & O. westward main track, but derail 50 on the Erie eastward main track was in non-derailing position and home signal 54 displayed approach for No. 2. Examination disclosed that the south trailing point of crossing 30 had been forced open, the lock rod and the operating rod were broken, and the north facing point was broken. The controlling circuits were so arranged that, when the route was
