**RAILROAD ACCIDENT INVESTIGATION**

REPORT NO 4101

**ERIE-LACKAWANNA RAILROAD COMPANY**

**GARRETTSVILLE, OHIO**

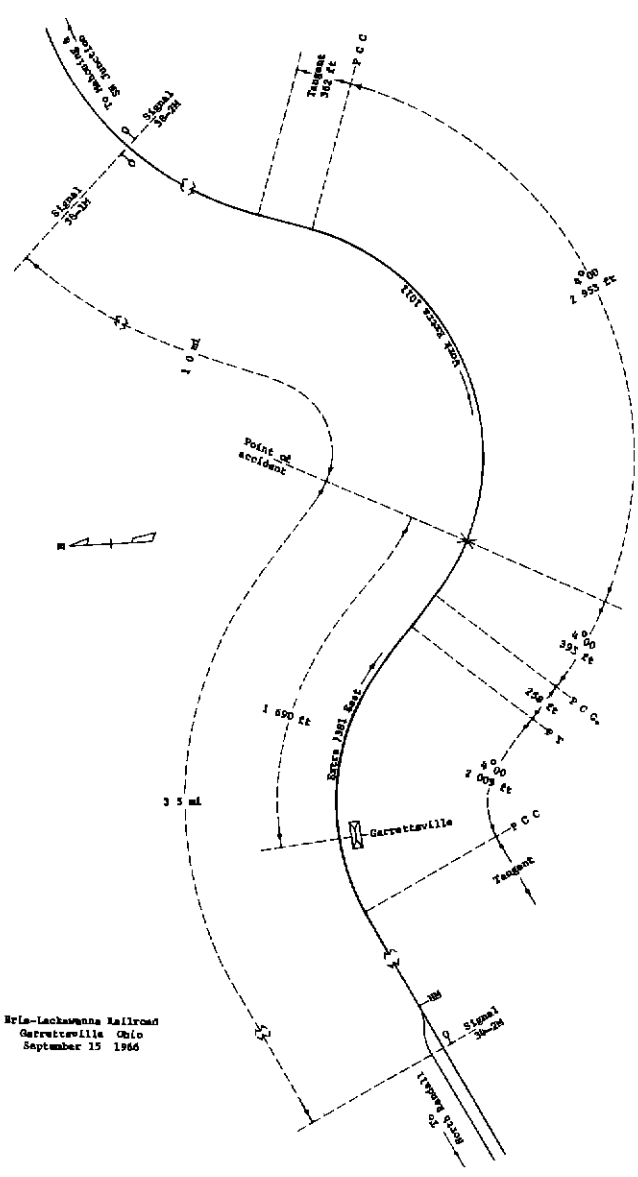
Erie-Lackawanna Railroad  
 Garrettsville Ohio  
 September 15 1946

○	SW Junction Ohio	1.5 mi
○	EH	7.1 mi
○	Mekoning	3.1 mi
*	Point of accident	0.3 mi
○	Garrettsville	1.2 mi
○	EH	1.5 mi
○	ES	17.9 mi
○	IX	1.5 mi
○	Carrollton	2.0 mi
○	North Randall Ohio

The collision occurred on the main track, 26.3 miles east of North Randall and 1,690 feet east of the station at Garrettsville.
