RAILROAD ACCIDENT INVESTIGATION

Report No 3794

FLORIDA EAST COAST RAILWAY COMPANY

COCOA JCT , FLA

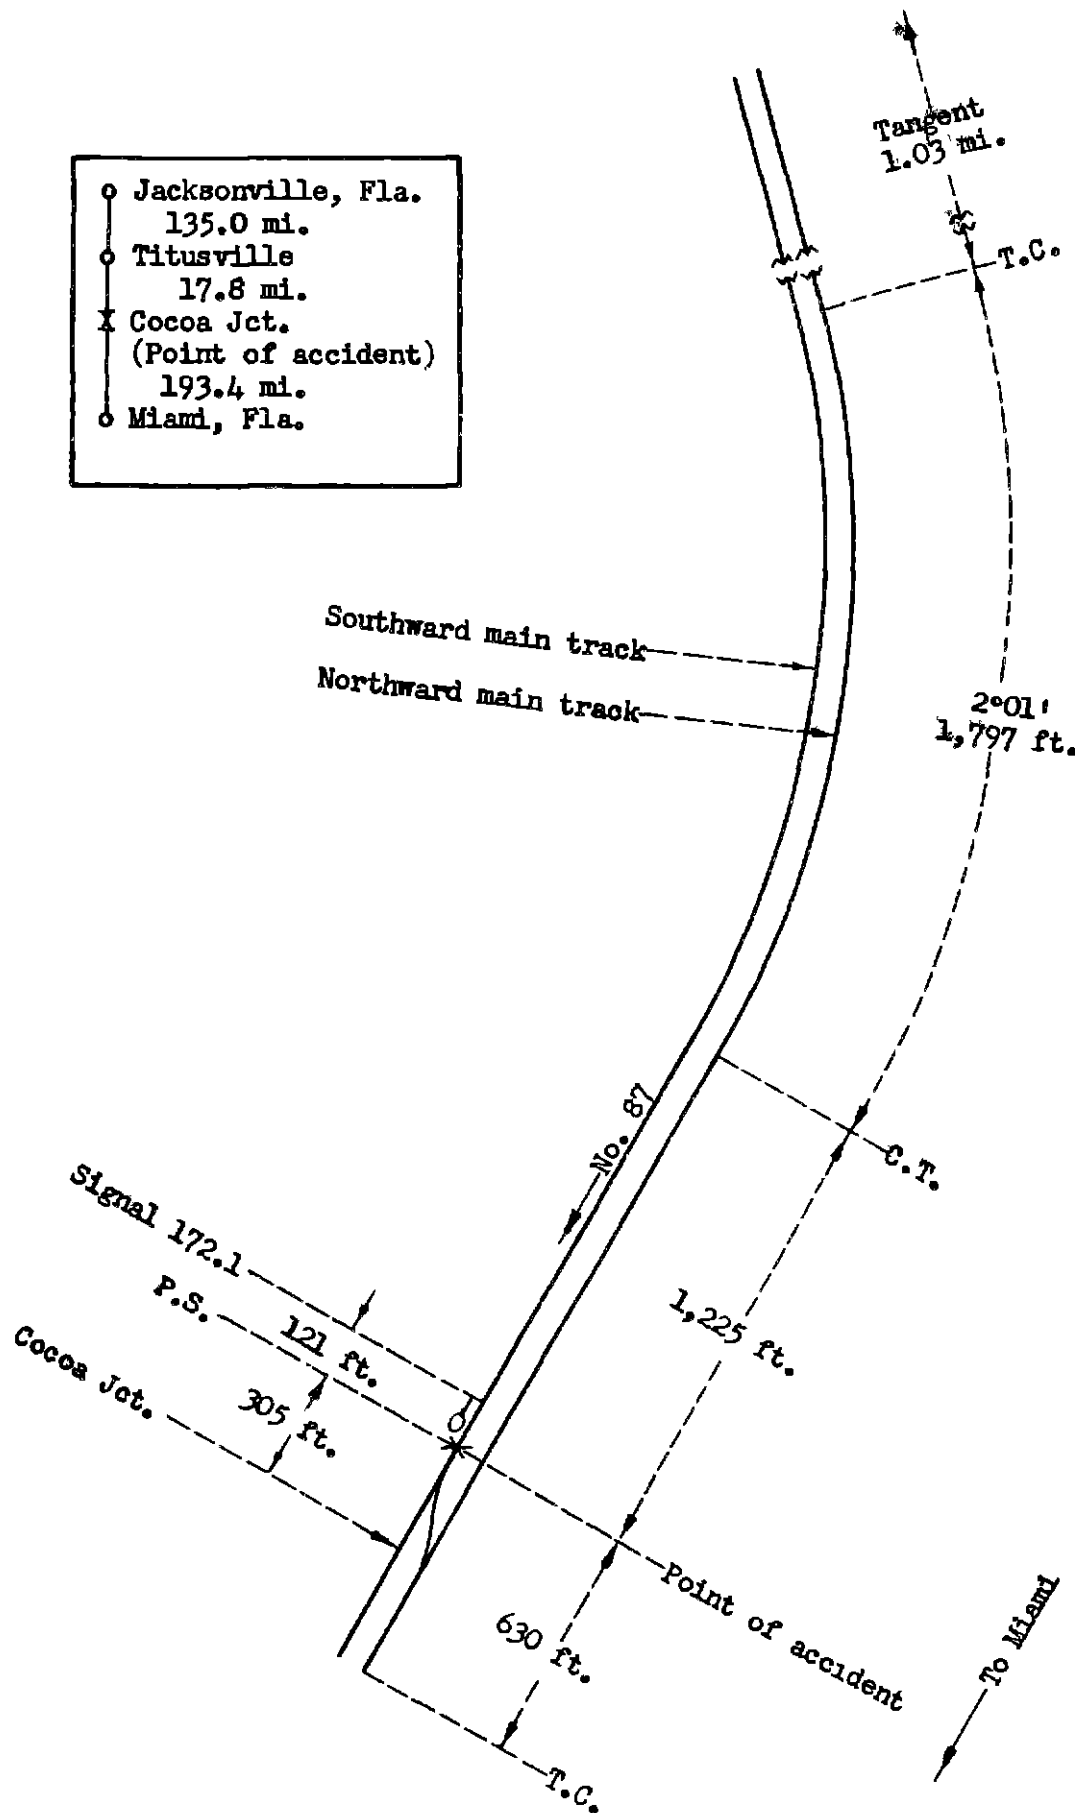
Florida East Coast Railway
Cocoa Jct., Fla.
December 26, 1957

o	Jacksonville, Fla.
	135.0 mi.
o	Titusville
	17.8 mi.
x	Cocoa Jct.
	(Point of accident)
	193.4 mi.
o	Miami, Fla.

Location of Accident and Method of Operation

This accident occurred on that part of the railroad extending between Jacksonville and Miami, Fla., 346.2 miles. In the vicinity of the point of accident this is a double-track line over which trains moving with the current of traffic are operated by timetable, train orders, and an automatic block-signal system. At Cocoa Jct., 152.8 miles south of Jacksonville, a facing-point crossover connects the main tracks. The north switch of this crossover is located 305 feet north of Cocoa Jct. The accident occurred on the southward main track at the north switch of the crossover. From the north there are, in succession, a tangent 1.03 miles in length, a 2°01' curve to the right 1,797 feet, and a tangent 1,225 feet to the point of accident and 630 feet southward. The grade for southbound trains is 0.26 percent descending at the point of accident.
