INVESTIGATION NO. 3197  
FORT WORTH AND DENVER CITY RAILWAY COMPANY  
REPORT IN RE ACCIDENT  
NEAR RAYMOND, TEX., ON  
AUGUST 13, 1948

Accident near Raymond, Tex., on August 13, 1948, caused  
by an inferior train occupying the main track on  
the time of an opposing superior train.

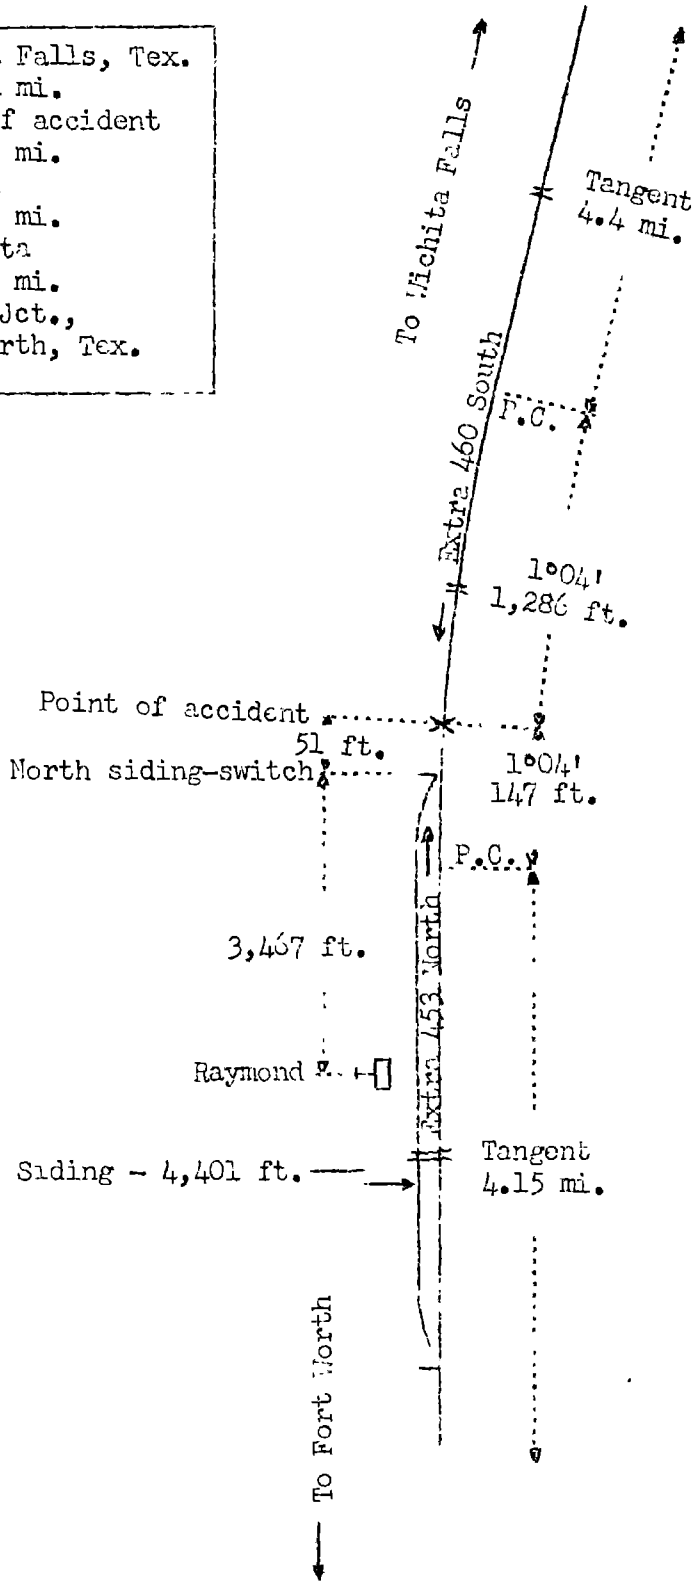
Inv. No. 3197  
 Fort Worth and Denver City Railway  
 Raymond, Tex.  
 August 13, 1948

Location of Accident and Method of Operation
