REPORT NO. 3742

FORT WORTH AND DENVER RAILWAY COMPANY

NEAR CLARENDON, TEX., ON

APRIL 1, 1957

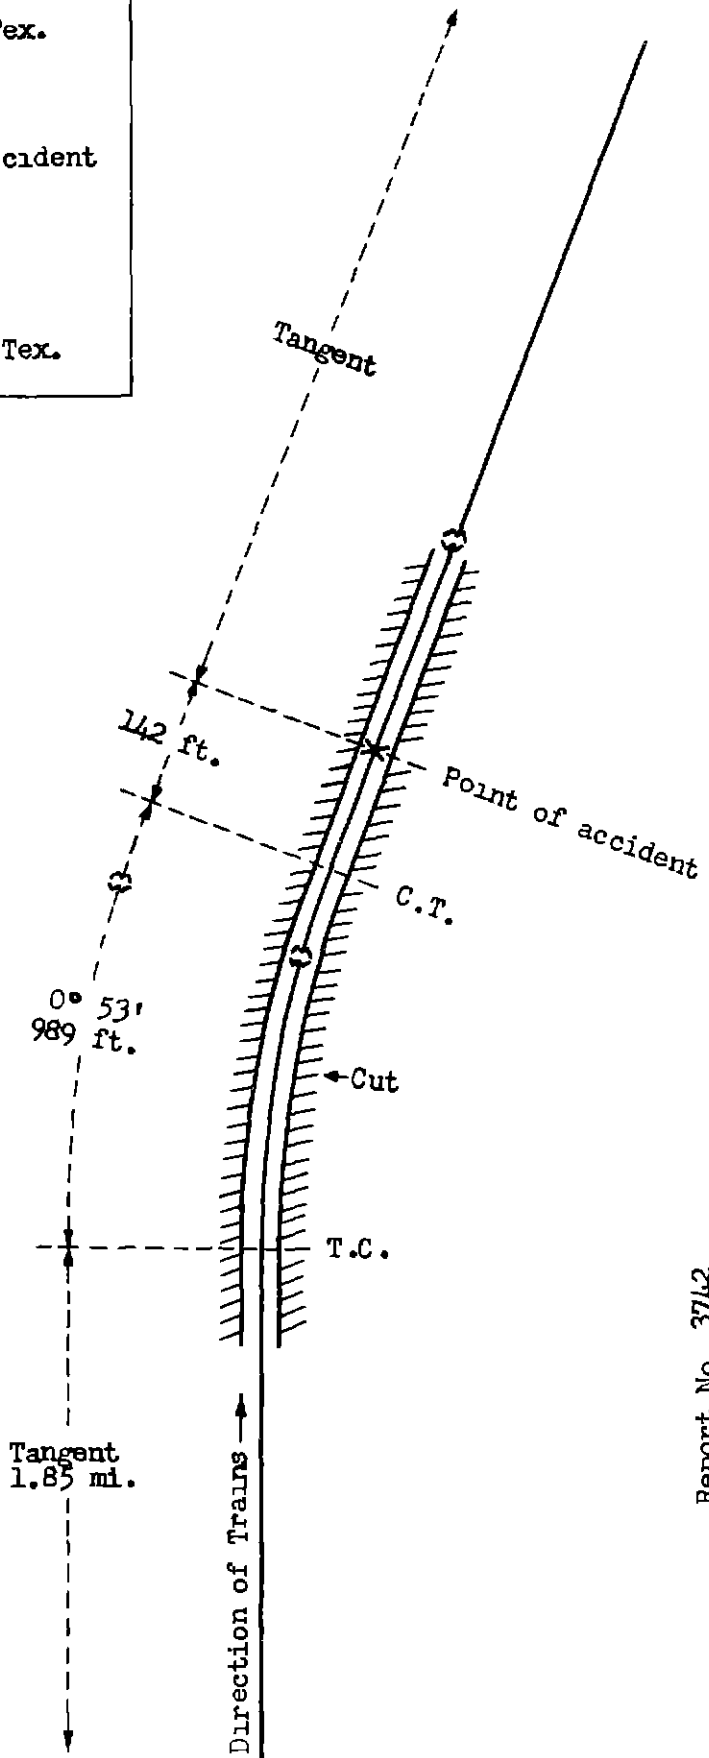
Location of Accident and Method of Operation

- Amarillo, Tex.  
57.8 mi.
- Clarendon  
1.8 mi.
- X Point of Accident  
25.3 mi.
- Memphis  
13.8 mi.
- Plains Jct.  
16.8 mi.
- Childress, Tex.
