INTERSTATE COMMERCE COMMISSION
WASHINGTON

REPORT NO. 3566
FORT WORTH AND DENVER RAILWAY COMPANY
IN RE ACCIDENT
NEAR KIRKLAND, TEX., ON
MAY 1, 1954

Accident near Kirkland, Tex., on May 1, 1954, caused by failure to provide adequate protection for a train occupying the main track on the time of a following superior train.

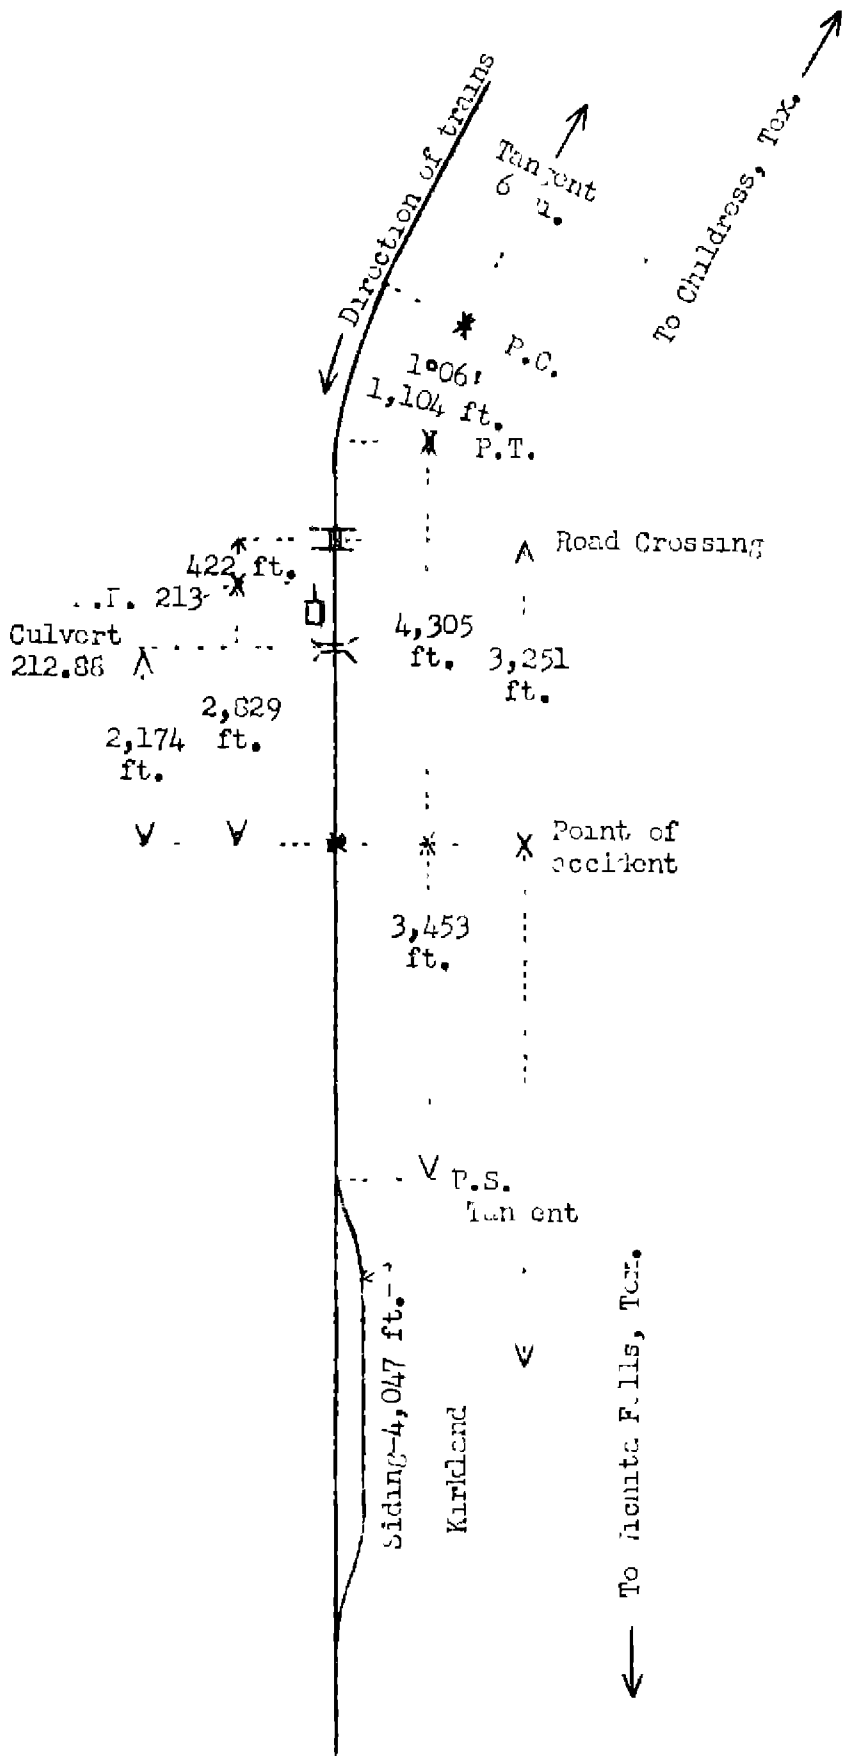
Report No. 3566
 Fort Worth and Denver Railway
 Kirkland, Tex.
 May 1, 1954

- Childress, Tex.
- | 7.7 mi.
- X Point of accident
- | 1.2 mi.
- Kirkland
- | 19.5 mi.
- Wauah
- | 77.8 mi.
- Wichita Falls, Tex.
