REPORT OF THE DIRECTOR

BUREAU OF SAFETY

ACCIDENT ON THE  
GEORGIA RAILROAD

INVESTIGATION NO. 2024

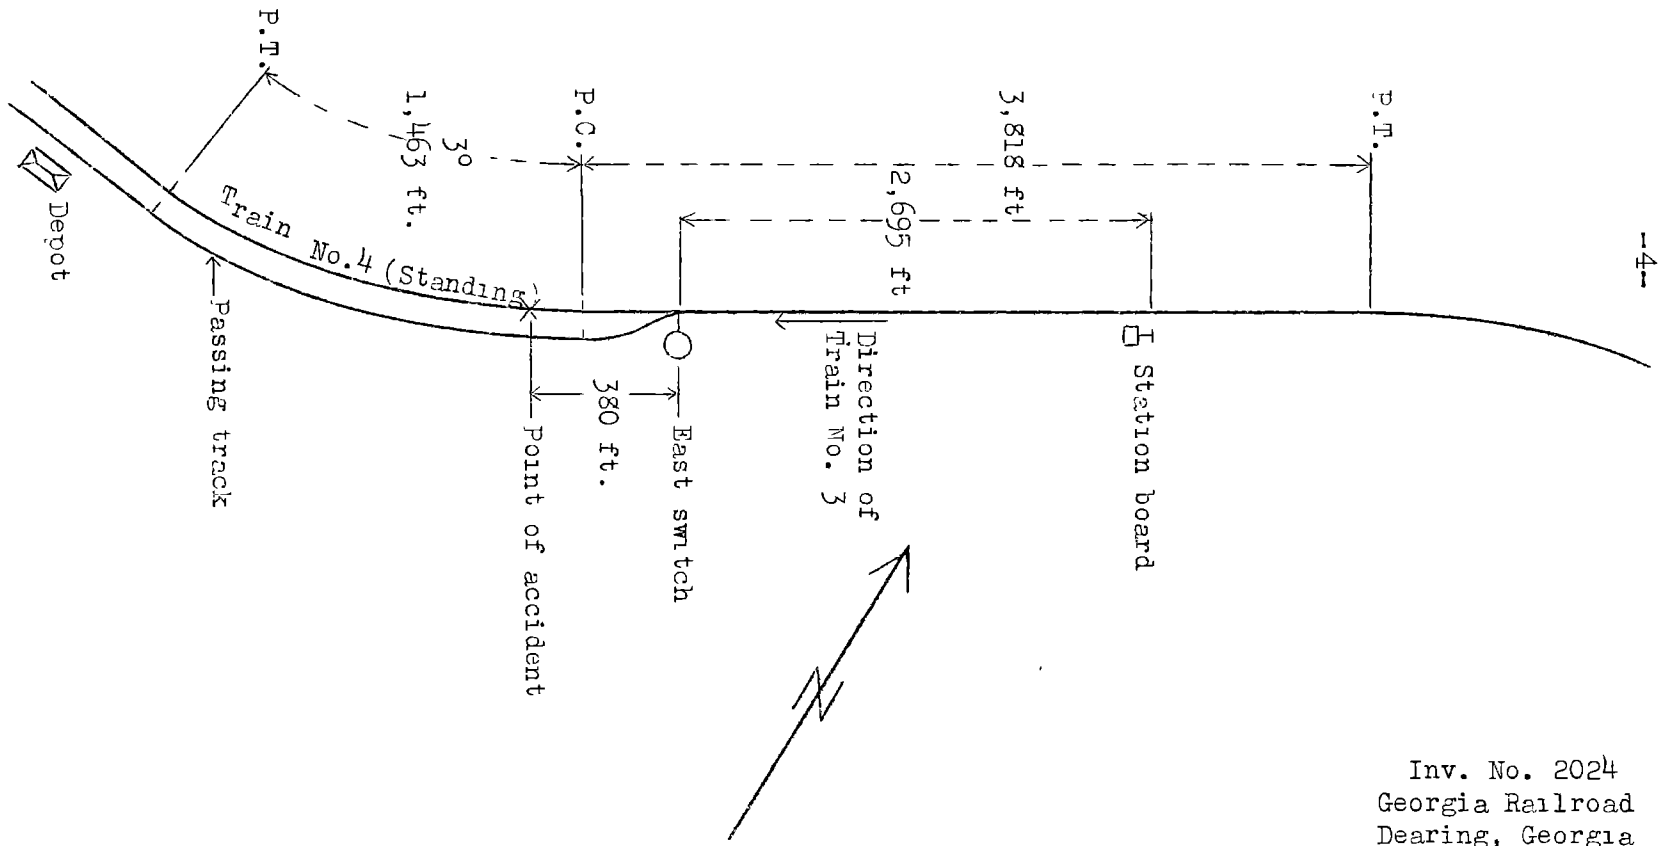
Inv. No. 2024  
 Georgia Railroad  
 Dearing, Georgia  
 Dec. 12, 1935

• Augusta, Ge.	
• Harrisonville	2.17 mi.
	22.38 mi.
• Harlem	
• (Point of accident)	4.32 mi.
• Dearing	
	47.23 mi.
• Union Point	
	94.77 mi.
• Atlanta, Ge.
