INVESTIGATION NO. 3159
GRAND TRUNK WESTERN RAILROAD COMPANY
REPORT IN RE ACCIDENT
NEAR BATTLE CREEK, MICH., ON
JANUARY 18, 1948

Accident near Battle Creek, Mich., on January 18, 1948,
caused by a broken journal, and by derailed freight
cars obstructing an adjacent main track in front
of an approaching freight train.

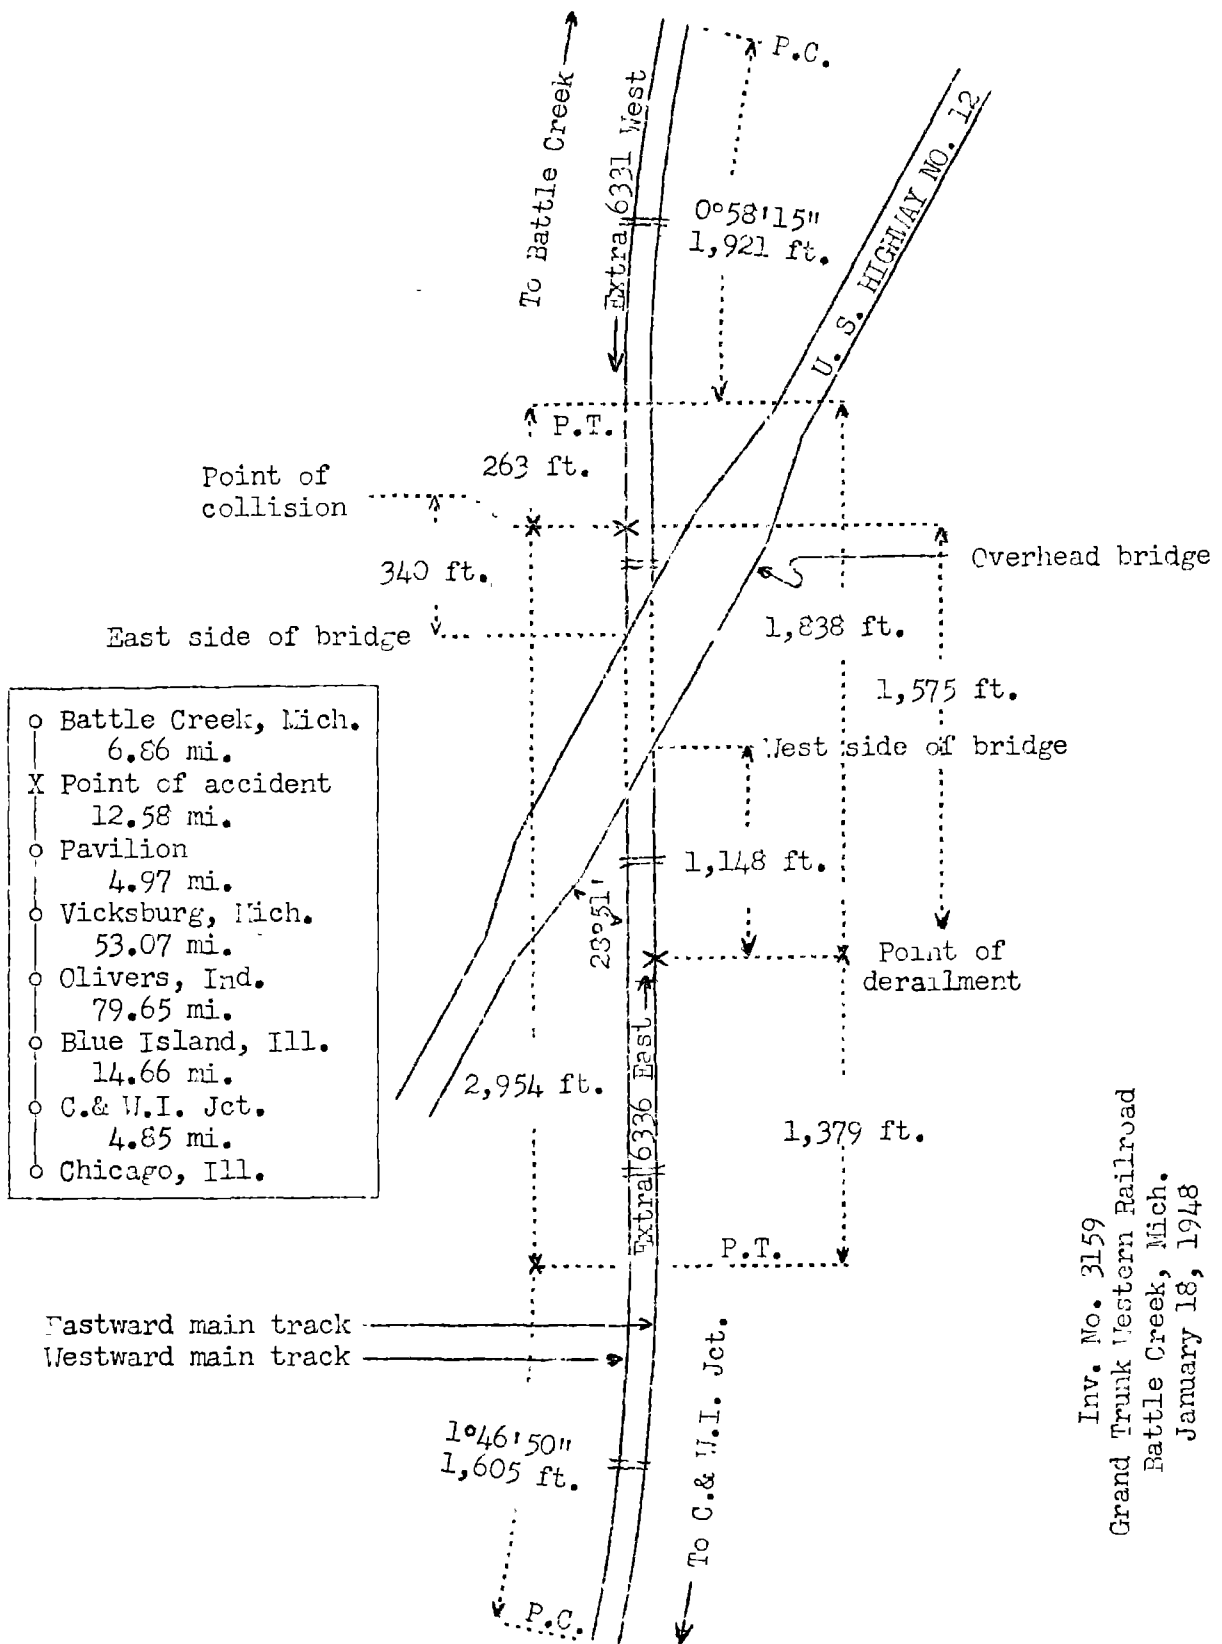
Inv. No. 3159
Grand Trunk Western Railroad
Battle Creek, Mich.
January 18, 1948

Location of Accident and Method of Operation
