INVESTIGATION NO. 3117
GREAT NORTHERN RAILWAY COMPANY
REPORT IN RE ACCIDENT
AT CANISTEO, MINN., ON
JULY 16, 1947

Railroad: Great Northern
Date: July 16, 1947
Location: Canisteo, Minn.
Kind of accident: Side collision
Trains involved: Engine and caboose : Freight
Train numbers: : Extra 2014 West
Engine numbers: 3206 : 2014
Consists: Caboose : 180 cars,
caboose
Speeds: Standing : 12 m. p. h.
Operation: Timetable and train orders;
yard limits
Track: Single; 3° curve; 0.32 percent
descending grade westward
Weather: Cloudy
Time: 11:24 p. m.
Casualties: 1 killed; 4 injured
Cause: Failure properly to control speed
of train moving within yard limits

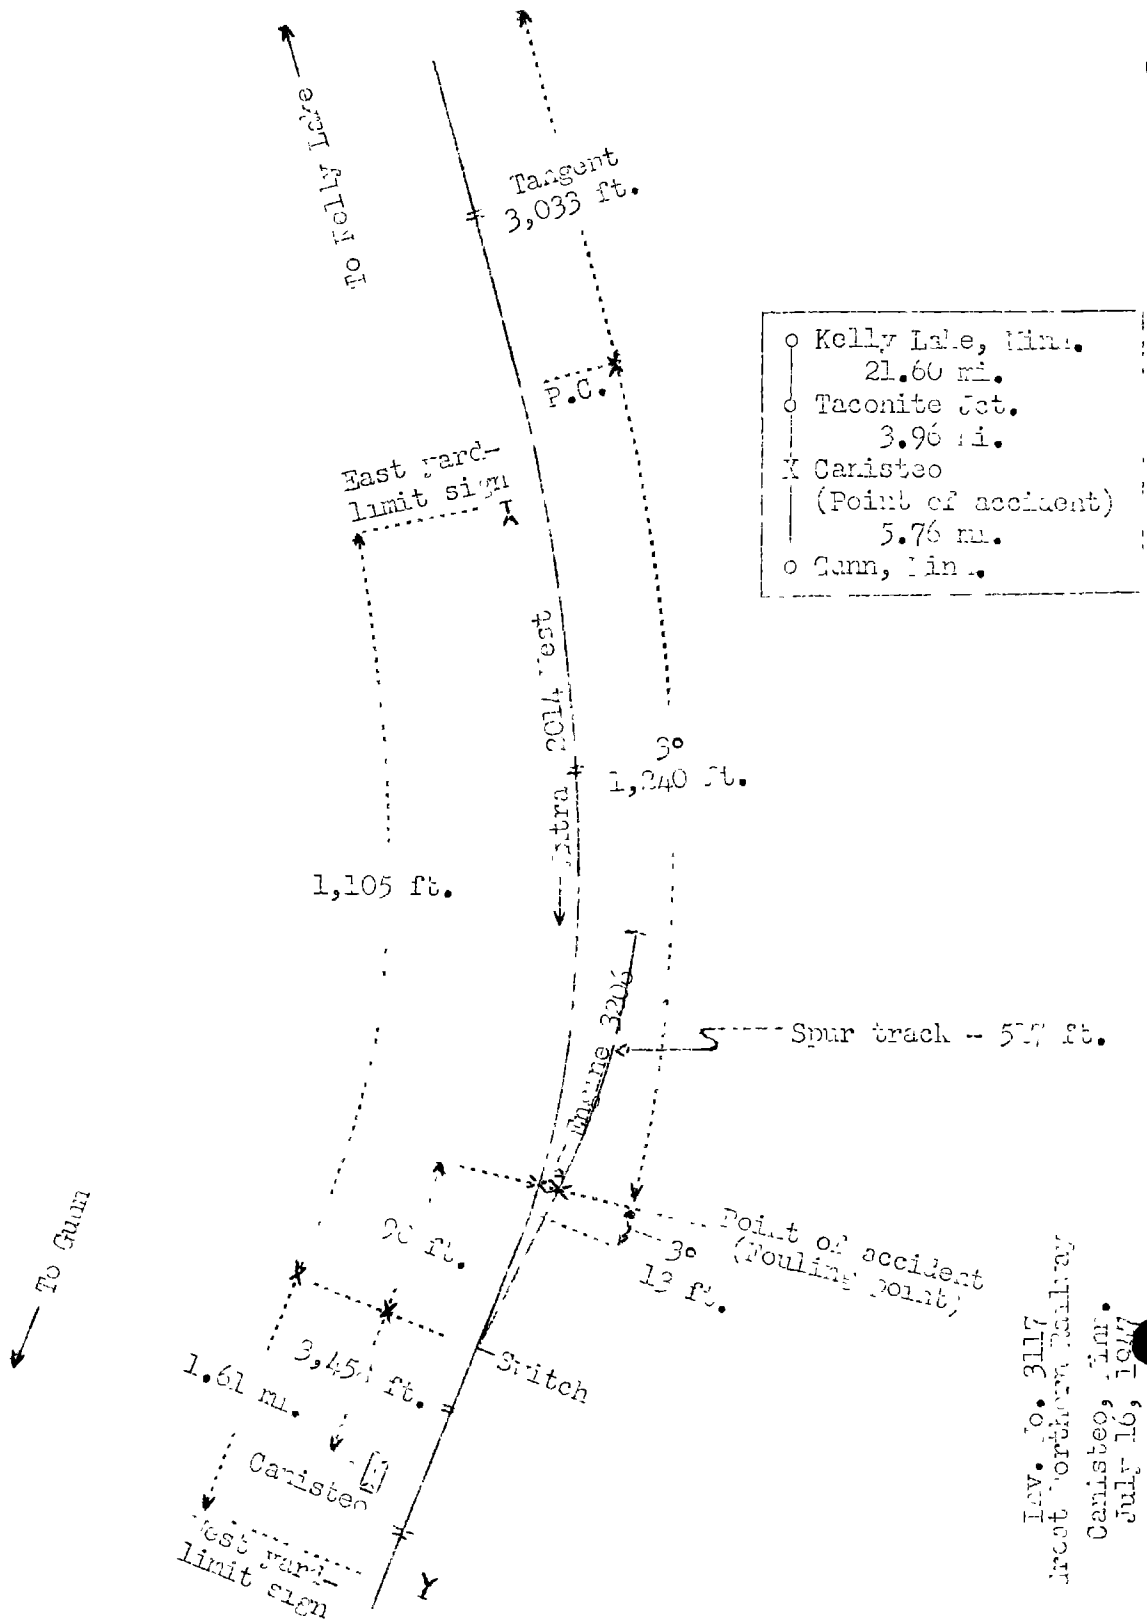
This accident occurred on that part of the Mesabi Division extending between Kelly Lake and Gunn, Minn., 31.32 miles, a single-track line, over which trains are operated by timetable and train orders. There is no block system in use. Within yard limits at Canisteo, 25.56 miles west of Kelly Lake, there is a spur track 517 feet in length on the south of the main track. The switch is trailing-point for west-bound movements, and is 1,105 feet west of the east yard-limit sign, 3,458 feet east of the station, and 1.61 miles east of the west yard-limit sign. The accident occurred at the fouling point of the main track and the turnout of the spur-track switch, at a point 90 feet east of the switch points and about 10 feet west of the clearance point. From the east on the main track there is a tangent 3,033 feet in length, and then a 3° curve to the right 1,240 feet to the point of accident and 13 feet westward. The grade is 0.32 percent descending westward.

Engine 3206 and the caboose were overturned and stopped on their left sides about 15 feet south of the turnout of the spur-track switch and practically parallel to it. The right side of engine 3206 was badly damaged. The engine and the first twenty-one cars of Extra 2014 West were derailed. The engine stopped upright, with the front end 93 feet west of the point of collision and 30 feet north of the main track. The front end of the engine, and the derailed cars were badly damaged.
