ACCIDENT ON THE
GREAT NORTHERN RAILWAY

CASS LAKE, MINN.

May 29, 1940

INVESTIGATION NO. 2429

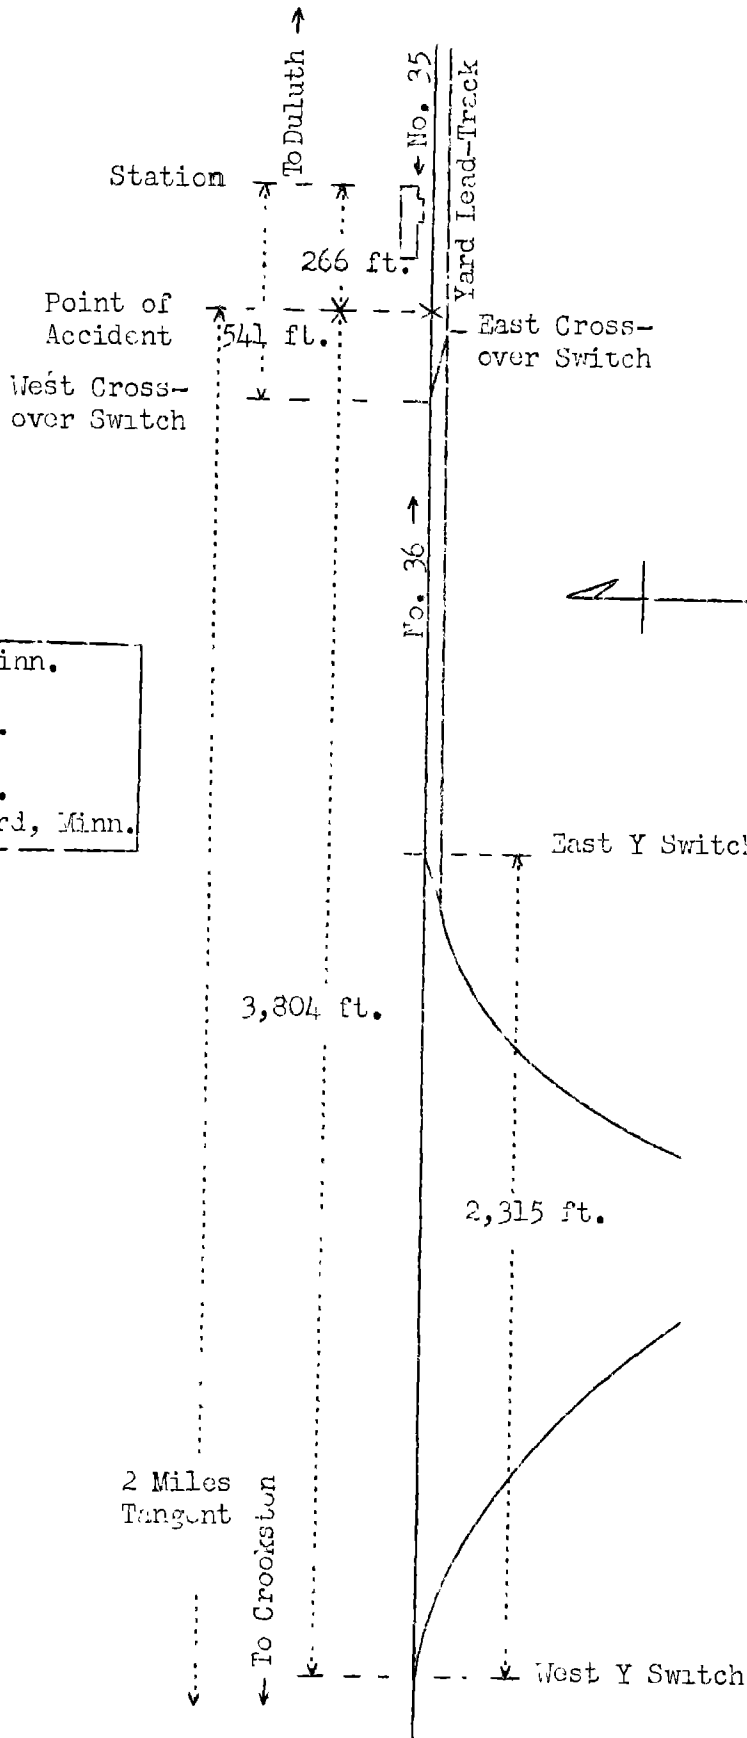
Inv. No. 2429
 Great Northern Ry.
 Cass Lake, Minn.
 May 29, 1940

⊗	Cass Lake, Minn.
	(P. of A.)
	15.27 mi.
○	Bemidji
	89.66 mi.
○	Crookston Yard, Minn.

This accident occurred on that part of the Mesabi Division designated as the Fourth Subdivision which extends between Crookston Yard and Cass Lake, Minn., a distance of 104.93 miles. In the vicinity of the point of accident this is a single-track line over which trains are operated by timetable and train orders; there is no block system in use. West-bound trains are superior to east-bound trains of the same class. The accident occurred on the main track at a point 266 feet west of the station at Cass Lake. Approaching from the west the track is tangent more than 2 miles to the point of accident and a considerable distance beyond. The grade for east-bound trains is level a distance of 4,000 feet and then 0.4 percent descending a distance of 2,255 feet to the point of accident. At Cass Lake a yard lead-track parallels the main track on the south. A facing-point crossover for east-bound trains connects the main track and the yard lead-track. The crossover is 241 feet long and its west switch is located 541 feet west of the station. The accident occurred at a point 275 feet east of this switch, which is provided with a Ramapo low switch-stand. There is no target on the switch-stand, which is located on the north side of the main track, but the switch lamp has a 2-1/2 inch rim around a 5-inch lens; the rim serves as a target. The center of the switch-stand is 5 feet 1 inch from the gage side of the north rail and the center of the switch-lamp lens is 2 feet 5 inches above the head-block. The switch lamp is lighted continuously.
