INVESTIGATION NO. 3199
GREAT NORTHERN RAILWAY COMPANY
REPORT IN RE ACCIDENT
AT FERO, N. DAK., ON
AUGUST 16, 1948

Railroad: Great Northern
Date: August 16, 1948
Location: Fero, N. Dak.
Kind of accident: Derailment
Train involved: Passenger
Train number: 3
Engine number: Diesel-electric units
358A, 358B and 358C
Consist: 18 cars
Speed: 55 m. p. n.
Operation: Timetable, train orders and
automatic block-signal system
Track: Single; tangent; 0.10 percent
ascending grade westward
Weather: Clear
Time: 9:01 p. m.
Casualties: 108 injured
Cause: Defective condition of spring-
frog assembly

Accident at Fero, N. Dak., on August 16, 1948, caused by
defective condition of a spring-frog assembly.

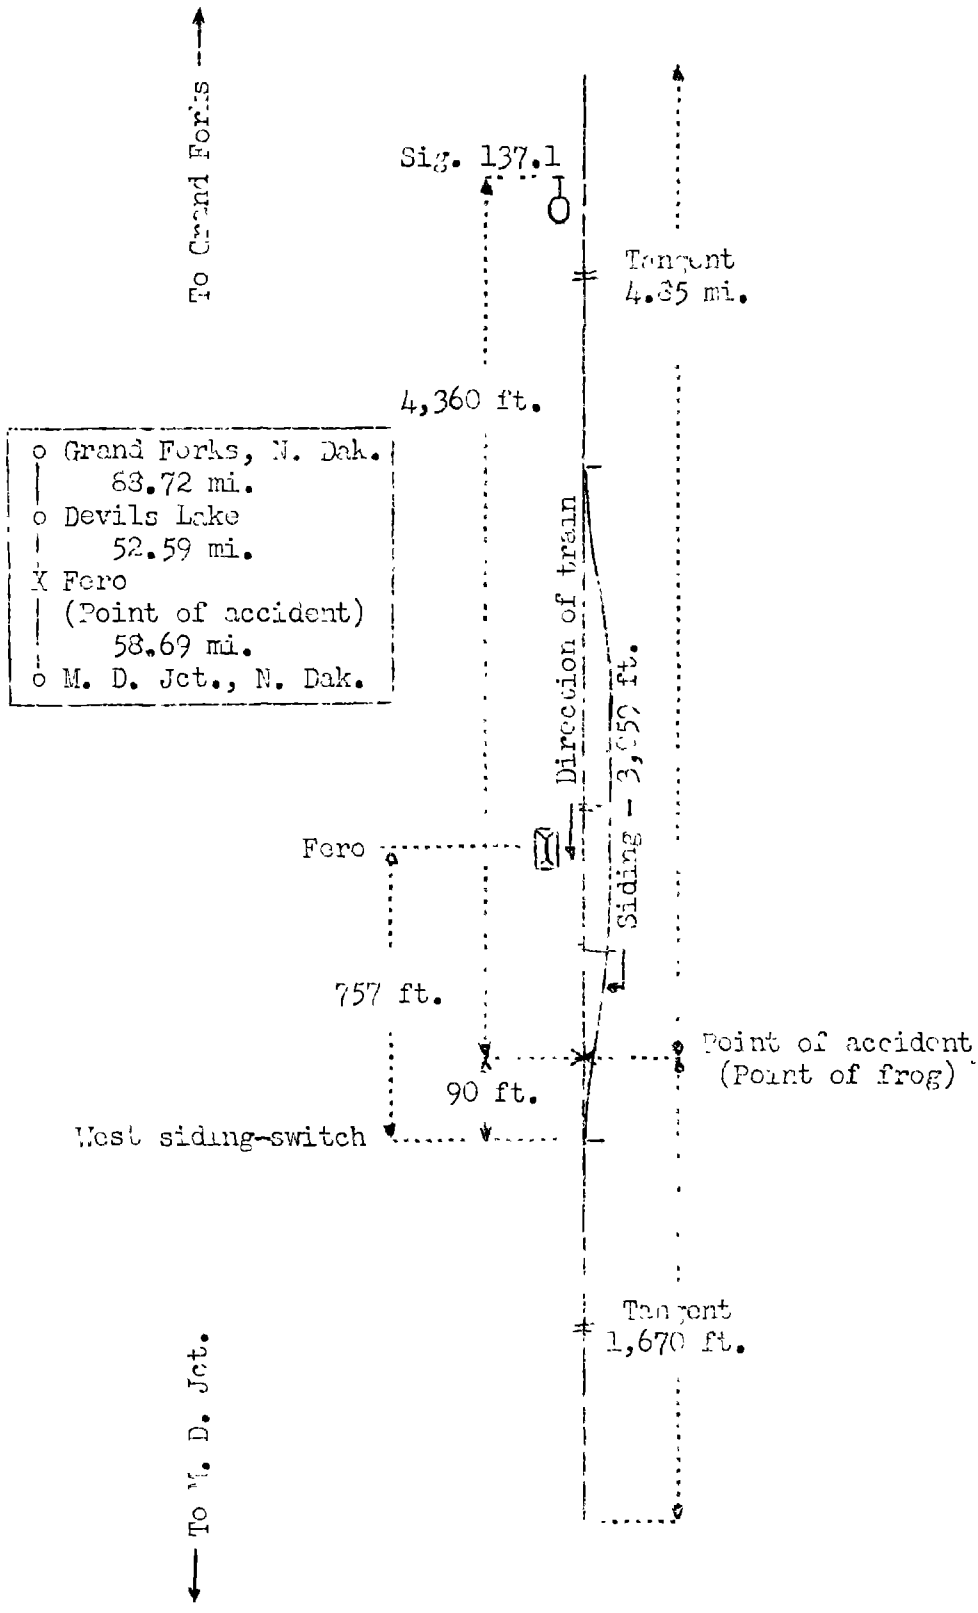
Inv. No. 3199
 Great Northern Railway
 Fero, N. Dak.
 August 16, 1948

- o Grand Forks, N. Dak. 63.72 mi.
- o Devils Lake 52.59 mi.
- X Fero (Point of accident) 58.69 mi.
- o M. D. Jct., N. Dak.

Location of Accident and Method of Operation
