REPORT NO. 3458
GREAT NORTHERN RAILWAY COMPANY
IN RE ACCIDENT
AT FORT BELKNAP, MONT., ON
APRIL 4, 1952

Kind of accident: Head-end collision

Accident at Fort Belknap, Mont., on April 4, 1952, caused
by a train occupying the main track immediately in
front of an opposing train.

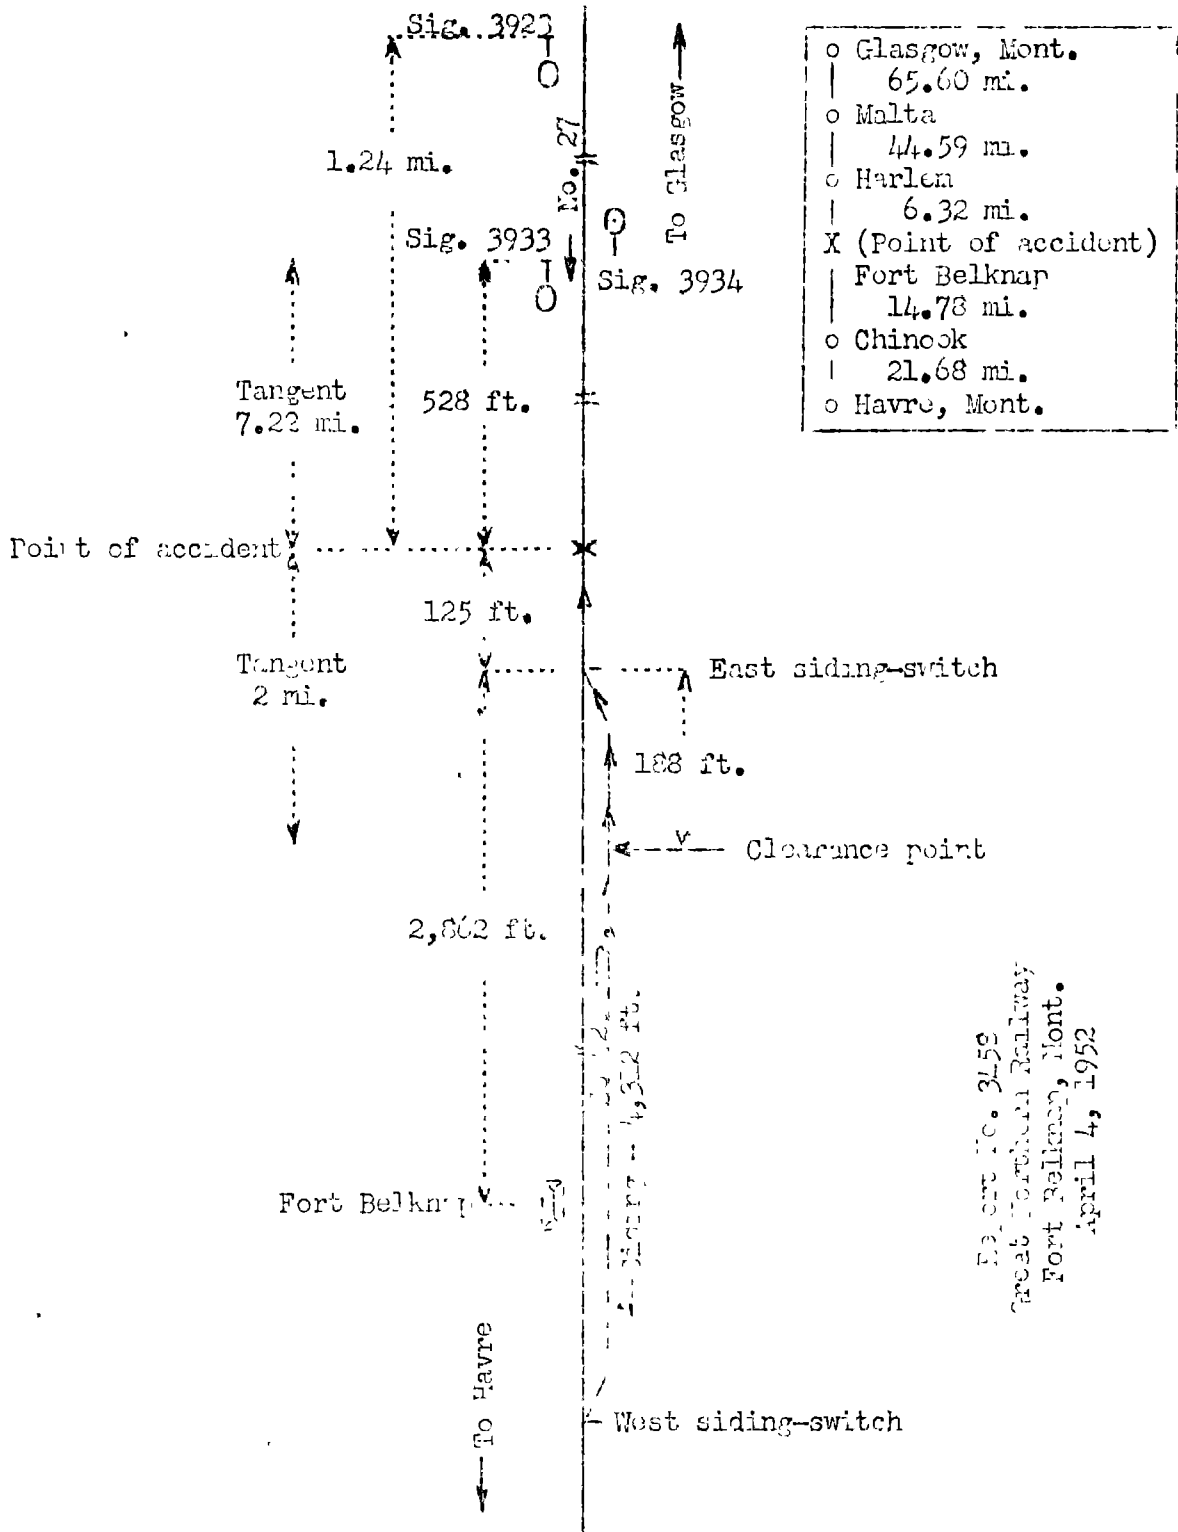
Location of Accident and Method of Operation

This accident occurred on that part of the Butte Division extending between Havre and Glasgow, Mont., 152.97 miles. In the vicinity of the point of accident this is a single-track line, over which trains are operated by time-table, train orders and an automatic block-signal system. At Fort Belknap, 36.46 miles east of Havre, a siding 4,812 feet in length parallels the main track on the south. The east switch of this siding is 2,662 feet east of the station. The accident occurred on the main track at a point about 125 feet east of the east siding-switch. The track is tangent throughout a distance of about 2 miles west of the point of accident and 7.22 miles eastward. From the west siding-switch, on the main track and on the siding, the grade for east-bound trains is, successively, 0.20 percent ascending a distance of 567 feet, level 300 feet, 0.20 percent descending 1,000 feet, 0.30 percent descending 2,445 feet to the east siding-switch, and 0.30 percent descending 125 feet to the point of accident and 430 feet eastward. The grade for west-bound trains throughout a considerable distance immediately east of the point of accident varies between 0.20 percent descending and 0.30 percent ascending.
