INVESTIGATION NO. 3023
GREAT NORTHERN RAILWAY COMPANY
REPORT IN RE ACCIDENT
AT LUPFER, MONT., ON
SEPTEMBER 14, 1946

Kind of accident: Head-end collision

Accident at Lupfer, Mont., on September 14, 1946, caused
by failure to obey a meet order.

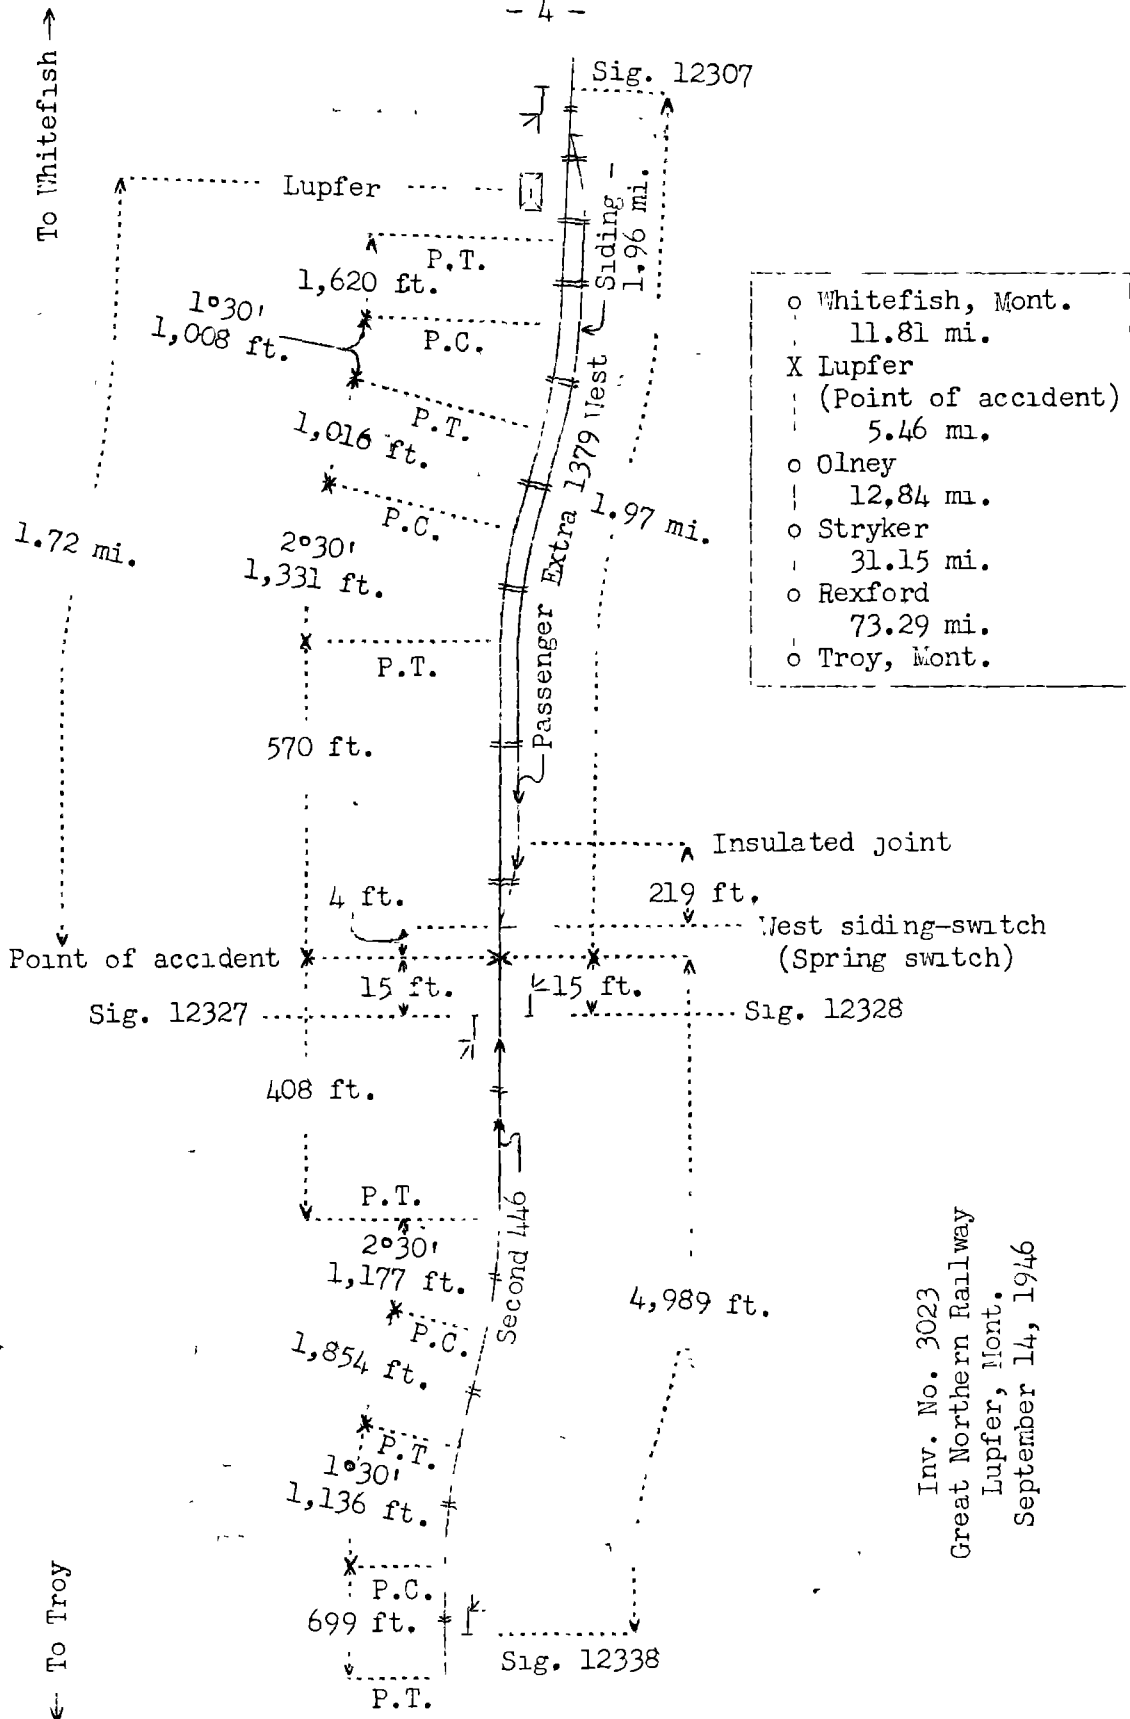
This accident occurred on that part of the Kalispell Division extending between Whitefish and Troy, Mont., 134.55 miles, a single-track line in the vicinity of the point of accident, over which trains are operated by time-table, train orders and an automatic block-signal system. At Lupfer, 11.81 miles west of Whitefish, a siding 1.96 miles in length parallels the main track on the south. The west switch of this siding is a spring switch and is 1.72 miles west of the station. The accident occurred on the main track at a point 4 feet west of the west siding-switch. From the east there are, in succession, a tangent 1,620 feet in length, a 1°30' curve to the right 1,008 feet, a tangent 1,016 feet, a 2°30' curve to the left 1,331 feet and a tangent 570 feet to the point of accident. From the west there are, in succession, a tangent 699 feet in length, a 1°30' curve to the right 1,136 feet, a tangent 1,854 feet, a 2°30' curve to the left 1,177 feet and a tangent 408 feet to the point of accident. The grade is 0.25 percent descending eastward.

Passenger Extra 1379 West entered the siding at Lupfer to meet No. 28, an east-bound first-class train. Soon after No. 28 passed the west siding-switch, the enginemen of Passenger Extra 1379 West observed that signal 12327, located 19 feet west of the west siding-switch, was displaying stop-then-proceed-at-restricted-speed. Passenger Extra 1379 West stopped with the engine standing immediately east of the east end of the track circuit of the fouling section of the turnout of the west siding-switch, and the enginemen again read their train orders. Since no train order had been issued restricting the authority of Passenger Extra 1379 West to proceed from Lupfer and since the restrictive indication displayed by signal 12327 permitted this train, after stopping short of the signal, to proceed prepared to stop short of a train or an obstruction, the train proceeded and had just entered the fouling section of the turnout when the fireman saw Second 446 approaching a few hundred feet distant, and called a warning to the engineer. The engineer immediately moved the brake valve

to emergency position, and Passenger Extra 1379 West had just stopped with the front of the engine standing about 4 feet west of the west siding-switch and 15 feet east of signal 12327 when the collision occurred. The enginemen thought that the restrictive indication displayed by signal 12327 was caused by a broken rail until they saw the approaching train.
