REPORT NO. 3463
GREAT NORTHERN RAILWAY COMPANY
IN RE ACCIDENT
NEAR SUPPLEE, WASH., ON
MAY 16, 1952

Accident near Supplee, Wash., on May 16, 1952, caused by
failure to provide adequate protection for the movement
of a track motor-car.

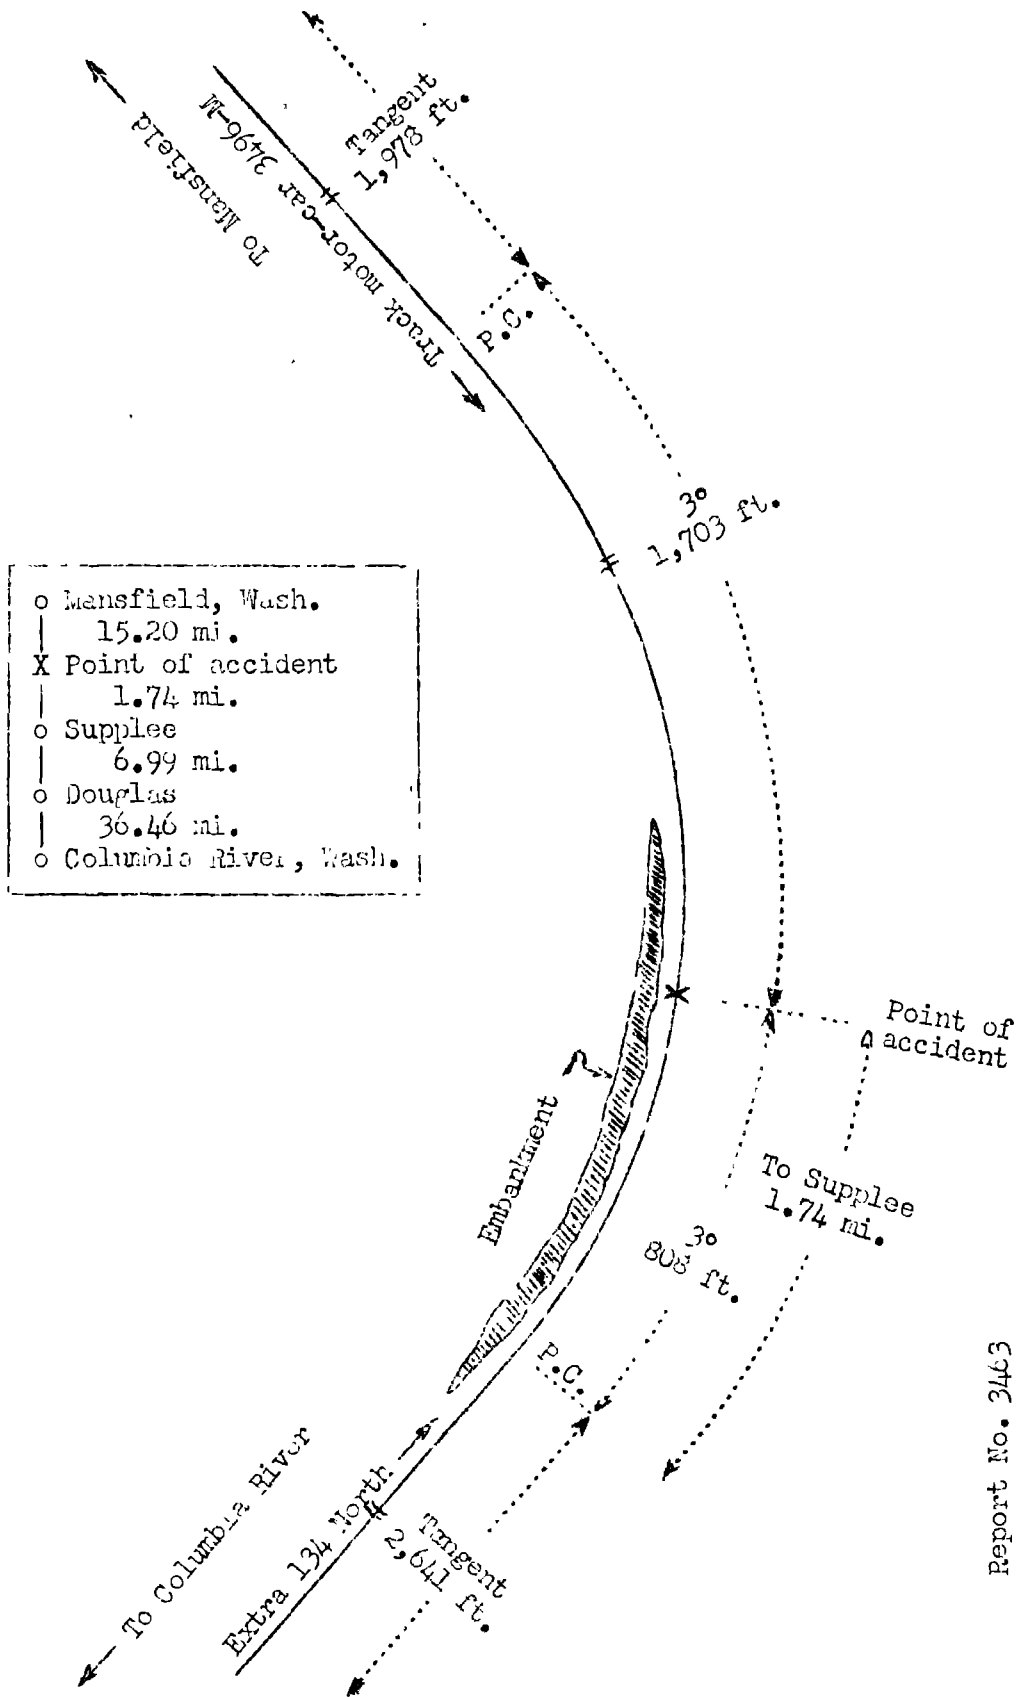
Report No. 3463
 Great Northern Railway
 Supplee, Wash.
 May 16, 1952

Location of Accident and Method of Operation

Track motor-car 3496-M, occupied by a section foreman, two section laborers, and a track motor-car repairman, departed south-bound from Mansfield about 9:10 a. m. About 9:35 a. m., while moving at an undetermined rate of speed, it collided with Extra 134 North at a point 15.20 miles south of Mansfield and 1.74 miles north of Supplee.

The track motor-car, which was not derailed, was moved northward approximately 282 feet. It was badly damaged. Extra 134 North stopped with the front of the locomotive 232 feet north of the point of accident. The front of the locomotive was slightly damaged.
