INVESTIGATION NO. 3157
GREAT NORTHERN RAILWAY COMPANY
REPORT IN RE ACCIDENT
AT WALDEN, N. DAK., ON
JANUARY 13, 1948

Railroad: Great Northern
Date: January 13, 1948
Location: Walden, N. Dak.
Kind of accident: Rear-end collision
Trains involved: Mixed : Freight
Train numbers: 200 : First 402
Engine numbers: 2524 : 3380
Consists: 22 cars : 72 cars, caboose
Speeds: Standing : 30 m. p. h.
Operation: Timetable, train orders and
automatic block-signal
system
Track: Single; tangent; 0.255 percent
descending grade eastward
Weather: Clear
Time: 8:20 p. m.
Casualties: 1 killed; 5 injured
Cause: Failure properly to control
speed of following train
in accordance with signal
indications

Accident at Walden, N. Dak., on January 13, 1948, caused
by failure properly to control the speed of the
following train in accordance with signal indications.

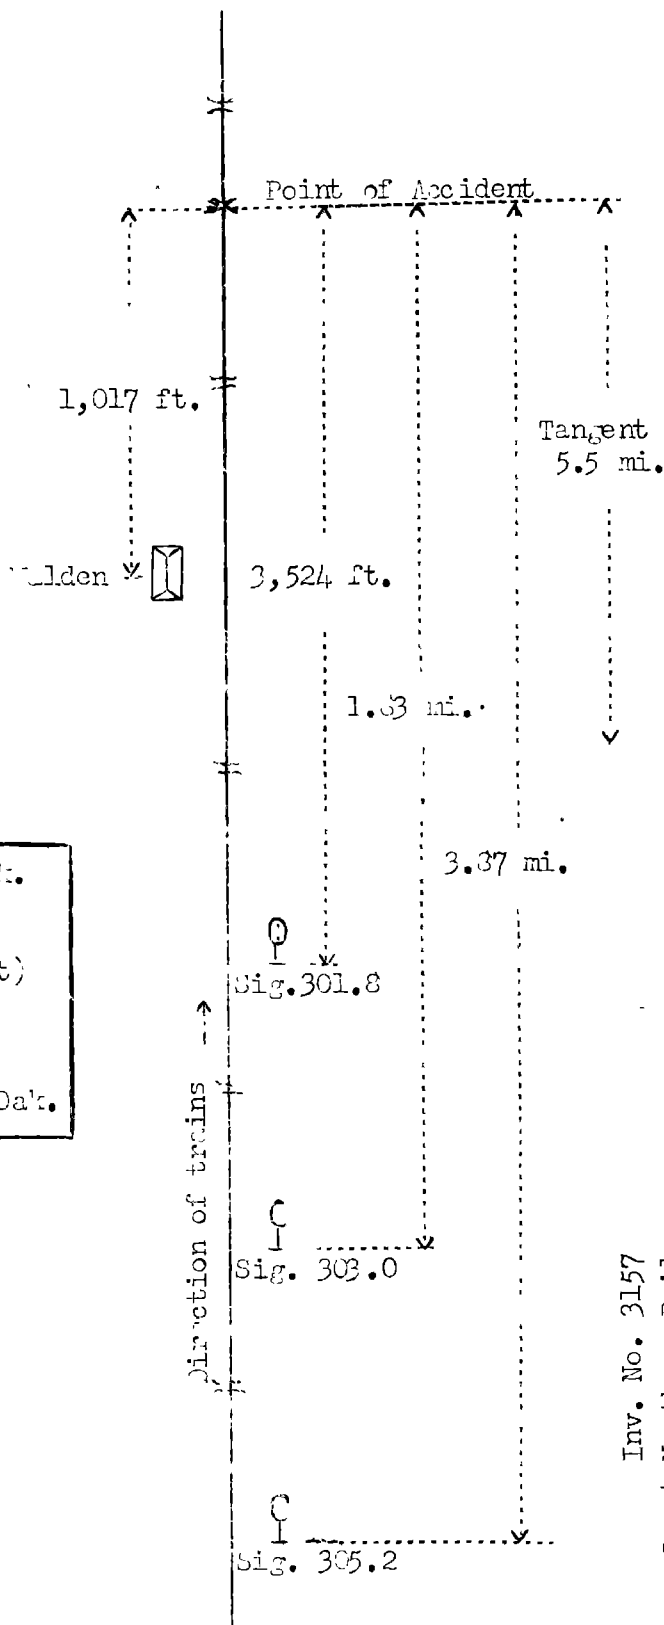
Inv. No. 3157
 Great Northern Railway
 Wajden, N. Dak.
 January 13, 1948

- o Fargo Job., N. Dak.
46.40 mi.
- X Wajden
(Point of accident)
25.50 mi.
- o Hannaford
51.35 mi.
- o New Rockford, N. Dak.

First 402, an east-bound third-class freight train consisting of engine 3380, 72 cars and a caboose, departed from Hannaford, 25.5 miles west of Walden, at 7:40 p. m., 2 hours 42 minutes late, passed signals 305.2 and 303.0, which displayed proceed-prepared-to-stop-at-next-signal, passed signal 301.8, which was dark because of a defective light bulb, and while moving at an estimated speed of 30 miles per hour it collided with No. 200.
