REPORT NO. 3397  
GREAT NORTHERN RAILWAY COMPANY  
IN RE ACCIDENT  
NEAR WILLOW LAKE, S. DAK., ON  
MARCH 22, 1951

Accident near Willow Lake, S. Dak., on March 22, 1951,  
caused by a broken rail.

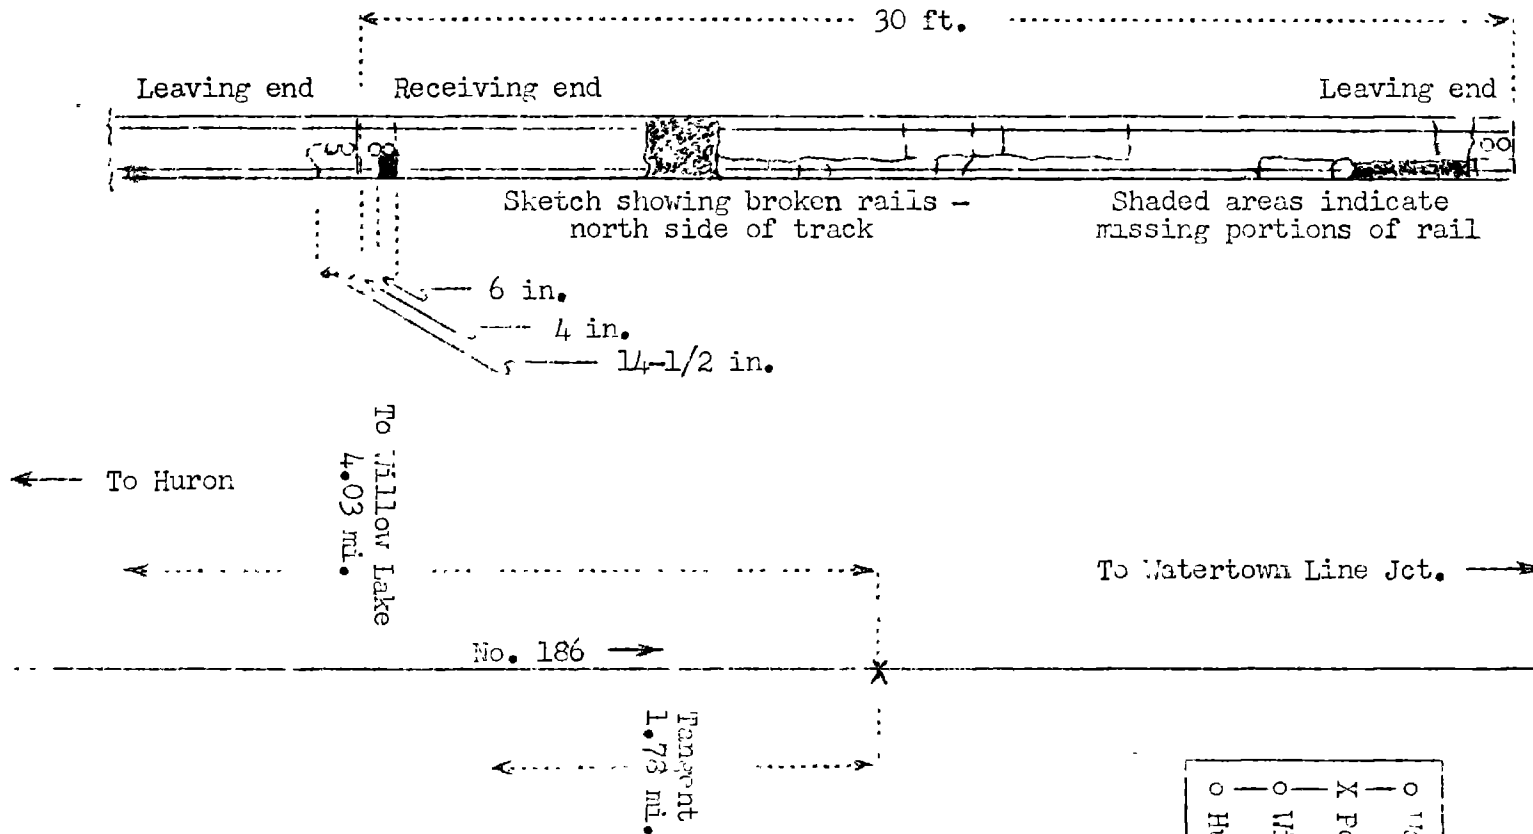
Report No. 3397  
 Great Northern Railway  
 Willow Lake, S. Dak.  
 March 22, 1951

o	Watertown Line Jct., Minn.
	119.24 mi.
	X Point of accident
	4.03 mi.
o	Willow Lake, S. Dak.
	37.78 mi.
o	Huron, S. Dak.

This accident occurred on that part of the Willmar Division extending between Huron, S. Dak., and Watertown Line Jct., Minn., 161.05 miles, a single-track line, over which trains are operated by timetable and train orders. There is no block system in use. The accident occurred on the main track at a point 41.81 miles east of Huron and 4.03 miles east of the station at Willow Lake. The track is tangent throughout a distance of 1.78 miles immediately west of the point of accident and a considerable distance eastward. The grade is 0.59 percent ascending eastward.
