INVESTIGATION NO. 2640
THE GULF, COLORADO AND SANTA FE RAILWAY COMPANY
REPORT IN RE ACCIDENT
AT BOBVILLE, TEXAS, ON
OCTOBER 24, 1942

Railroad: Gulf, Colorado and Santa Fe
Date: October 24, 1942
Location: Bobville, Texas
Kind of accident: Head-end collision
Trains involved: Freight : Freight
Train numbers: 239 : Extra 3024 North
Engine numbers: 1906-1609 : 3024
Consist: 40 cars, caboose : 52 cars, caboose
Speed: 8 m. p. h. : Standing
Operation: Timetable and train orders;
accident occurred within
yard limits
Track: Single; 2° curve; vertical curve
Weather: Partly cloudy
Time: About 12:05 a. m.
Casualties: 2 killed
Cause: Accident caused by failure
properly to control speed of
No. 239 within yard limits

Accident at Bobville, Texas, on October 24, 1942, caused
by failure properly to control speed of No. 239
within yard limits.

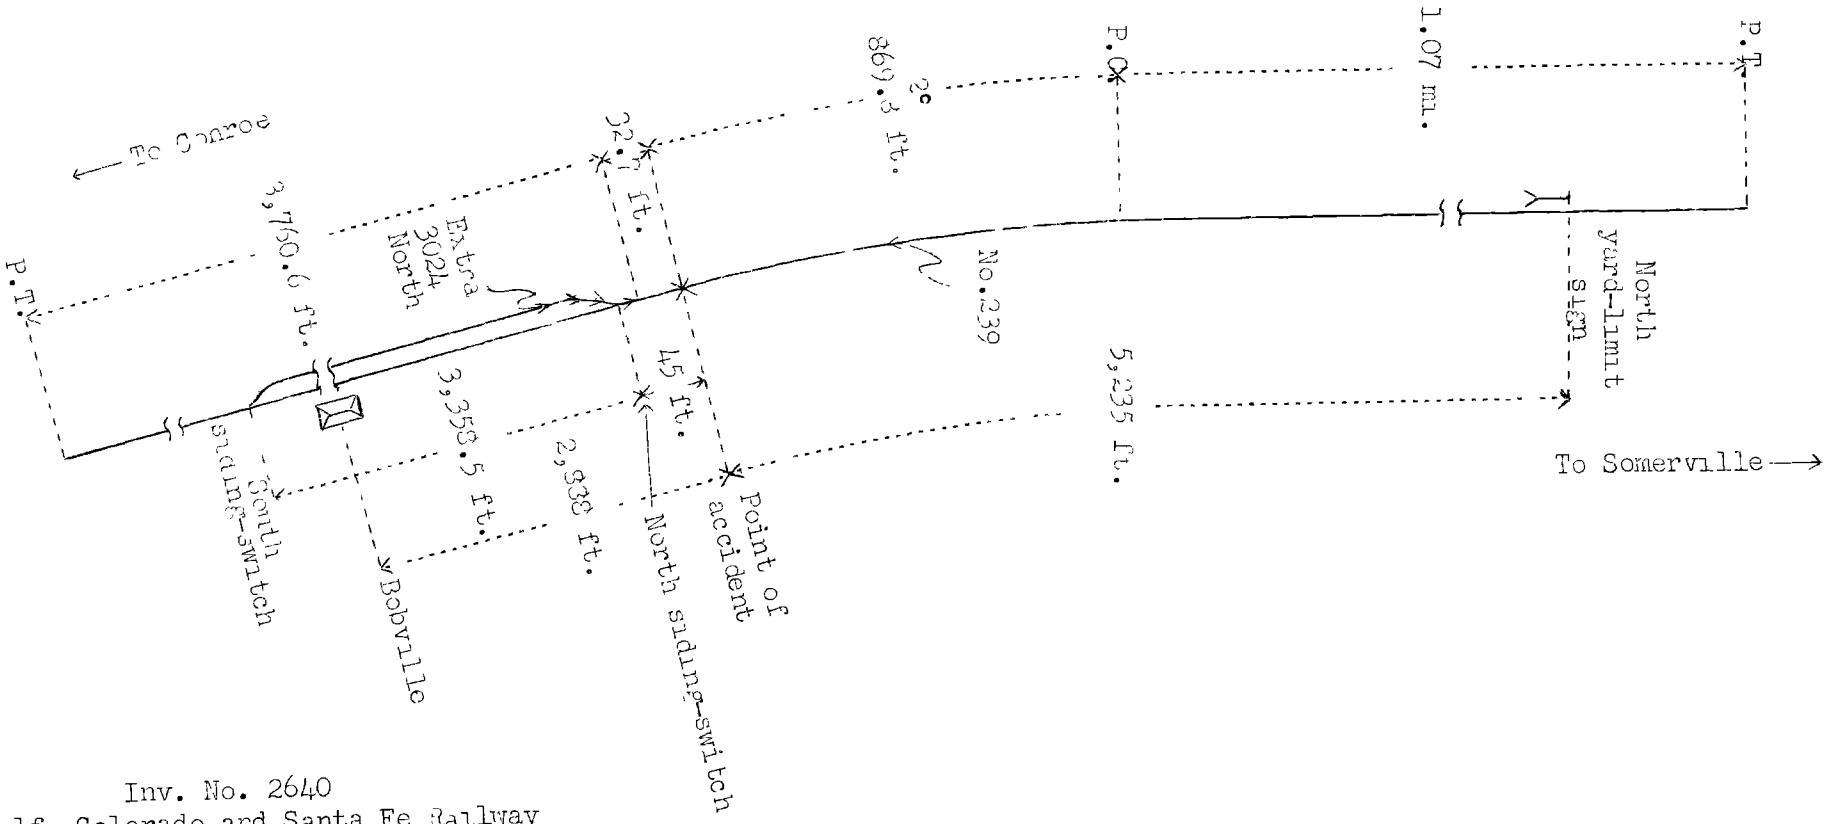
Inv. No. 2640
 Gulf, Colorado and Santa Fe Railway
 Bobville, Texas
 October 24, 1942

- o Somerville, Texas
23.3 mi.
- o Nivisota
20.7 mi.
- x Bobville (P. of A.)
1.0 mi.
- o Dobbin
22.3 mi.
- o Conroe, Texas

Location of Accident and Method of Operation

This accident occurred on that part of the Gulf Division designated as the Somerville District and extending between Somerville and Conroe, Texas, a distance of 72.3 miles. In the vicinity of the point of accident this is a single-track line over which trains are operated by timetable and train orders. There is no block system in use. The accident occurred within yard limits on the main track at a point 2,888 feet north of the station at Bobville and 5,235 feet south of the north yard-limit sign. A siding 3,358.5 feet in length parallels the main track on the west. The accident occurred at a point 45 feet north of the north siding-switch. Approaching from the north there is a tangent 1.07 miles in length, which is followed by a 2° curve to the left 369.8 feet to the point of accident and 32.7 feet beyond. Approaching from the south there is a tangent 3,760.6 feet in length, which is followed by the curve on which the accident occurred. The grade for south-bound trains is 0.91 percent descending 1,700 feet, then there are, in succession, a vertical curve 1,700 feet, a 1.26 percent ascending grade 500 feet and a vertical curve 273 feet to the point of accident and 127 feet beyond.
