INVESTIGATION NO. 2888
GULF, COLORADO AND SANTA FE RAILWAY COMPANY
REPORT IN RE ACCIDENT
AT LOMETA, TEX., ON
MAY 4, 1945

Accident at Lometa, Tex., on May 4, 1945, caused by
failure properly to control the speed of a train
moving within yard limits.

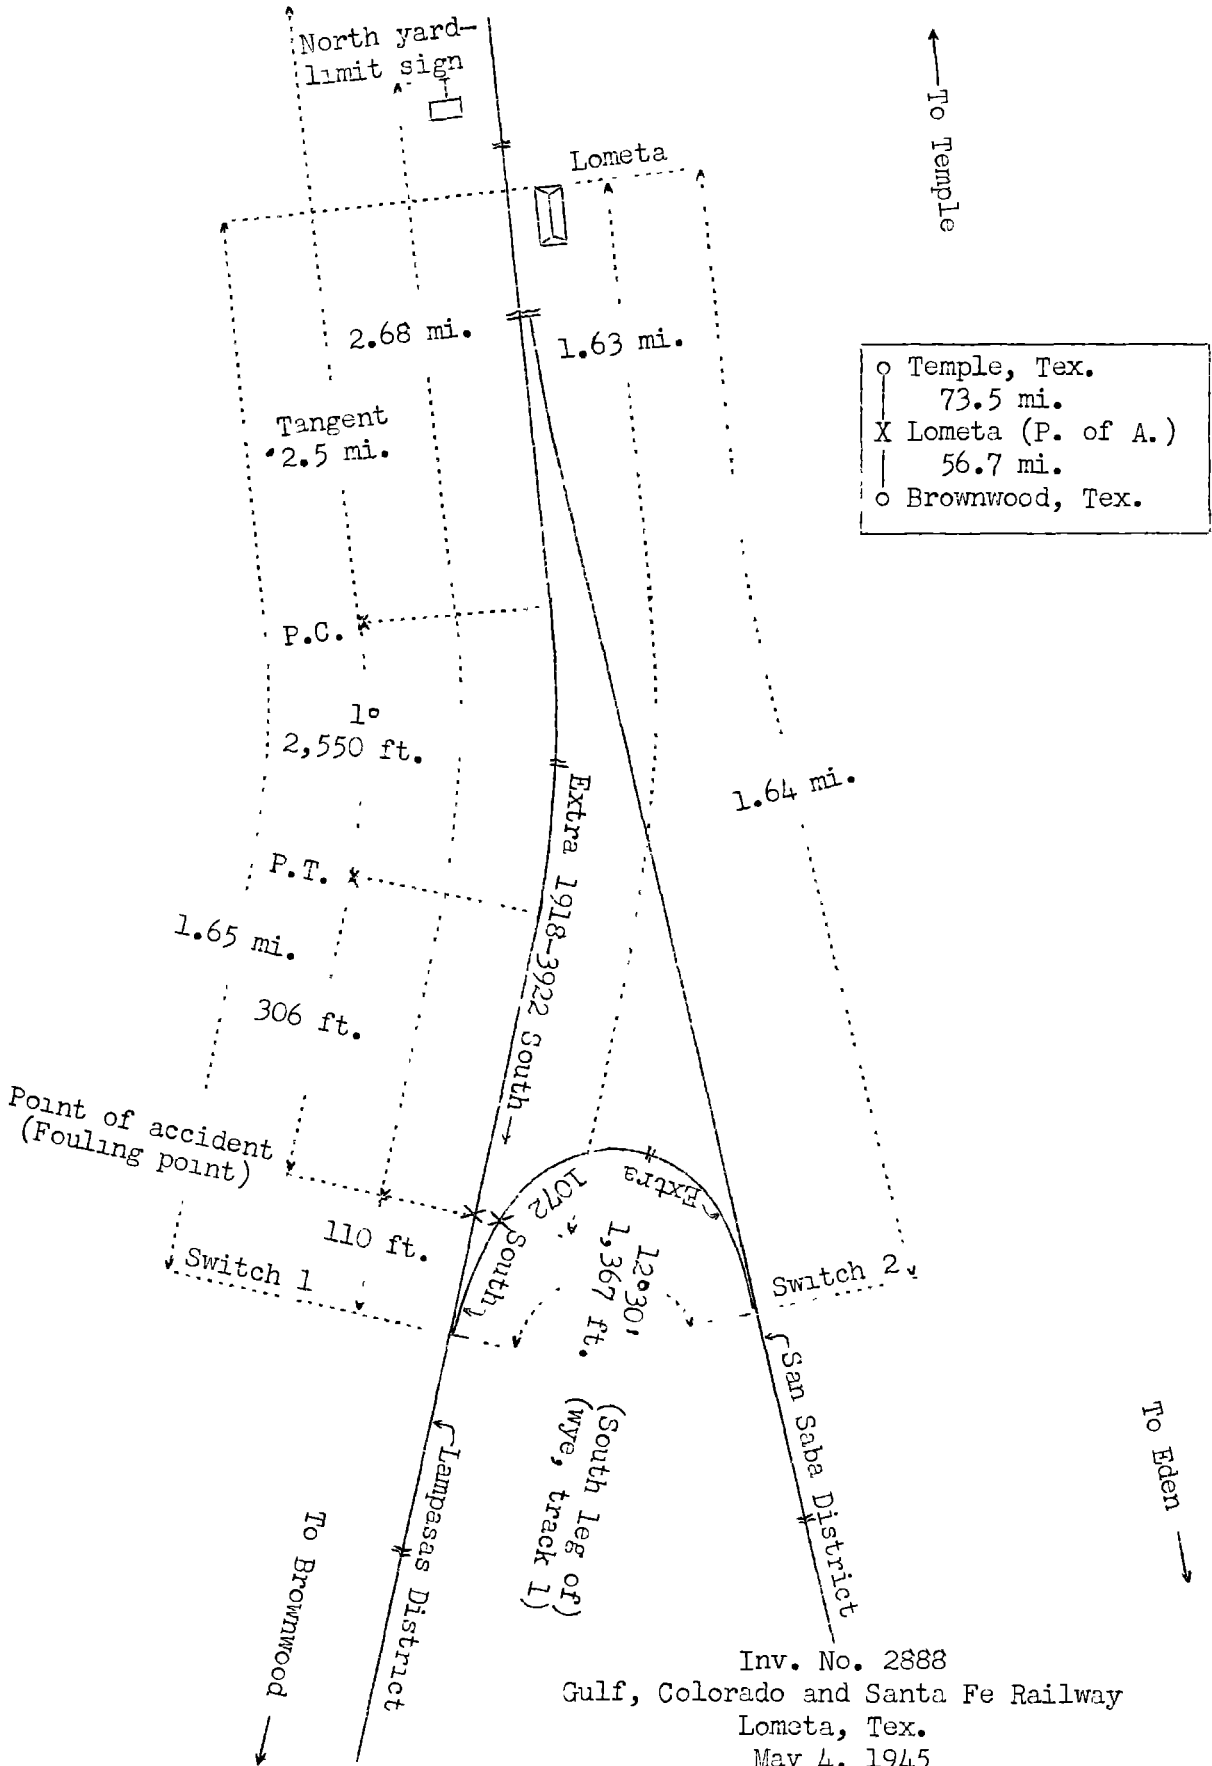
Inv. No. 2888
 Gulf, Colorado and Santa Fe Railway
 Lometa, Tex.
 May 4, 1945

| o | Temple, Tex. | 73.5 mi. |
| X | Lometa (P. of A.) | 56.7 mi. |
| o | Brownwood, Tex. | |

This accident occurred on that part of the Southern Division designated as the Lampasas District and extending westward from Temple to Lometa, Texas, 73.5 miles, and thence north-westward to Brownwood, Texas, 56.7 miles, a single-track line. In the vicinity of the point of accident trains are operated by timetable and train orders. There is no block system in use. Within yard limits at Lometa this line converges with a single-track line designated as the San Saba District and extending westward to Eden, Texas, 98 miles. According to timetable directions trains moving from Temple to Brownwood are south-bound, and trains moving from Eden to Lometa are north-bound. Hereinafter, time-table directions are used in this report. The south leg of a wye, 1,367 feet long and hereinafter referred to as track 1, connects the line of the Lampasas District and the line of the San Saba District. The switch of track 1 on the Lampasas District, hereinafter referred to as switch 1, is 1.65 miles south of the station. The switch of track 1 on the San Saba District, hereinafter referred to as switch 2, is 1.64 miles south of the station. The accident occurred 2.68 miles south of the north yard-limit sign and 1.63 miles south of the station, at the fouling point of the Lampasas District main track and the turnout of switch 1. From the north on the Lampasas District the main track is tangent throughout a distance of about 2.5 miles, then there is a 1° curve to the right 2,550 feet, which is followed by a tangent 306 feet to the point of accident and a considerable distance southward. For movements from the San Saba District to the Lampasas District on track 1 the curvature is 12°30' to the left. On the Lampasas District the grade for south-bound trains is 1.20 percent descending 1,700 feet, then there is a vertical curve 1,000 feet, which is followed by a 1.24 percent ascending grade 1,150 feet to the point of accident and 850 feet southward.
