REPORT NO. 3355
GULF, COLORADO AND SANTA FE RAILWAY COMPANY
IN RE ACCIDENT
NEAR LOMETA, TEX., ON
AUGUST 31, 1950

Accident near Lometa, Tex., on August 31, 1950, caused
by broken joint bars.

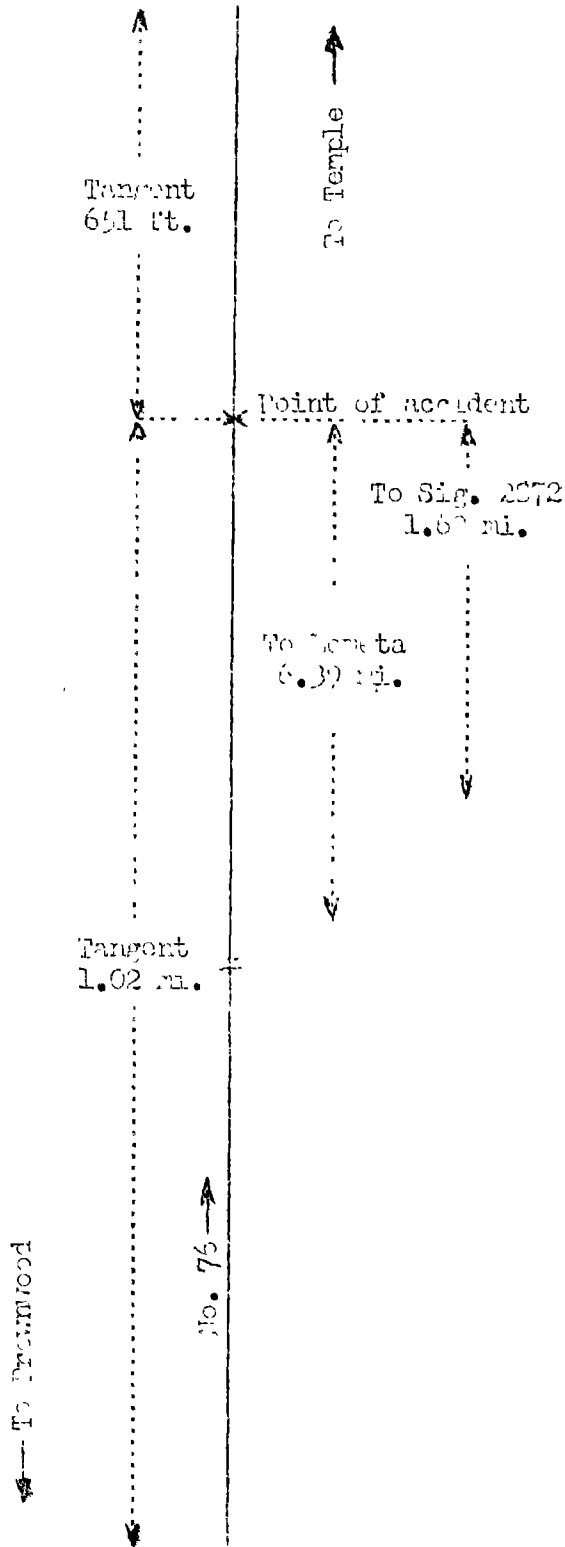
Report No. 3355
 Gulf, Colorado and Santa Fe Railway
 Loneta, Tex.
 August 31, 1950

o Temple, Tex.
67.11 mi.
X Point of accident
6.39 mi.
o Loneta
56.30 mi.
o Brownwood, Tex.

Location of Accident and Method of Operation
