INVESTIGATION NO. 2762
THE GULF, COLORADO AND SANTA FE RAILWAY COMPANY
REPORT IN RE ACCIDENT
AT NOVICT, TEX., ON
JANUARY 13, 1944

Railroad: Gulf, Colorado and Santa Fe
Date: January 13, 1944
Location: Novice, Tex.
Kind of accident: Rear-end collision
Trains involved: Passenger : Passenger
Train numbers: Second 75 : Extra 1279 South
Engine numbers: 3432 : 1279
Consist: 12 cars : 4 cars
Speed: Standing : 30 m. p. h.
Operation: Timetable and train orders
Track: Single; tangent; 0.4 percent
descending grade southward
Weather: Snowing
Time: About 12:52 p. m.
Casualties: 7 killed; 105 injured
Cause: Failure of the Gulf, Colorado and
Santa Fe Railway Company to pro-
vide adequate safeguards for
movement of trains
Recommendation: That the Gulf, Colorado and Santa
Fe Railway Company establish an
adequate block system on the line
on which this accident occurred

Accident at Novice, Tex., on January 13, 1944, caused by failure of the Gulf, Colorado and Santa Fe Railway Company to provide adequate safeguards for the movement of trains.

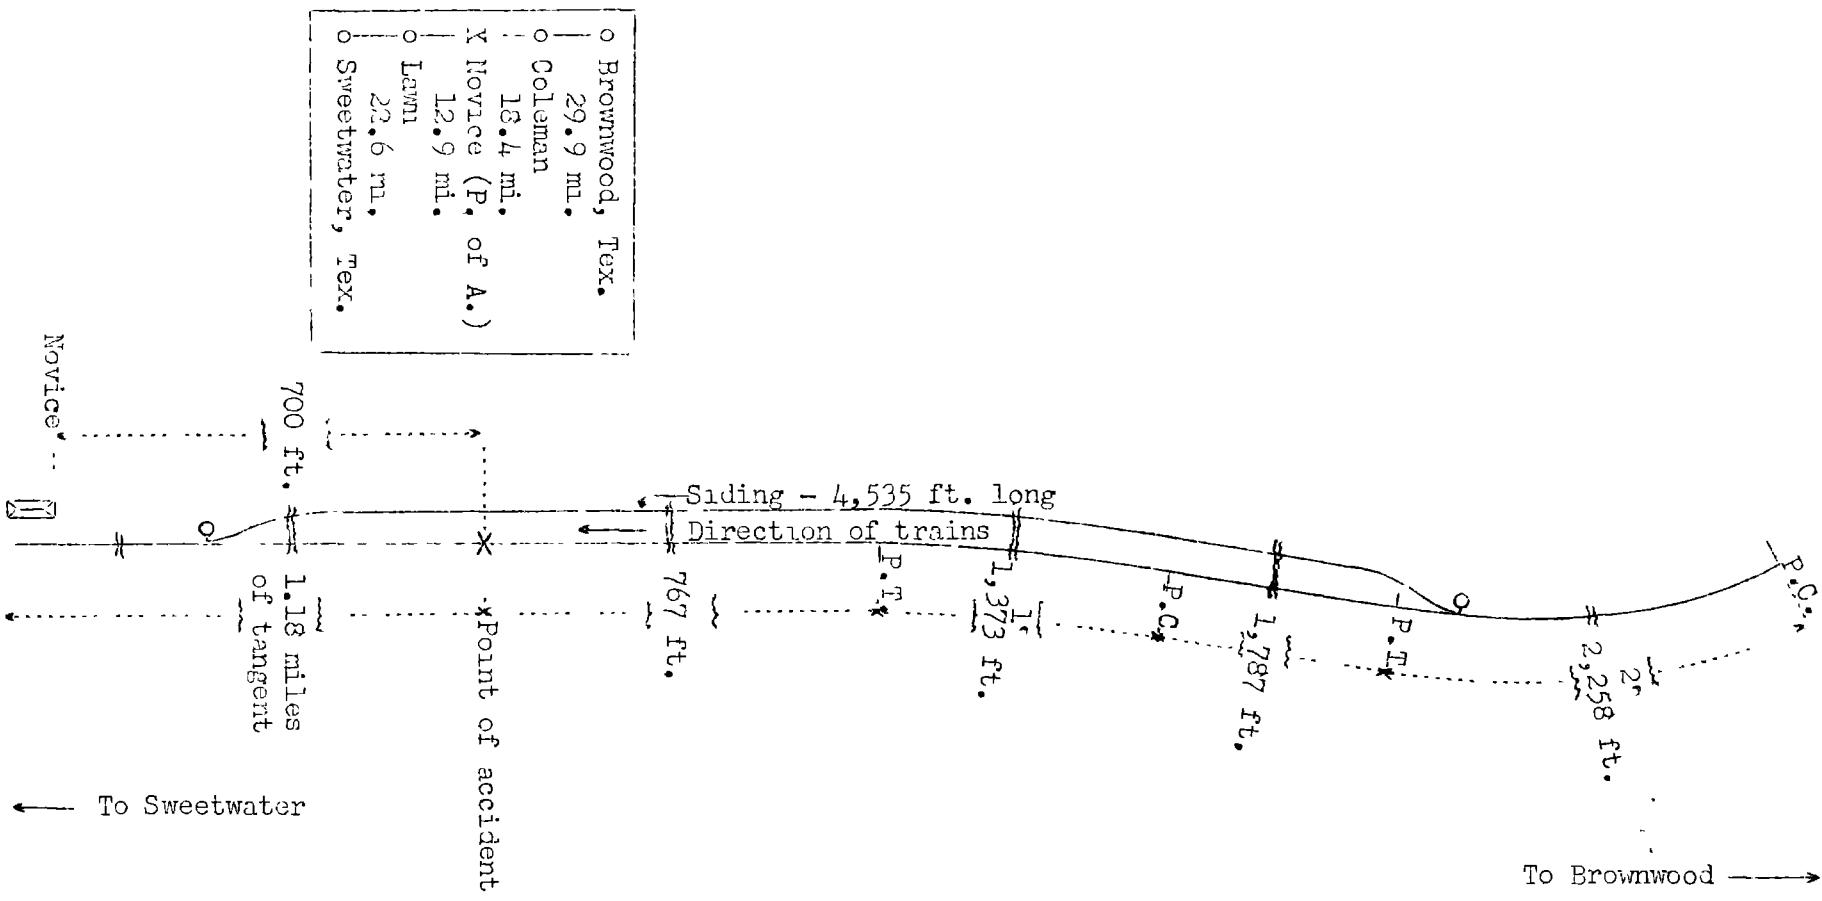
Inv-2762
Gulf, Colorado and Santa Fe Railway
Novice, Tex.
January 13, 1944

This accident occurred on that part of the Southern Division designated as the Sweetwater District and extending between Brownwood and Sweetwater, Tex., 113.8 miles. In the vicinity of the point of accident this was a single-track line over which trains were operated by timetable and train orders. There was no block system in use. The accident occurred on the main track 700 feet north of the station at Novice. From the north there were, in succession, a 2° curve to the right 2,258 feet in length, a tangent 1,787 feet, a 1° curve to the left 1,373 feet, and a tangent 767 feet to the point of accident and 1.18 miles beyond. At this point the grade was 0.4 percent descending southward.
