ACCIDENT ON THE
HOUSTON BELT & TERMINAL RAILWAY

HOUSTON, TEX.

AUGUST 3, 1937

INVESTIGATION NO. 2192

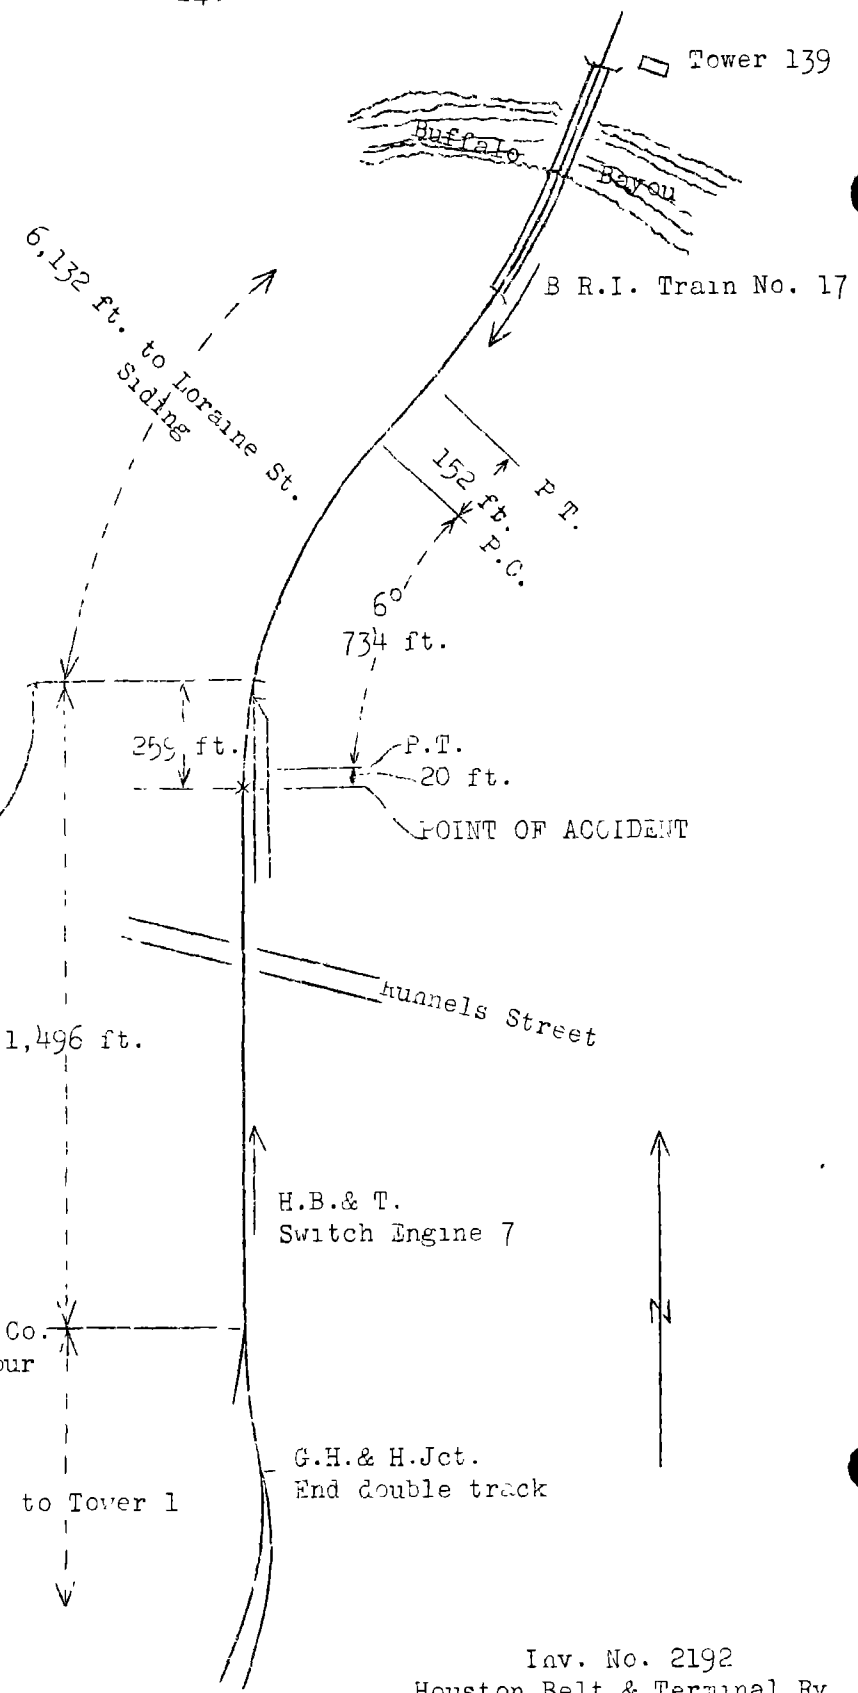
Inv. No. 2192
 Houston Belt & Terminal Ry.
 Houston, Texas
 August 3, 1937

- Gulf Coast, Texas
1.68 mi.
- Belt Junction
2.71 mi.
- Loraine St. Siding
0.31 mi.
- Tower 26
0.53 mi.
- Tower 139
0.10 mi.
- Buffalo Bayou D.B.
0.32 mi.
- ✕ Point of accident
0.60 mi.
- Tower 1
0.18 mi.
- Houston Union Station, Tex.

South Texas Stone Co. switch

This accident occurred on the North Belt District, which extends between Gulf Coast and Houston Union Station, a distance of 6.43 miles; in the immediate vicinity of the point of accident this is a jointly used single-track line over which trains are operated by timetable and train orders, no block-signal system being in use. Hereinafter the Burlington-Rock Island Railroad is referred to as the B-RI, and the Houston Belt & Terminal Railway, as the HB&T. The accident occurred within yard limits and on the main track, about 1 mile north of Houston Union Station, at a point 259 feet south of a facing-point switch for southward movements, which leads to the South Texas Stone Company's spur track. Approaching the point of accident from the north there are several tangents and short curves, then 152 feet of tangent, followed by a 6° curve to the left 734 feet in length and 20 feet of tangent to the point of accident, this tangent extending 1,086 feet beyond. The grade in this locality is undulating, being 1 percent ascending southward for a distance of 214 feet to the point of accident, and for 400 feet beyond; it is then practically level for about 1,300 feet.
