INVESTIGATION NO 2534
THE HUDSON & MANHATTAN RAILROAD COMPANY
REPORT IN RE ACCIDENT
AT EXCHANGE PLACE STATION,
JERSEY CITY, N. J., ON
APRIL 26, 1942

Kind of accident: Derailment

Accident at Exchange Place Station, Jersey City, N. J., on
April 26, 1942, caused by excessive speed on sharp
curve.

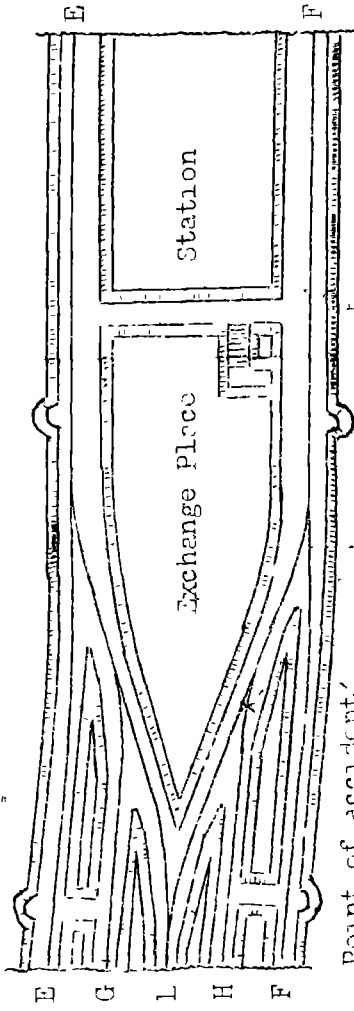
Inv-2584
 Hudson & Manhattan Railroad
 Exchange Place Station,
 Jersey City, N. J.
 Apr 26, 1942

- 5.69 mi. → Hudson Terminal, New York City, N. Y.
- 3.20 mi. X Exchange Place Sta., Jersey City, N. J.
- Grove Street Sta.
- Journal Square
- Harrison
- Market Street Sta., Newark, N. J.

Location of Accident and Method of Operation

MU coach 1972 was derailed to the north. It demolished signal 399B and stopped upright and in line with the track, with its front end standing 303 feet east of the first mark of derailment. The first and second cars were separated a distance of 65 feet. The left front corner and the right front corner-post of the first car were damaged as a result of striking the tunnel wall and the signal equipment, and the left side was scraped near the rear end as a result of rubbing against the station platform, which is 3 feet 6 inches above the level of the rails. The second car became detached from its trucks and stopped, badly damaged, in line with the track and leaned to the north at an angle of 45 degrees. The third car became detached from its trucks and stopped, badly damaged, behind the second car. The front end of the fourth car overrode the station platform a distance of about 20 feet, and the rear end remained on its truck but was disengaged from the center plate. This car stopped against the third car, and the third car telescoped the right side of the fourth car a distance of about 3 feet. The rear two cars were neither derailed nor damaged. The track at the west entrance of the station was destroyed.

The signal system was so arranged that if a train exceeded an average speed of 6.6 miles per hour between signals 399B and 229, the train would receive a stop indication at signal 229 and the automatic train-stop system would cause the brakes to become applied if the train passed signal 229 while this signal was displaying stop. Since signal 229 was located east of the point of accident, this signal did not protect movement over the sharp turnout involved. If the signals on the descending grade west of signal 229 had been time signals under all conditions, the train-stop system would have caused the brakes of the train involved to become applied whenever the authorized speed between two signals was exceeded, and undoubtedly this accident would not have occurred.
