INTERSTATE COMMERCE COMMISSION
WASHINGTON

REPORT OF THE DIRECTOR
BUREAU OF SAFETY

ACCIDENT ON THE
ILLINOIS CENTRAL RAILROAD

ARCOLA, ILL.

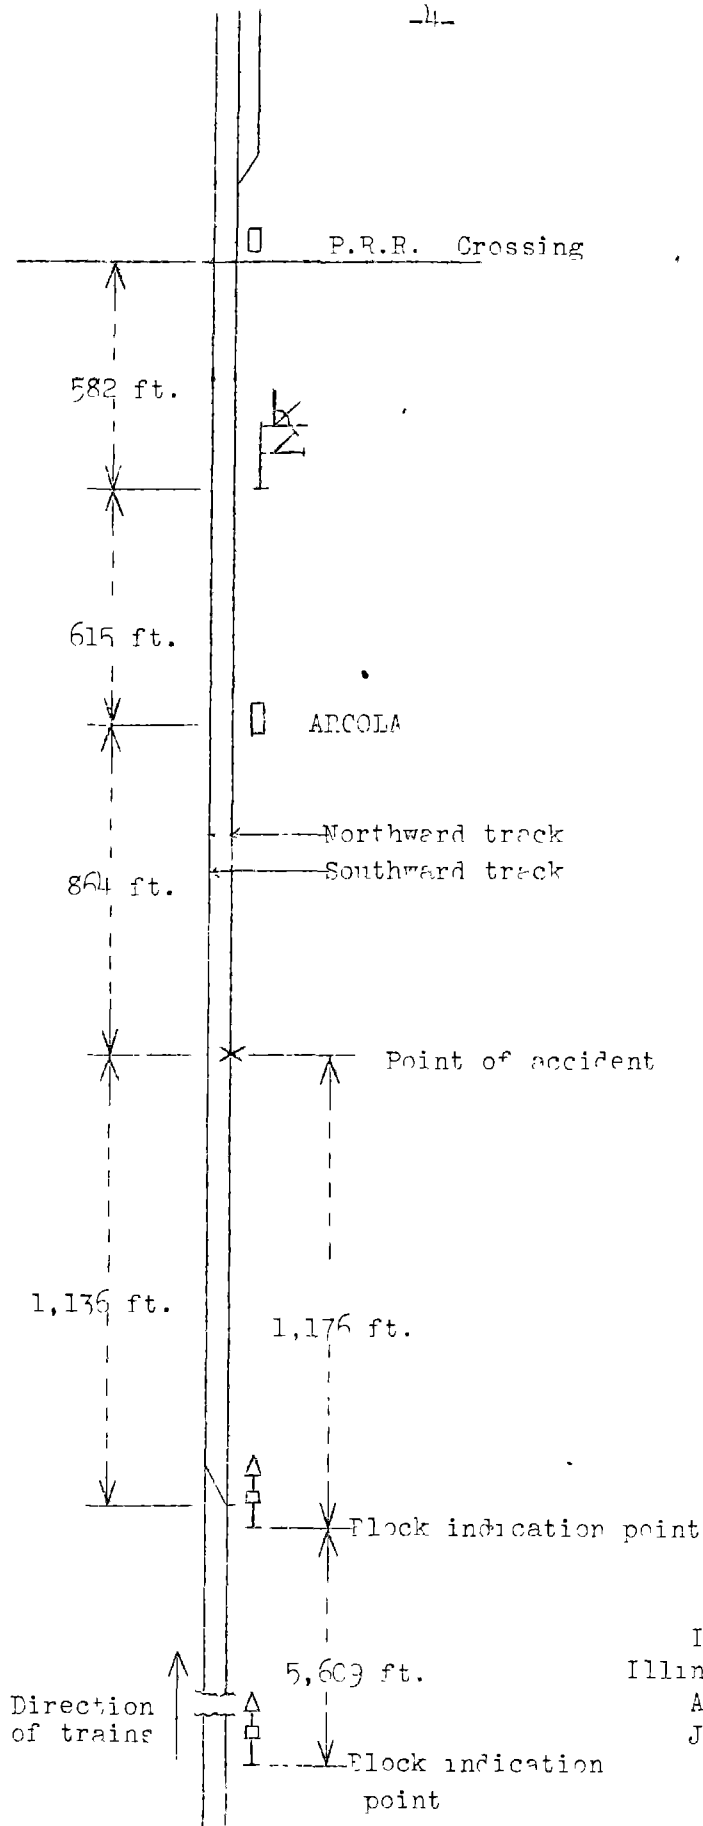
Inv. No. 2403
 Illinois Central R.P.
 Arcola, Ill.
 Jan. 1, 1940

o	Champaign, Ill.
	22.0 mi.
o	Fuscola
	8.1 mi.
x	Arcola (Point of accident)
	5.7 mi.
o	Humboldt
	8.8 mi.
o	Wattoon
	11.9 mi.
o	Neoga
	14.9 mi.
o	Effingham
	15.4 mi.
o	Edgewood
	3.9 mi.
o	LaCade
	4.6 mi.
o	Farina
	5.8 mi.
o	Kinmundv
	15.3 mi.
o	Odin
	5.7 mi.
o	Branch Junction
	2.7 mi.
o	Centralia, Ill.

The automatic cab-signal and train stop system is of the continuous-inductive type; engines are equipped with two-indication color-light cab signals which display either a green or a red aspect. There are no wayside signals except semiautomatic home signals located at interlockings. Cab signals are actuated at block-indication points which correspond with the points at which wayside signals, if used, would be located. When the cab signal changes from a green to a red aspect a warning whistle in the cab of the engine sounds; if the red aspect is not acknowledged within 6 seconds, by operation of the engineman's acknowledging lever, an automatic brake application sufficient to stop the train will occur. When a brake application is forestalled by an engineman, the train may proceed under his control in accordance with operating rules. When a train is operated under a red cab-signal aspect in two consecutive blocks and it passes a block-indication point between the two blocks, the cab signal changes to green while the engine is moving over an energized section of the track 200 feet in advance of the block-indication point and then changes back to a red aspect, which causes the cab warning-whistle to sound and the automatic train-stop device to operate if it is not forestalled by the engineman. Block-indication points are located 6,785 and 1,176 feet south of the point of
