INVESTIGATION NO. 2974  
ILLINOIS CENTRAL RAILROAD COMPANY  
REPORT IN RE ACCIDENT  
AT REMSEN, IOWA, ON  
FEBRUARY 15, 1946

Accident at Remsen, Iowa, on February 15, 1946, caused  
by failure of the railroad to provide adequate  
safeguards for the movement of the trains involved.

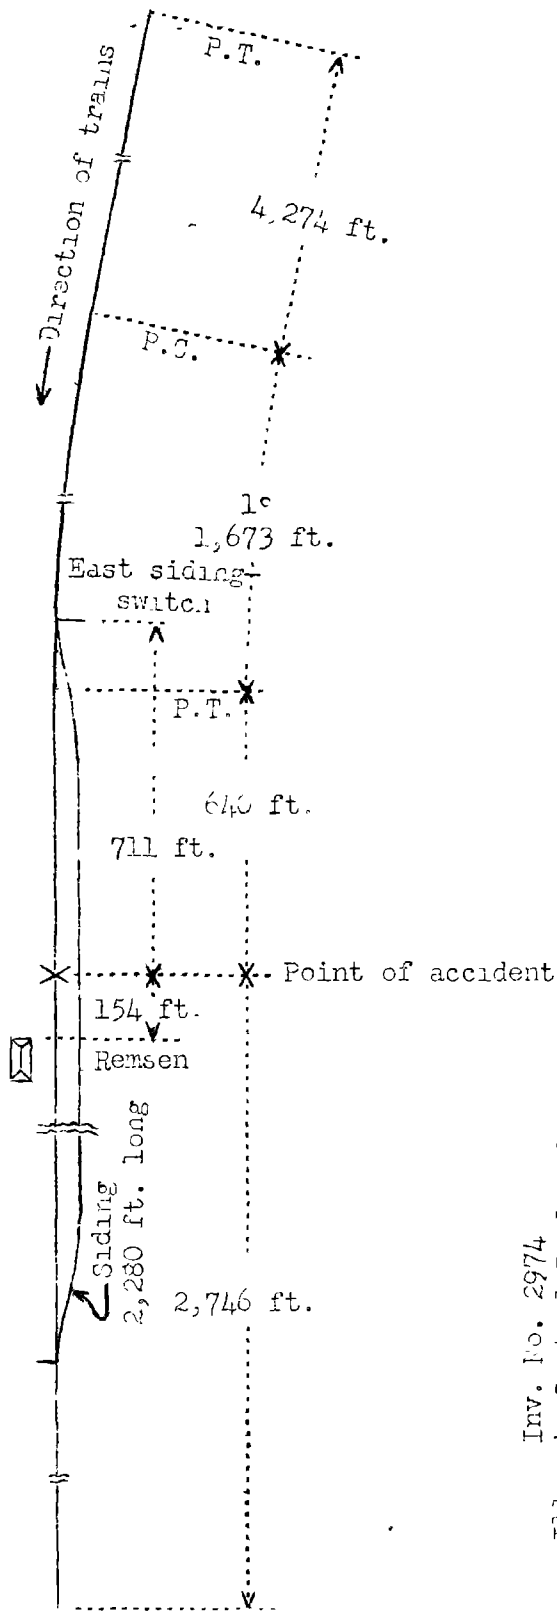
Inv. No. 2974  
 Illinois Central Railroad  
 Remsen, Iowa  
 February 15, 1946

o	Fort Dodge, Iowa	5.9 mi.
o	Tara	69.9 mi.
o	Cherokee	15.1 mi.
o	Marcus	8.5 mi.
X	Remsen (P. of A.)	10.4 mi.
o	Lenars	25.1 mi.
o	Sioux City, Iowa

Location of Accident and Method of Operation
