REPORT OF THE DIRECTOR  
BUREAU OF SAFETY

ACCIDENT ON THE  
ILLINOIS CENTRAL RAILROAD

ROBBS SPUR, ILL.

INVESTIGATION NO. 2325

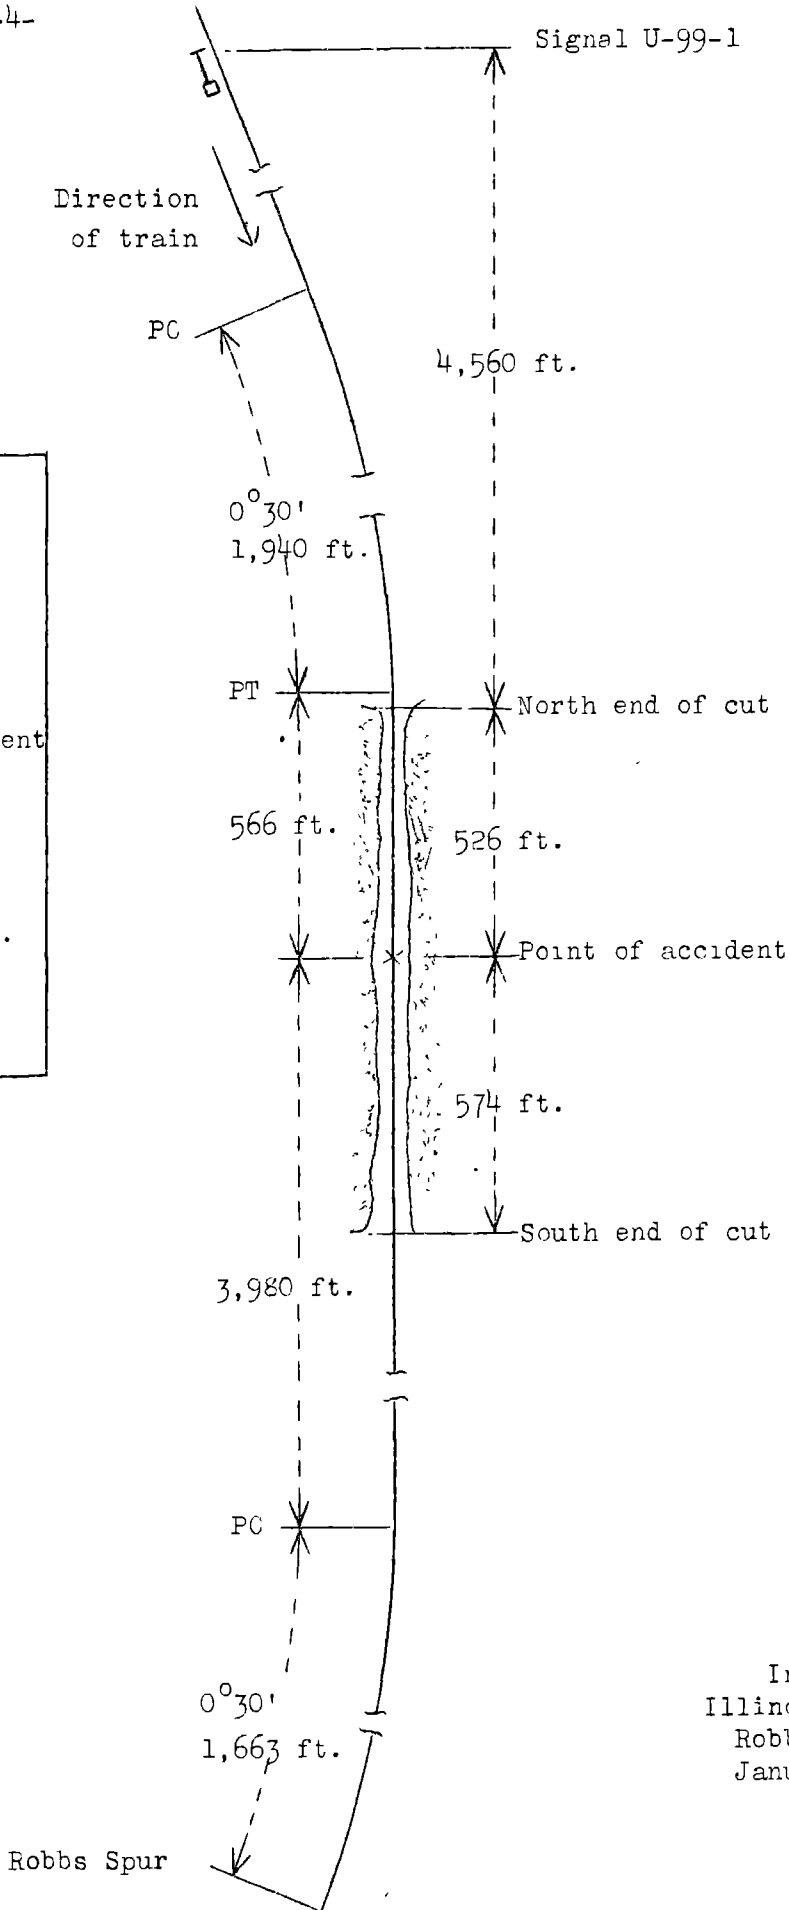
Inv. No. 2325  
 Illinois Central R.R.  
 Robbs Spur, Ill.,  
 January 29, 1939.

o	Bluford, Ill.
	44.2 mi.
o	Delta
	14.9 mi.
X	Point of accident
	1.1 mi.
o	Robbs Spur
	21.2 mi.
o	Metropolis Jct.
	45.6 mi.
o	New Yard, Ky.
